## Monthly Technical Review (Dec 2018 Data)

Flex CFT

23 Jan 2019

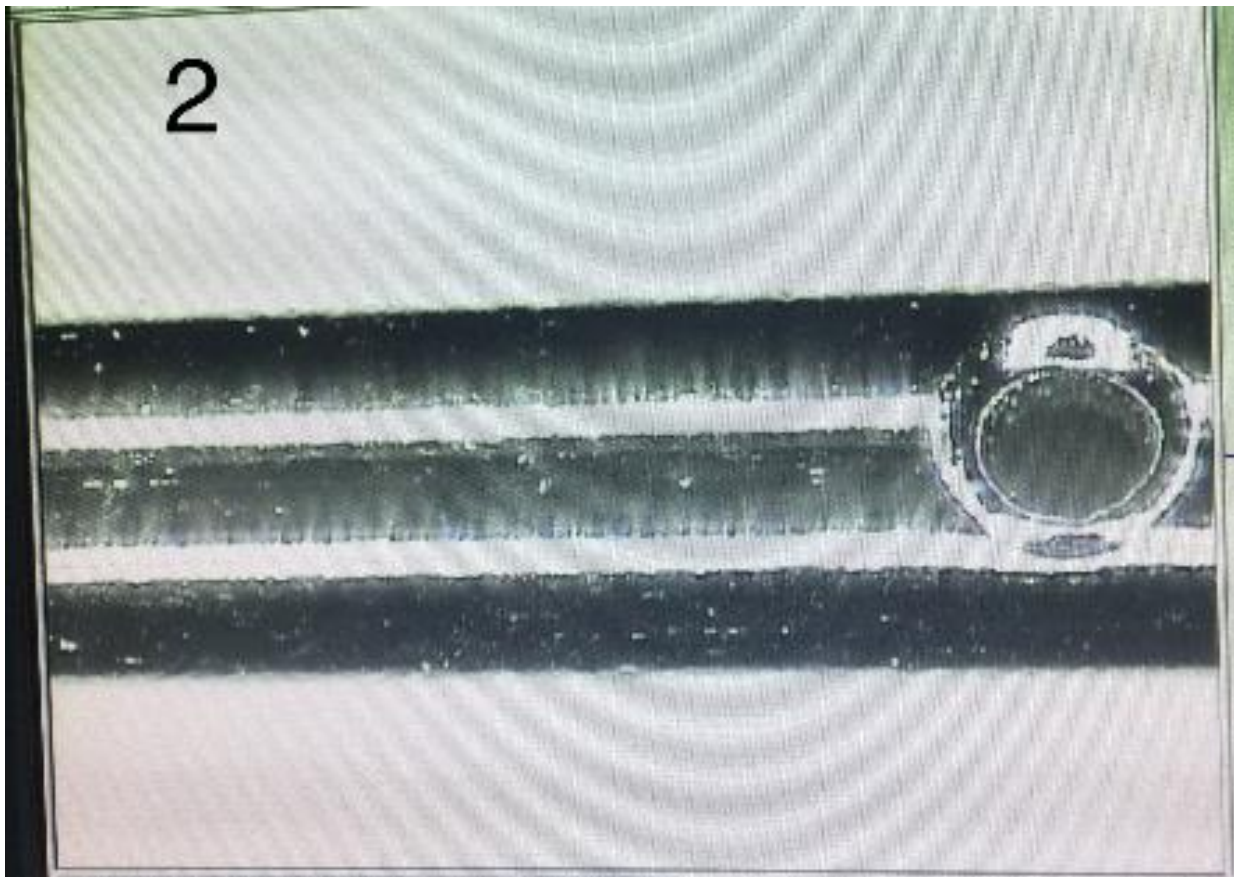
Visual – No scratch (40x mag)

No longitudinal scratches observed

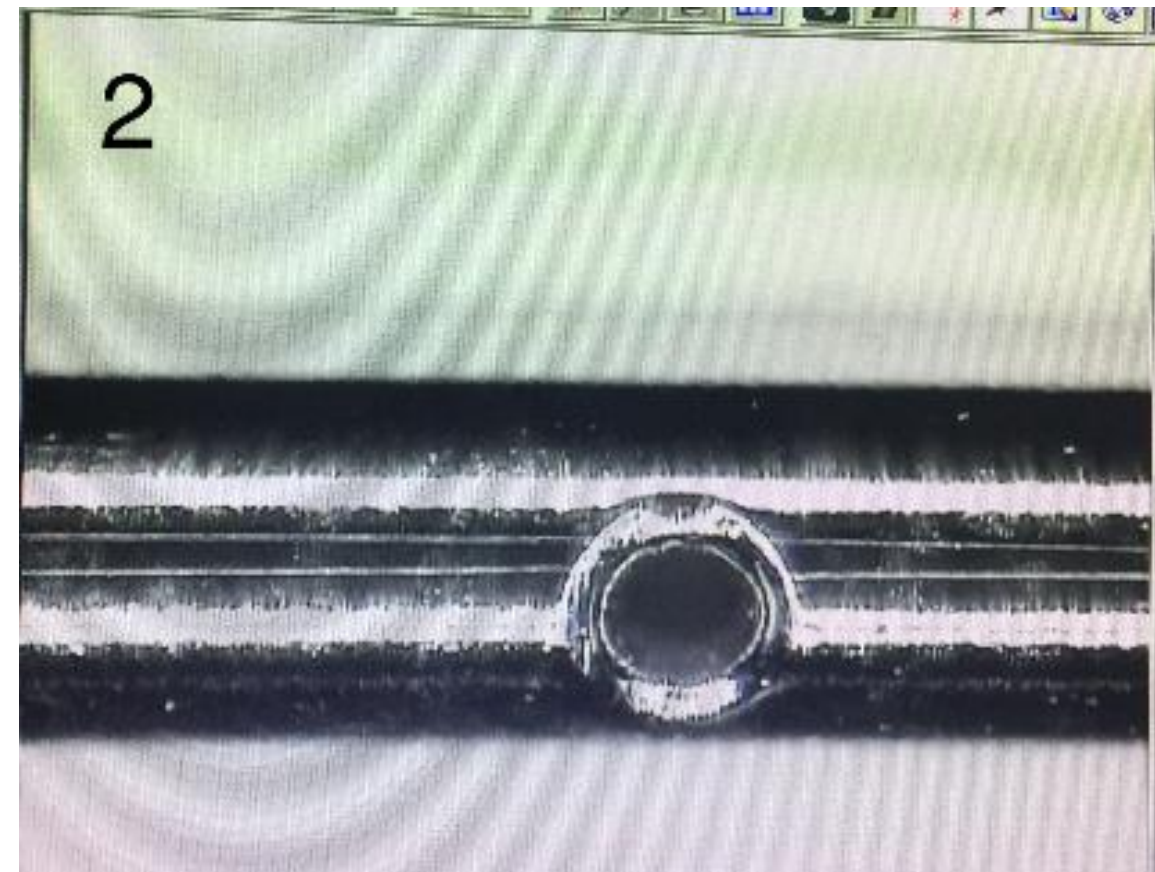
Visual - Scratch observed (40x mag)

Decay Test – PASS

Longitudinal scratches observed

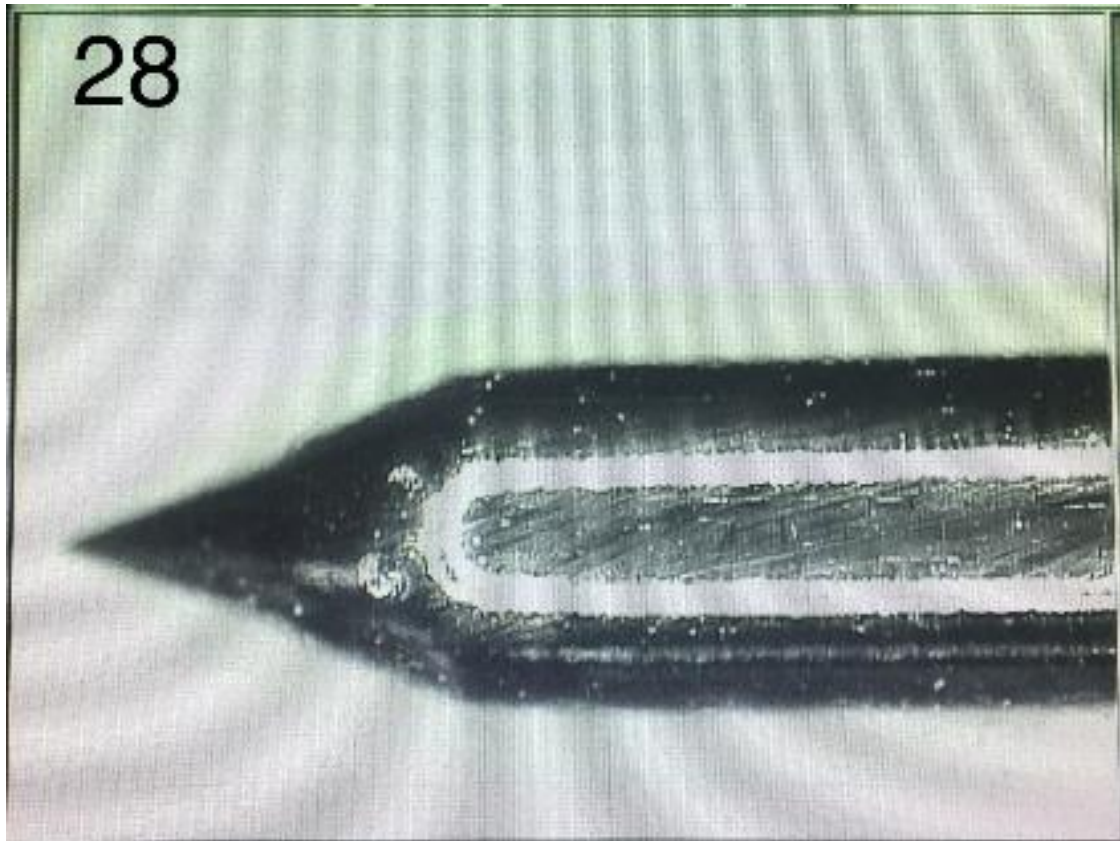
Visual – No scratch (40x mag)

No longitudinal scratches observed

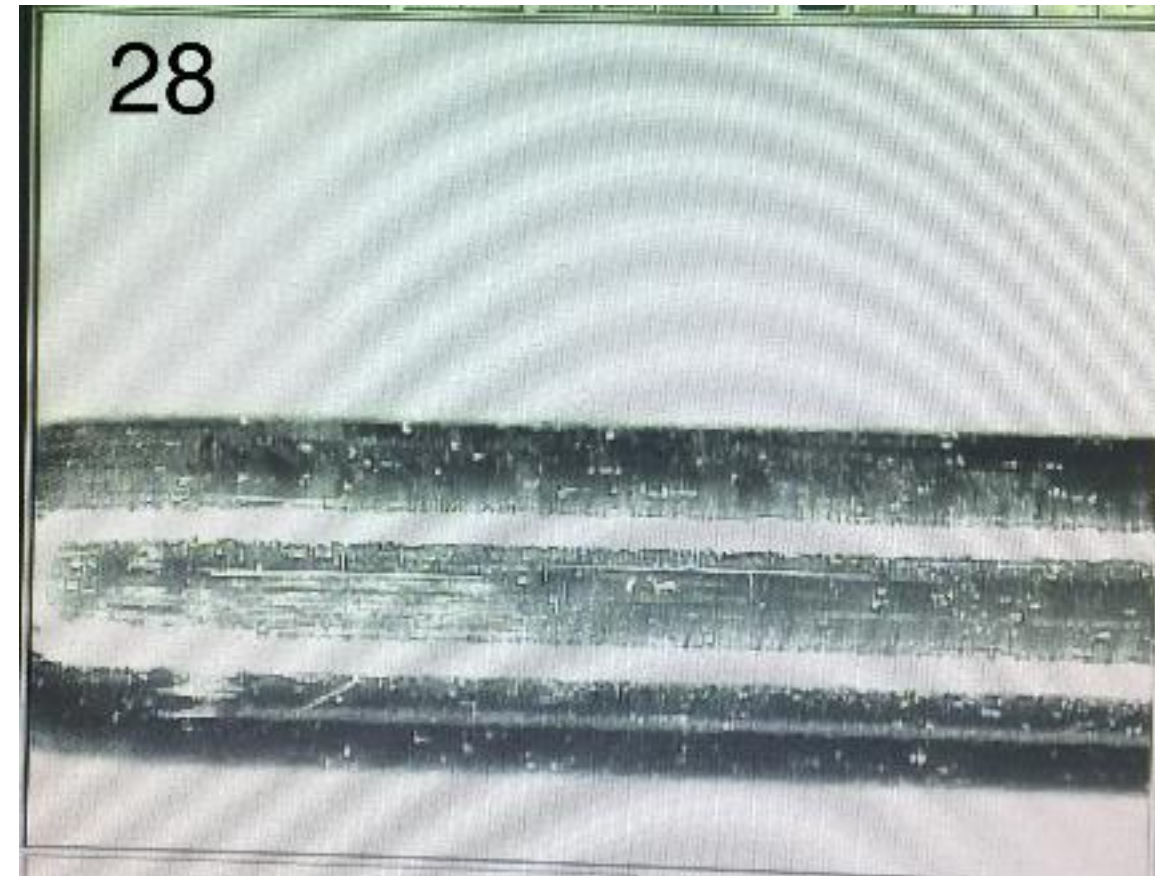
Visual - Scratch observed (40x mag)

Decay Test – PASS

Longitudinal scratches observed

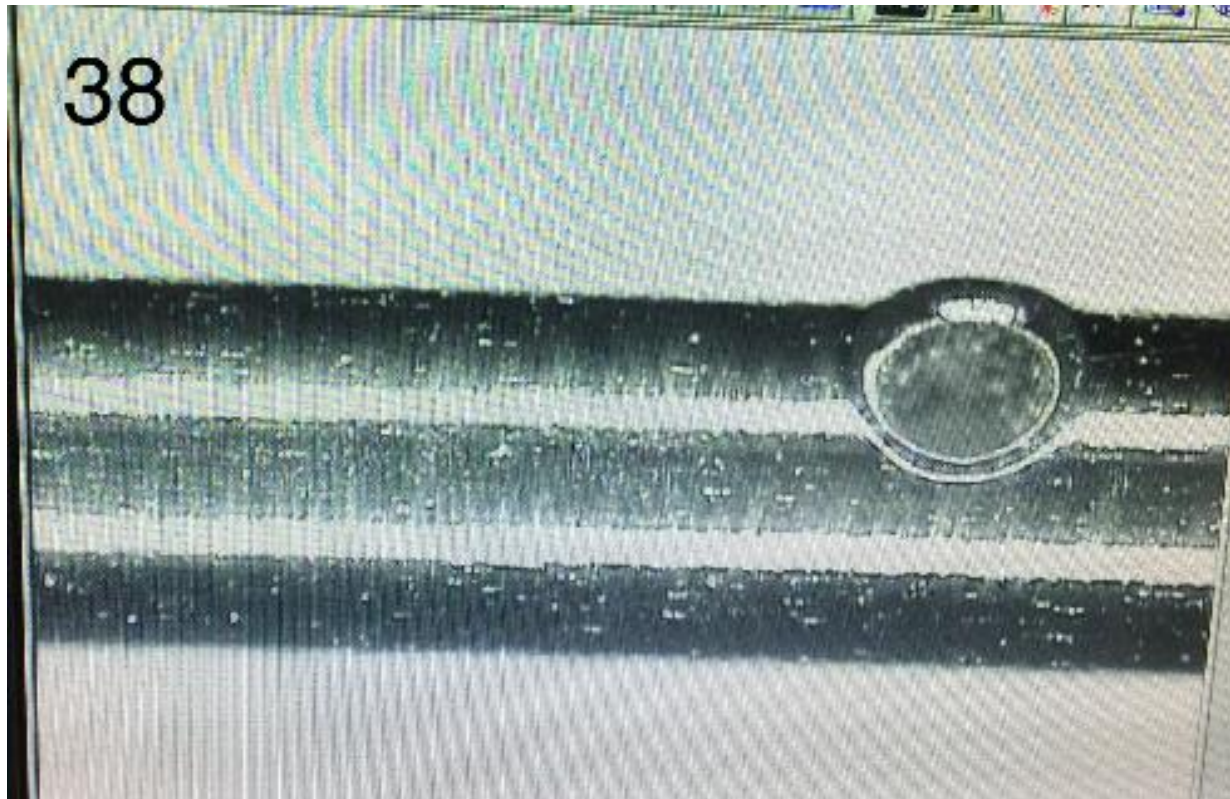
Visual – No scratch (40x mag)

No longitudinal scratches observed

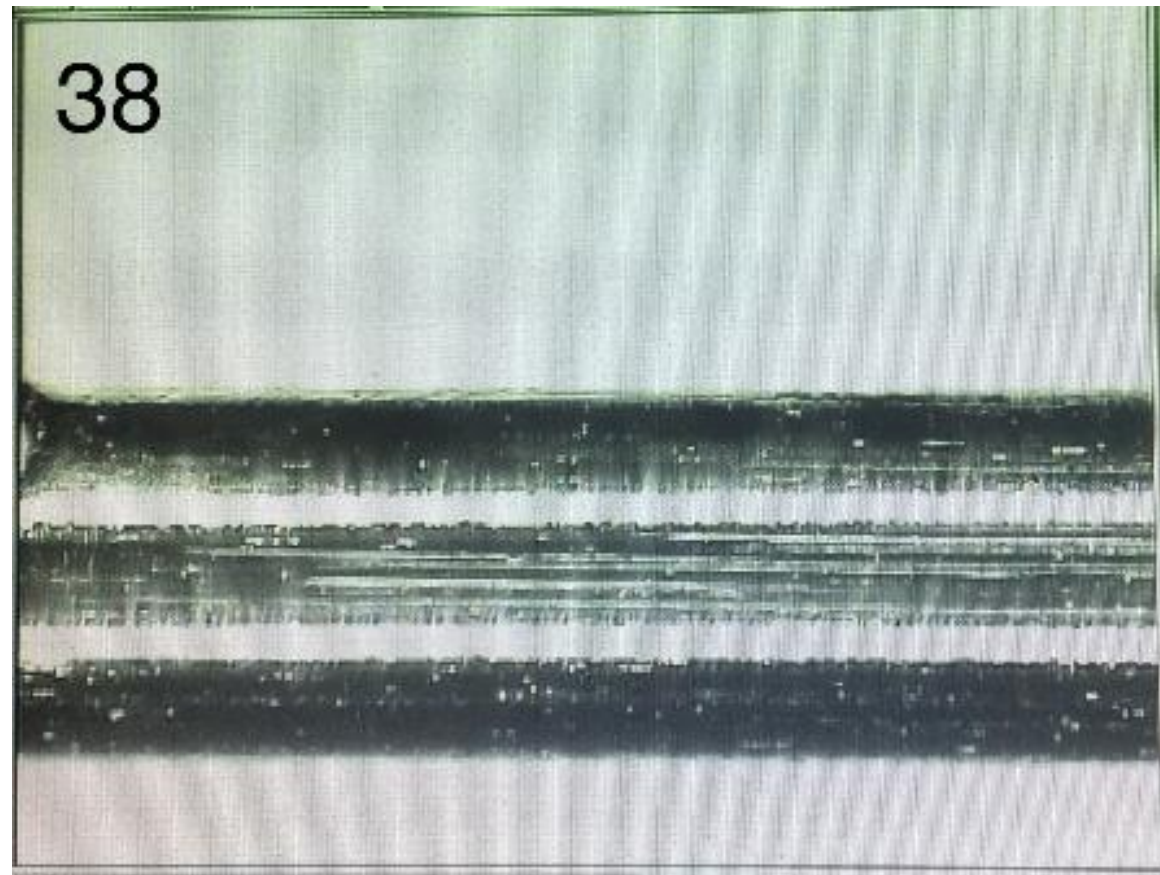
Visual - Scratch observed (40x mag)

Decay Test – PASS

Longitudinal scratches observed

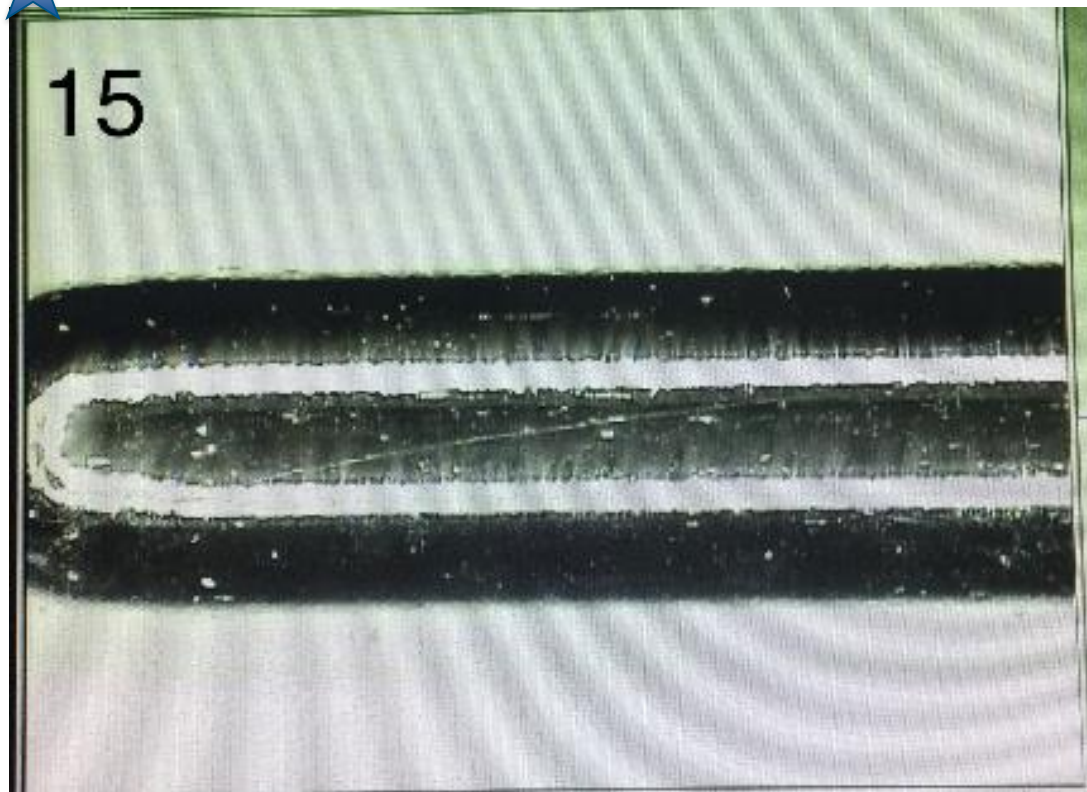
Visual – No longitudinal scratch

Before testing no longitudinal scratches (but 'slanted' scratches observed)

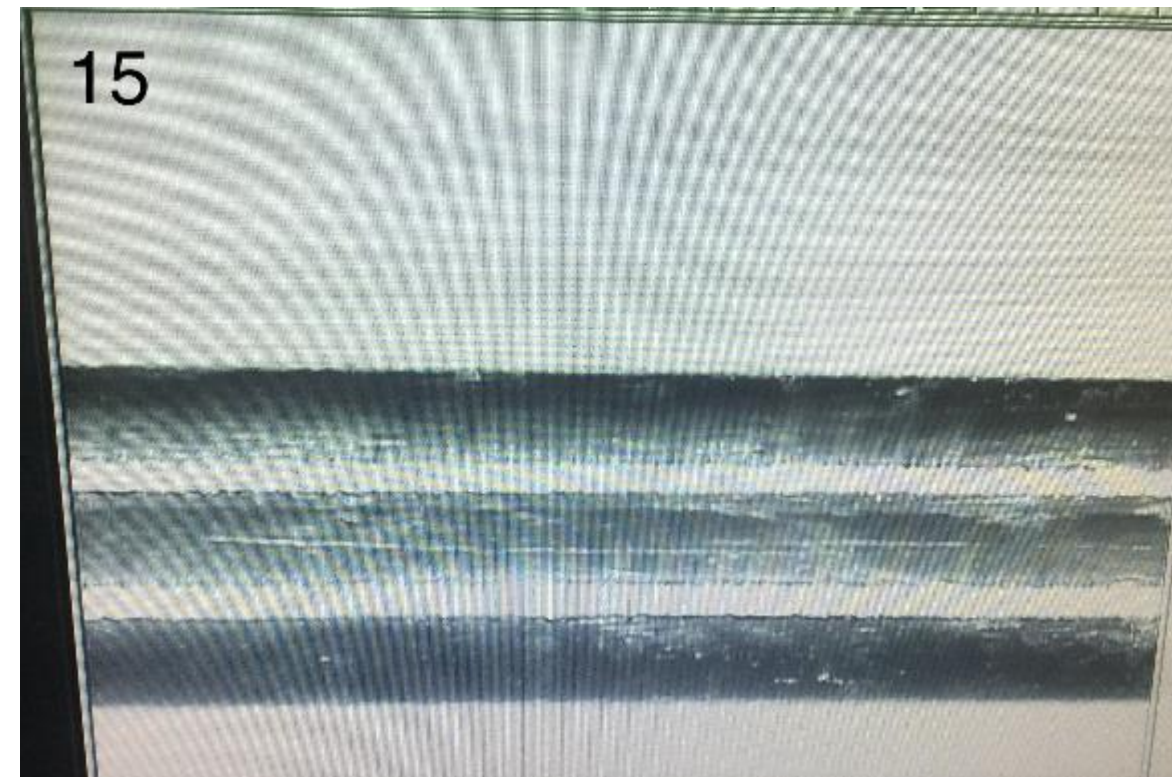
Visual – Longitudinal Scratch observed

Decay Test – **FAIL**

Longitudinal scratches observed

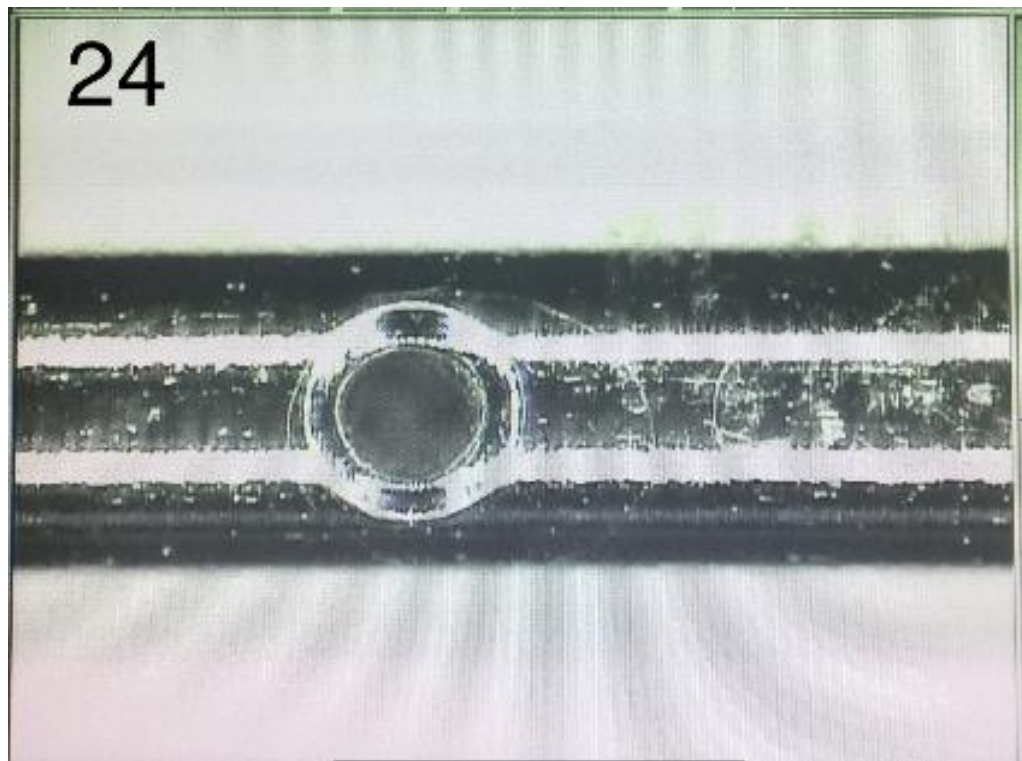
Visual – No longitudinal scratch

Before testing, no longitudinal scratches observed but circular scratches observed near the needle hole as per above photo.

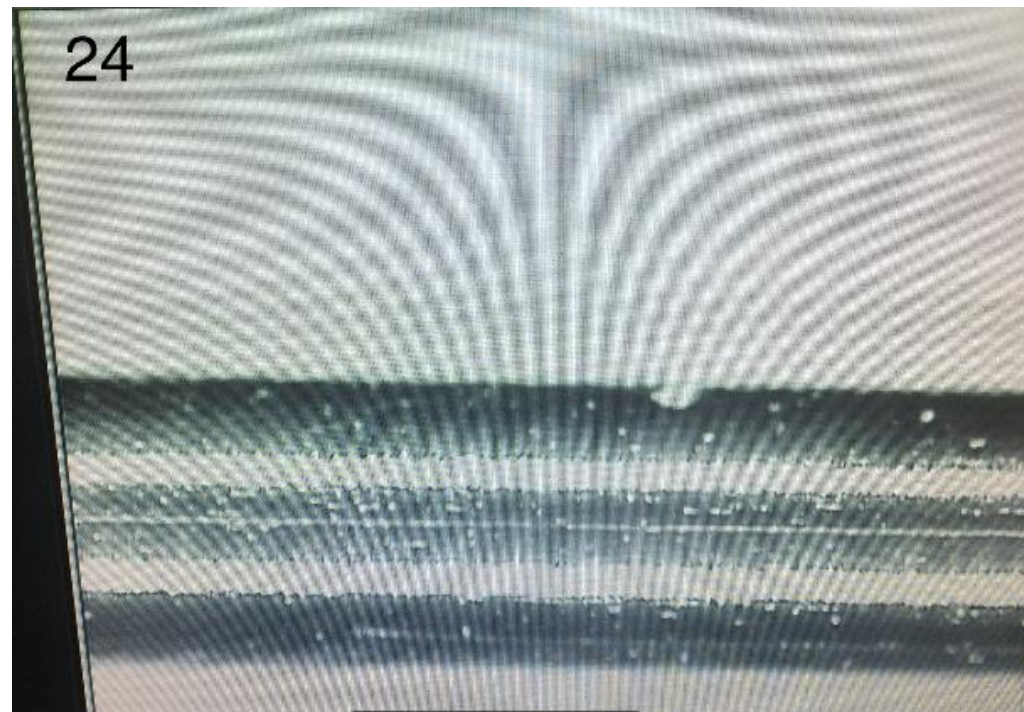
Visual – Longitudinal Scratch observed

Decay Test – **FAIL**

Longitudinal scratches observed

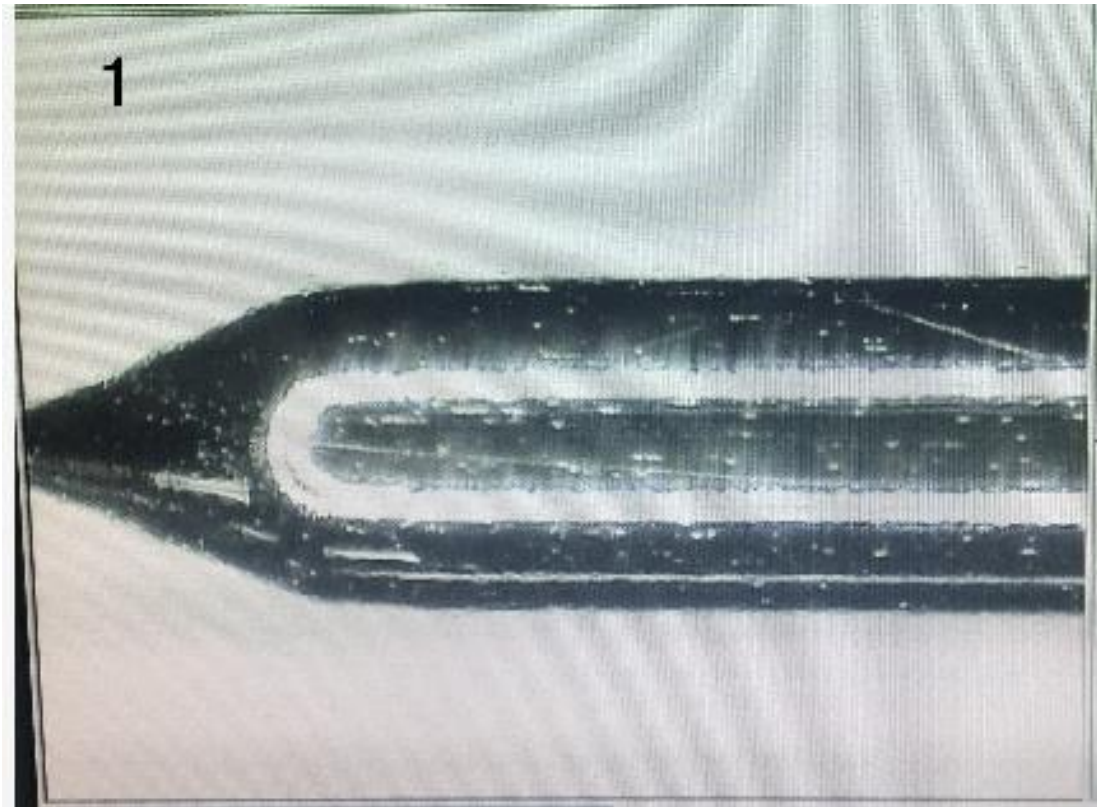
Visual – Longitudinal scratch observed

Before testing, longitudinal scratches observed

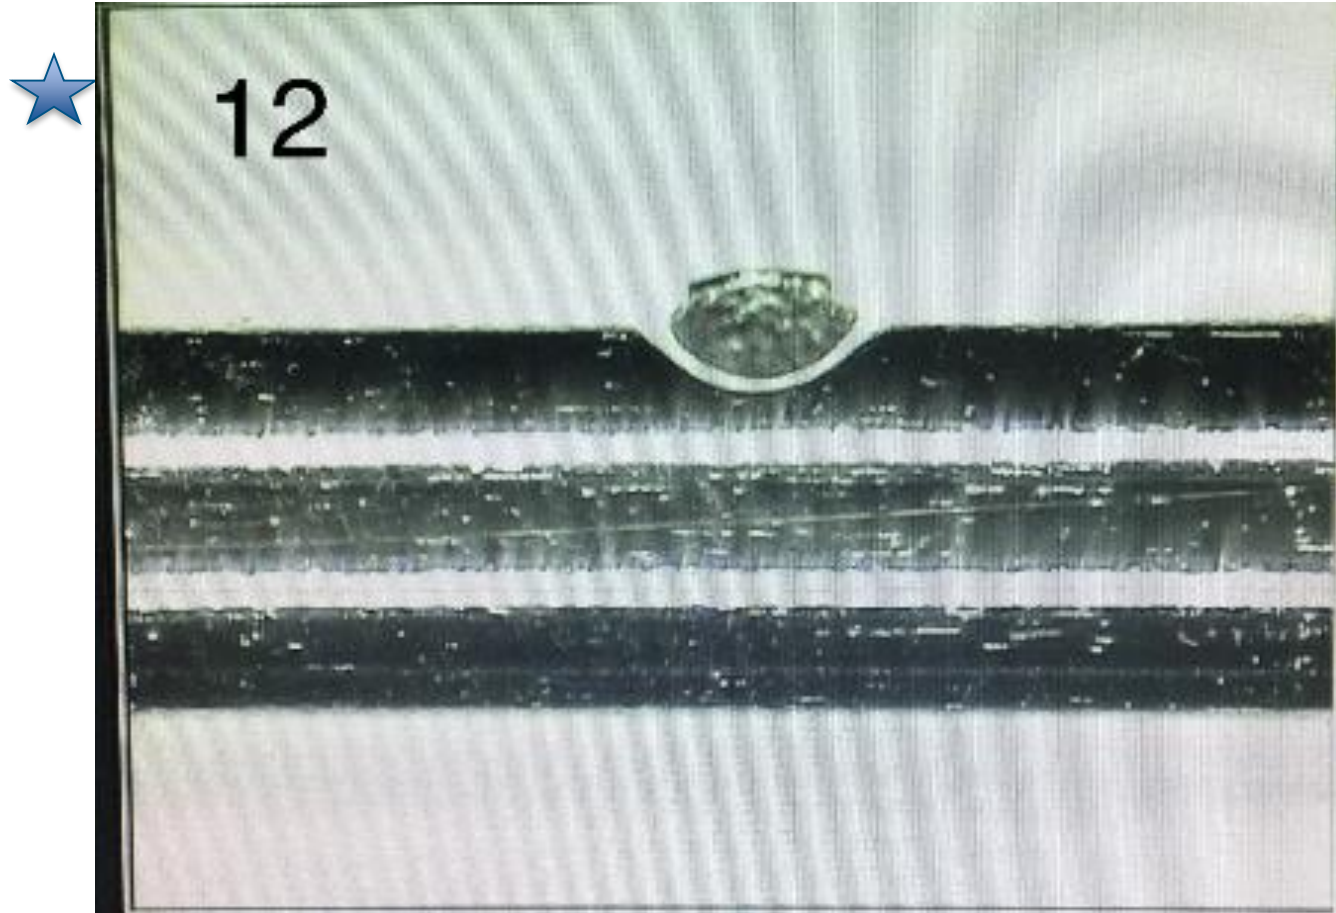
Visual – Longitudinal scratch observed

Before testing, longitudinal scratches observed

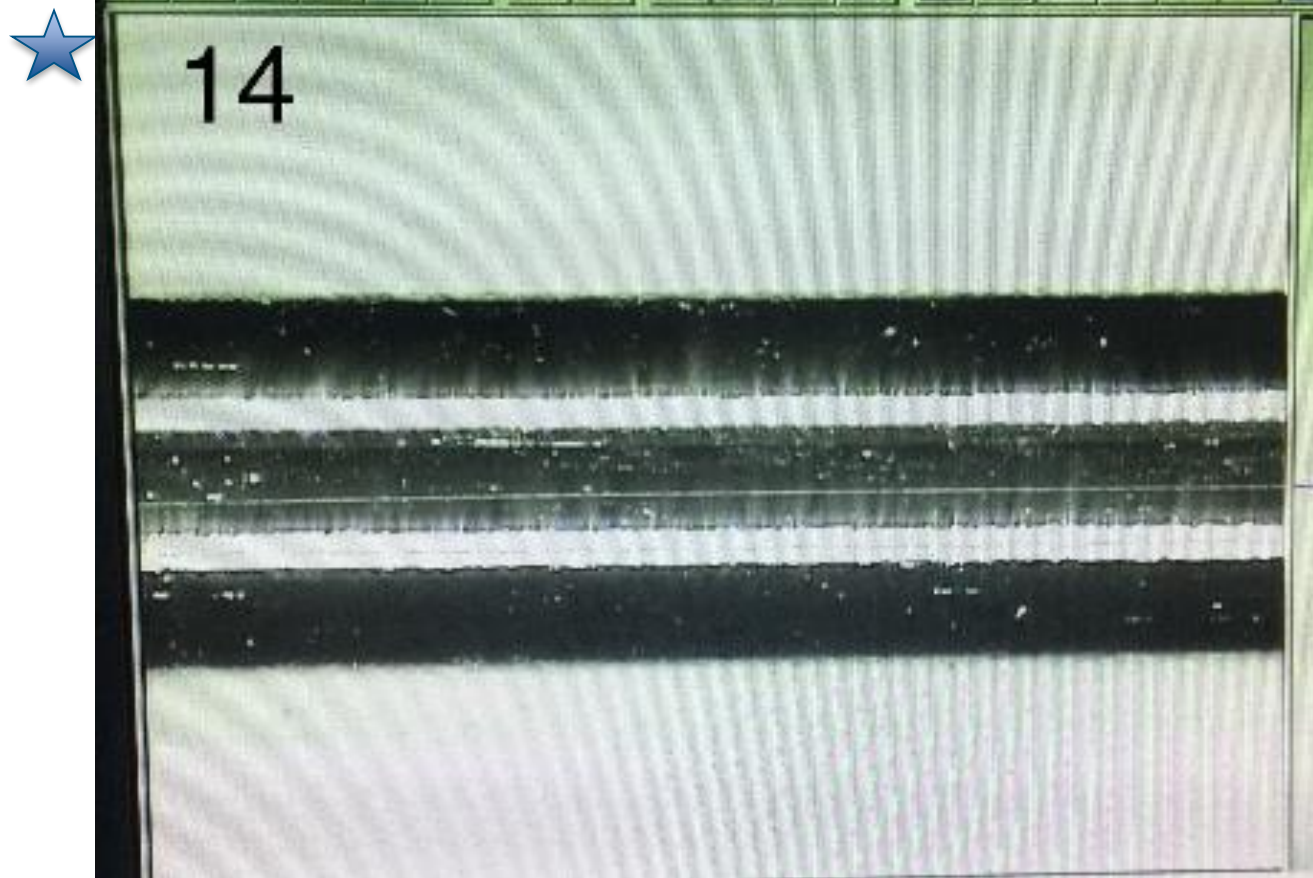
Visual – Longitudinal scratch observed

Before testing, longitudinal scratches observed

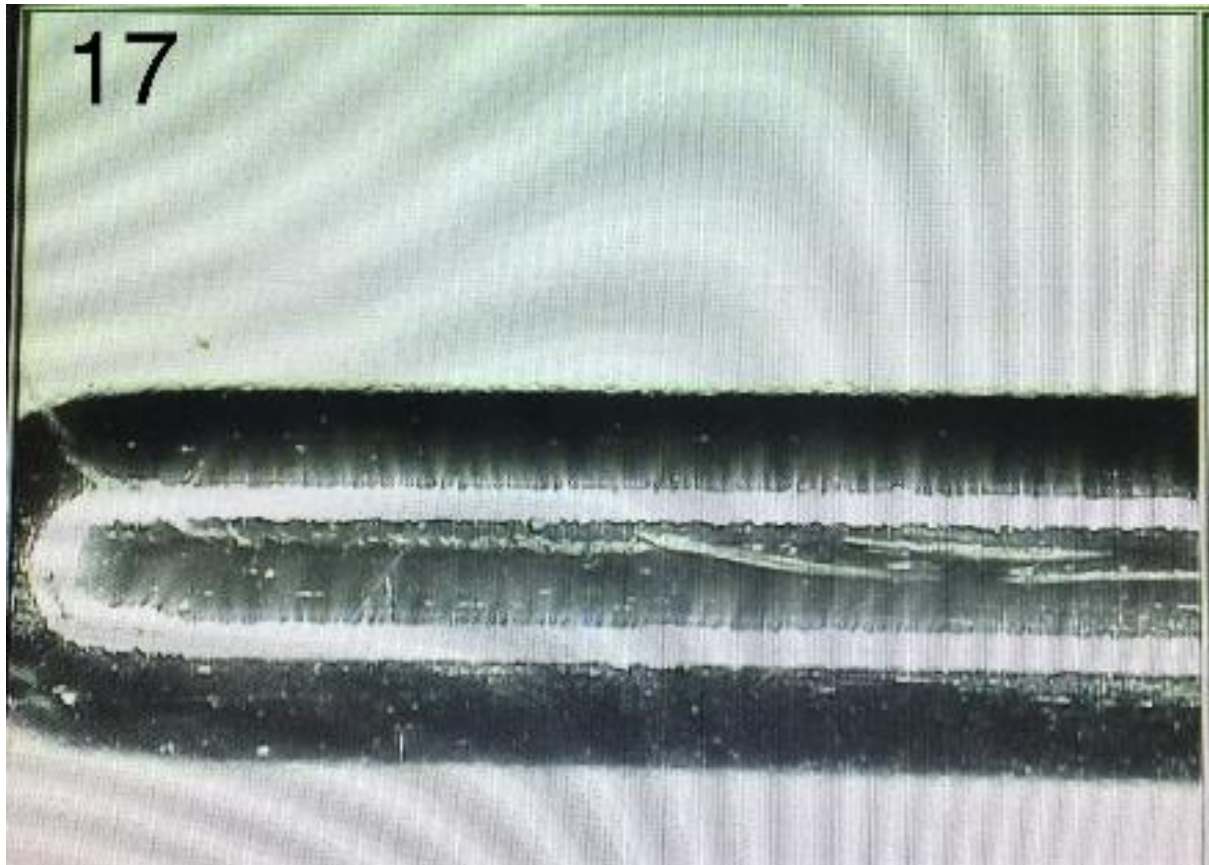
Visual – Longitudinal scratch observed

Before testing, longitudinal scratches observed
