## Monthly Technical Review (Jul 2018 Data)

Flex CFT

15 Aug 2018

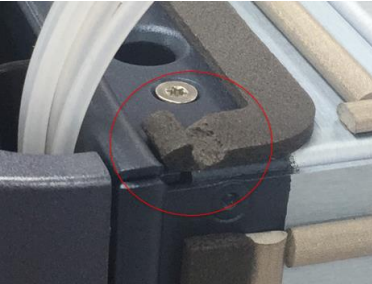
<p>Manufacturing Date: Jul 2018<br/>Chassis supplier: Baiteng</p> <p><u>Note:</u><br/>DTS sampling inspection, Lot 1 to Lot 6, no issue was found (total 89u were inspected by WPPL)<br/>This problem happened on the 7<sup>th</sup> lot of inspection.</p> | <p><b><u>Containment Actions:</u></b></p> <p>1) Flex CFT members proposed and demonstrated to WPPL (Eugene Tan) the method to replace the torn Spill Gasket. After review the reworked Spill Gasket, the method was agreed upon.<br/>Completed by CK Tan (ME) on 11 Jul 2018</p> <p>2) Q-Alert raised to create awareness of IQA, FQA and Production personnel's of this issue.<br/>Completed by Ivy Marges (PQE) on 12 Jul 2018</p> <p>3) Briefing conducted to Production for Step by Step on replacing the Spill Gasket and the technique of closing the Top cover to Chassis assembly to avoid damaging the Spill Gasket.<br/>Completed by CK Tan (ME) on 12 Jul 2018</p> <p>4) There is no WIP for QSM (PN: 186015018). QSM Plus (PN: 186015080) and Raw Chassis level (PN: 289005258) screened.</p> <p>Result:</p>

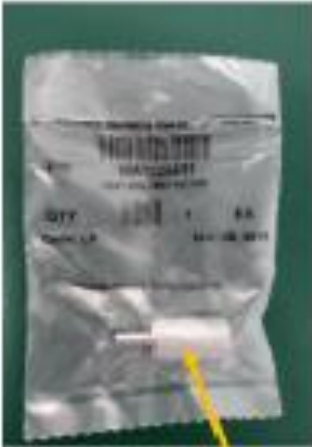
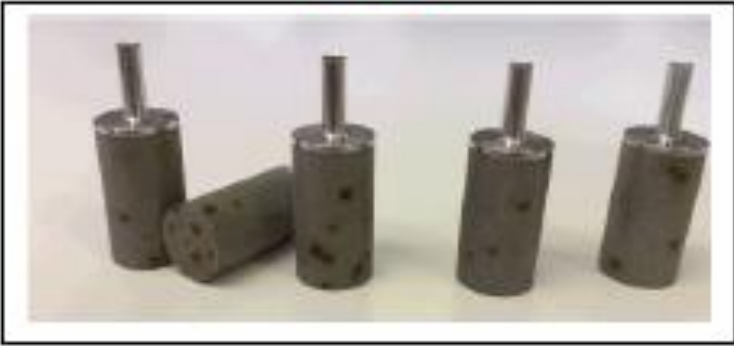
| Description / Sketches/Diagram :<br>1. Customer has feedback that the Solvent Filter has rusting issue.<br>2. PN: WAT-WAT025531-05, to inspect the Solvent Filter for "sign of rust". | | | |

Q-Alert Notice raised for IQA and Production for PN: WAT025531 to inspect the parts for any sign of rust.

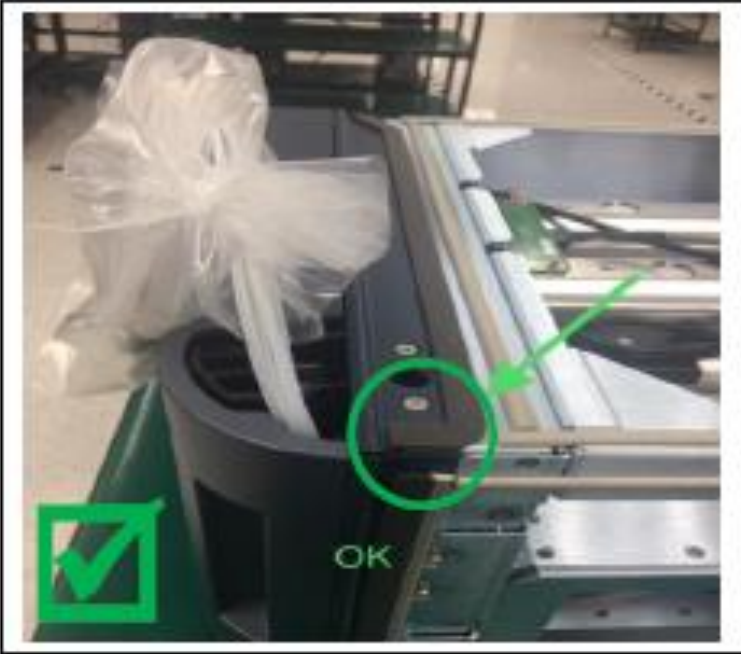
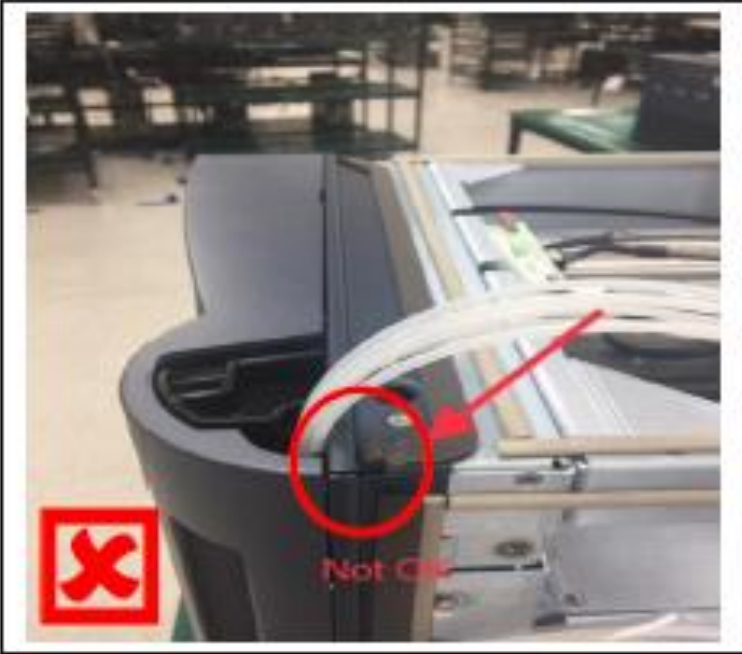
| Q-Alert Notice | | It is the Area/department representatives to retain Q-Alert Notice. | |
|---|--|---|--|
| Issue: During Dock-to-stock inspection of Customer for QSM Plus (Part Number: 186015080) found chassis spill gasket torn. | | | |

| Q-Alert Notice | | It is the Area/department representatives to retain Q-Alert Notice. | |
|---|--|---|--|
| <ul style="list-style-type: none"><li>To check top surface of chassis spill gasket is not torn.</li></ul> | | | |
