## WATERS Weekly FPY review (WW26 – 2018)

04 Jul 2018

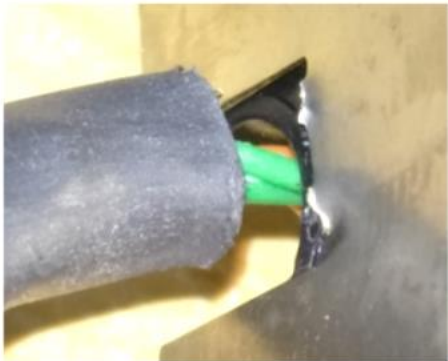
Failed part

- WW52'18: one instrument (PN 186299800) failed Communication error. Investigation: after replace PN 441001280 (Ethernet Cable), the Instrument has passed.
- Further Investigation: it was found that the Grounding was broken (damaged)

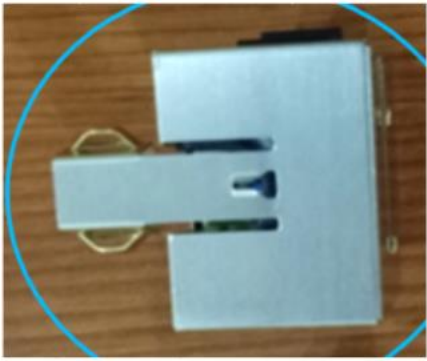
Raw part before bent

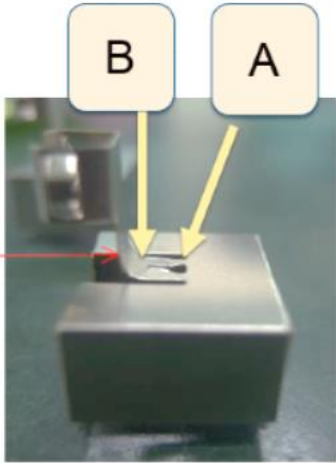
A – current bending point  
B – proposed bending point

- CMTi reported that there is no failure reported at their outgoing since May 2017 (Qty tested: 9200 pcs)
- CMTi proposed to change the bending point.
- See Appendix A for more detail

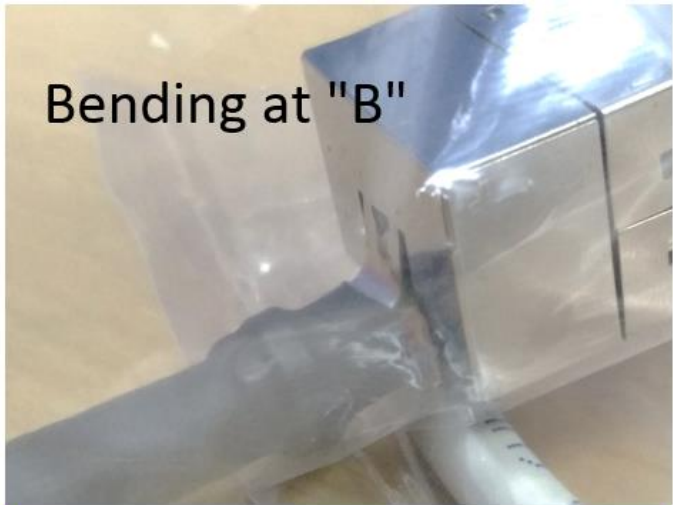
Bending at "B"

2 samples - proposed method

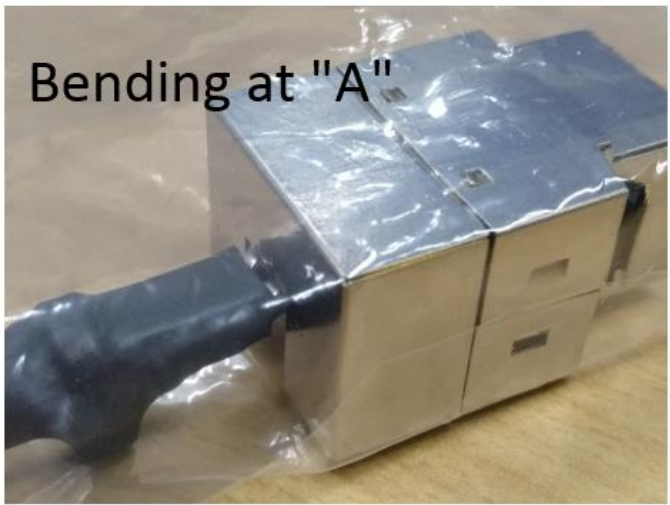
Bending at "A"

1 sample - current method

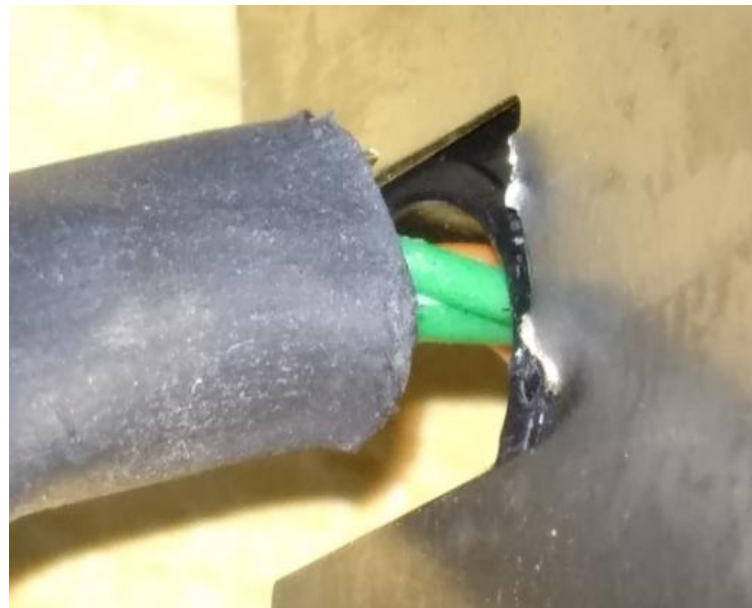
Failed part

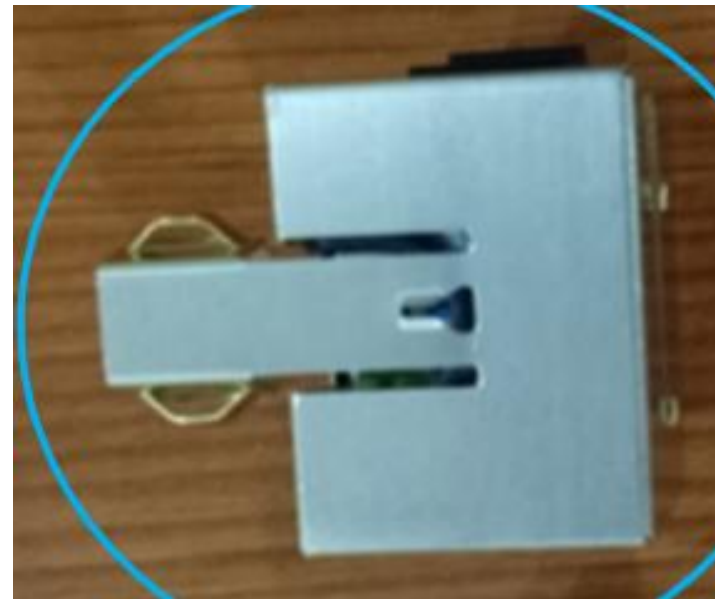
Raw part before bent

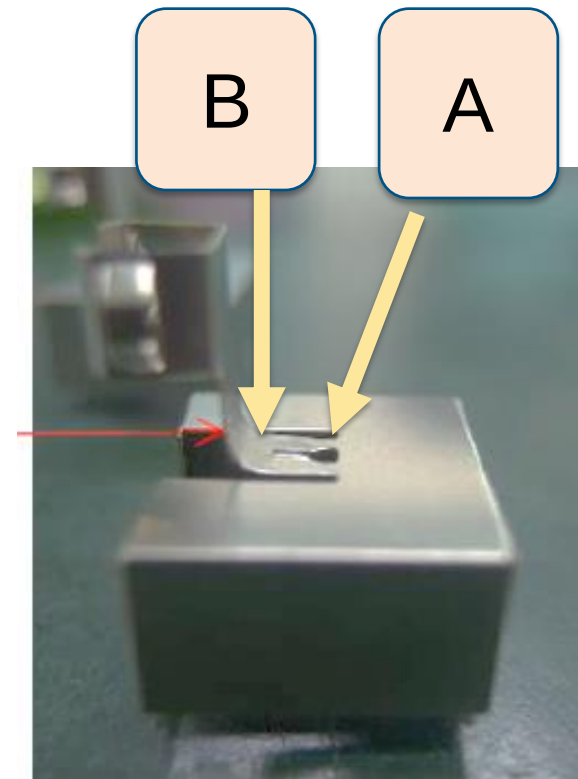
A – current bending point  
B – proposed bending point

- Option A – if we were to proceed with this change, CMTi will have to raise a PCN (Process Change Notice). A small qty for trail is proposed before implementation in mass production.
- Option B – no change is needed. Based on the performance the failure rate is relatively low.

- There is no failure in Feb 2018 and Mar 2018 (Total > 600 instrument build)
- As the occurrence (Ethernet cable failing) is low and random, Flex does not recommend to go ahead with this change (Option A).
- Flex recommends to further monitor the yield and keeping this proposal as an option for future discussion.

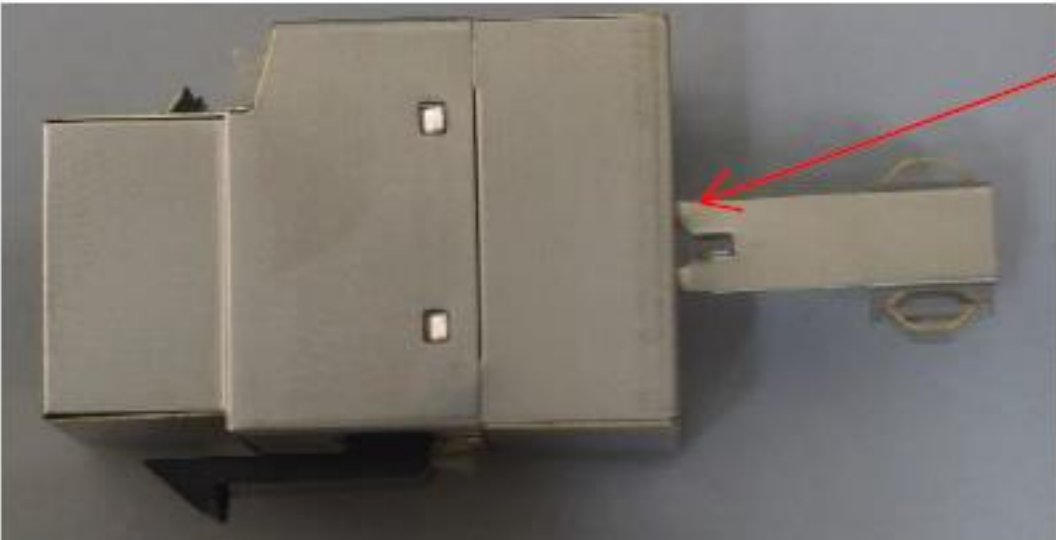
Bend area

Current bending area :

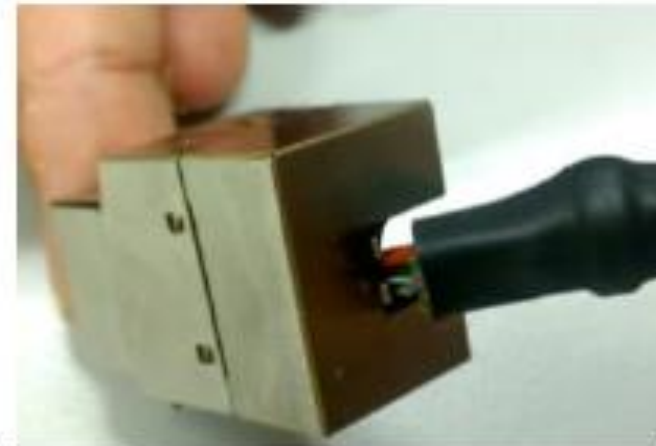
Current bend method

- ✓ Current bending method : Connector broken after 22 times bending
- ✓ Propose bending Method : Connector broken after 64 times bending

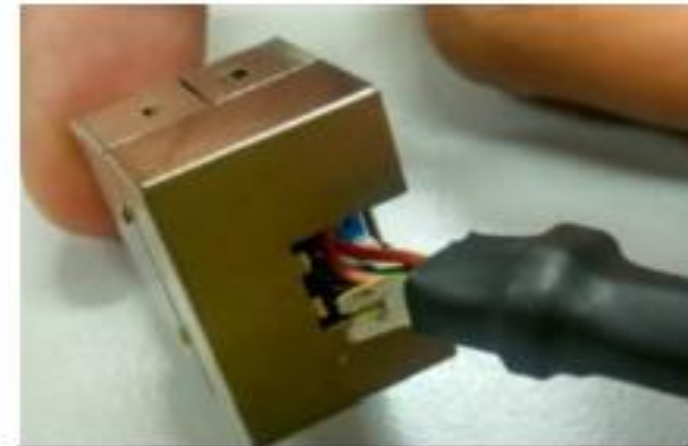
Propose bend method

1. Propose bending method strength result is better than current bending method
2. Cable position of propose bending method is out of connector surface (refer to below picture for comparison)

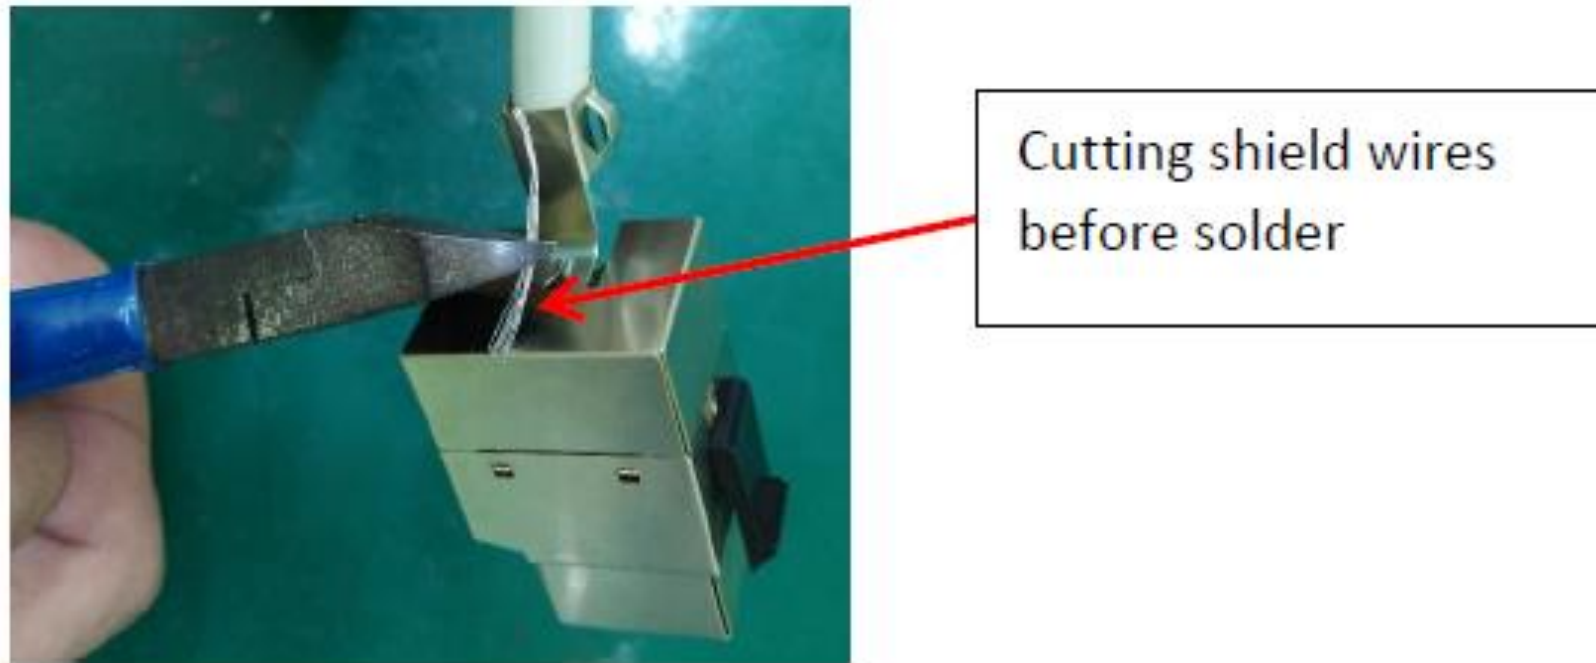
3. There's additional cutting process for shield wire before solder to metal shield

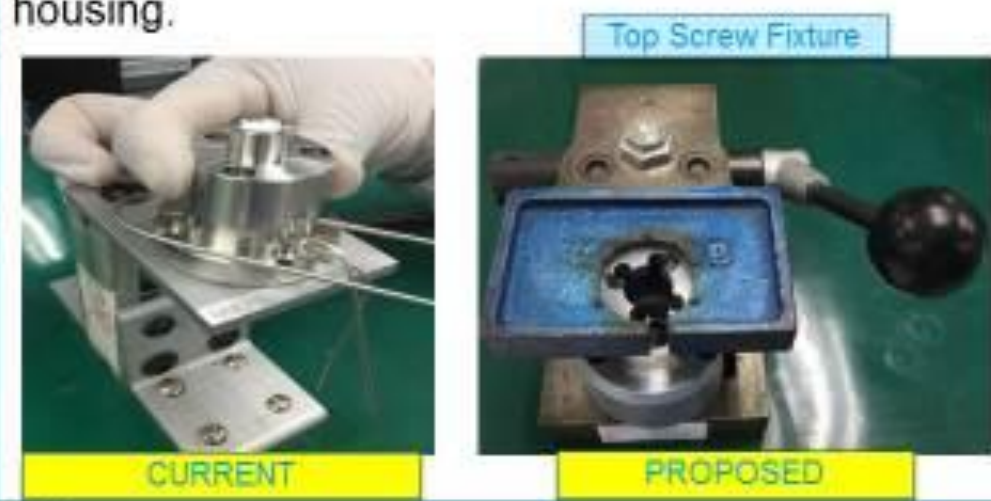
| Category | Possible Causes | Verification | Possible cause (Y/ N) | Proposed Actions |
|---|---|---|---|---|
| Machine | No manufacturing Aids/Fixtures/Jigs. | 1)Press fixtures were ok and no abnormality found.<br>2)Current Holding Fixture 999044874 does not allow to hold and press down Top, Middle and Bottle housing assembly into holding fixture before screwing assembly. | Y | Propose to purchase new fixture with top cover plate to hold and press down the Top, middle and bottom housing.<br><div data-bbox="2299 1219 3265 1707"> <p>Top Screw Fixture</p> <p>CURRENT PROPOSED</p> </div> |

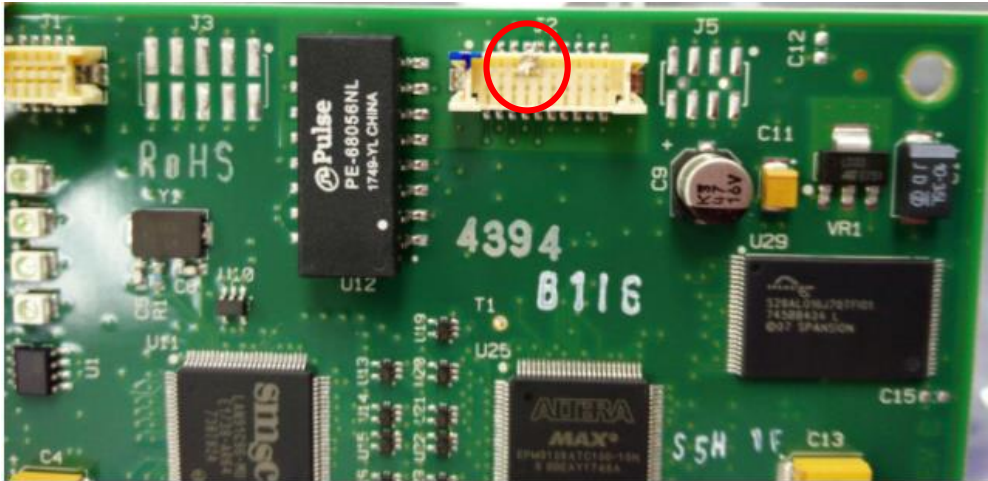
| Problem Statement | Investigation/<br>Possible Root Cause | Corrective Action/<br>Improvement |
|---|---|---|
| <p>Reported Date: 11 Apr 2018</p> <p>Instrument Part Number: 186248900<br/>Instrument SN: D1887E318A<br/>Affected Qty: 1u</p> <p>Problem: Solder residue found at socket pin (J2)</p> <p>Date of Manufactured: Apr 2018</p> <p>Reported site: Flex Kallang</p> | <p><b>Investigation:</b><br/>On 11 Apr: Technician visual checked all Connections – no visual issue.</p> <p><b>Containment Actions:</b><br/>On 11 Apr, Technician replaced one PCB, CPU (PN: 210000520), from SN 160318582C to SN 160318221C.<br/>Retest Instrument – passed.<br/>Defective part transferred to Non Conformance Area<br/>Performed by: Technician (842185)</p> <p>The Defective part is to be RTV to Supplier.<br/>PCB, CPU Supplier: CEI LIMITED</p> <p><b>Root Cause</b><br/>It is confirmed that the Defective part has caused the Instrument to fail Final Test as per stated in the Problem Statement.</p> | <p><b>Corrective Action:</b><br/>Flex Kallang: NA</p> <p>Supplier:<br/>RMA 25918 received on 4 May 18.<br/>30 May 18 board collected by supplier. Analysis in progress.</p> |
