## WATERS Weekly FPY review (WW29 – 2018)

25 Jul 2018

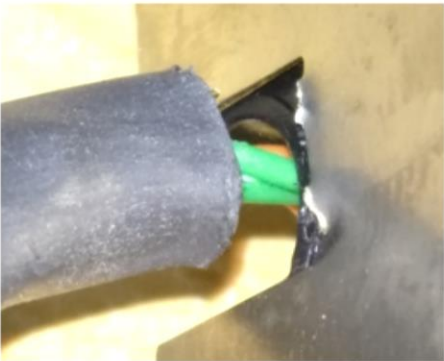
| Description | Owner | To complete by | Status |
|---|---|---|---|
| <div>2) Ethernet Cable (PN 441001280) – reopen this issue</div> <div><div><div>• Background: WW52 – one cable found damaged and failed Final Test.</div><div>• Proposal for improvement from CMTI – refer to next slides.</div><div>• 01 May: To jointly review if to go ahead with this proposal.</div><div>• 23 May: CMTi to provide samples.</div><div>• 04 Jul: 2 x samples received. To put up a PCN to WPPL for review.</div></div></div> | Flex | TBA | Open |

Failed part

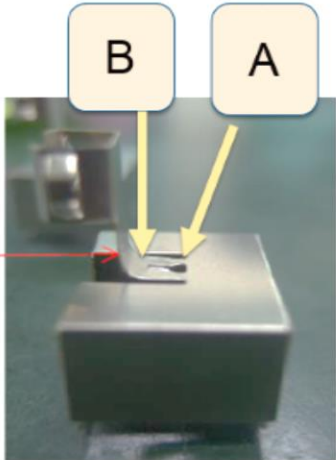
A – current bending point  
B – proposed bending point

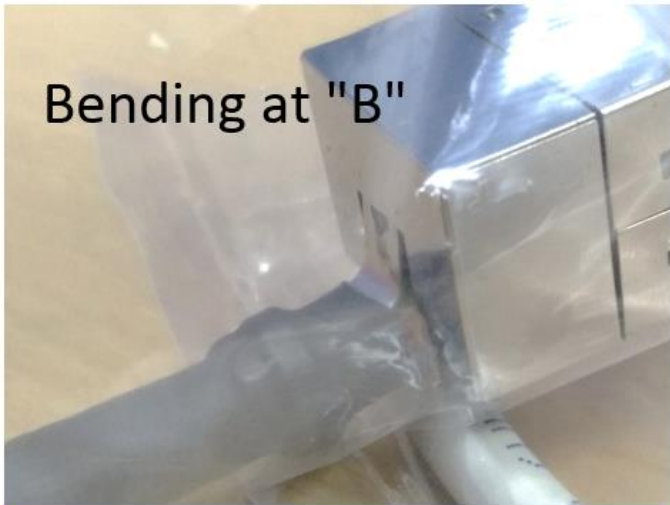
Bending at "B"

2 samples - proposed method

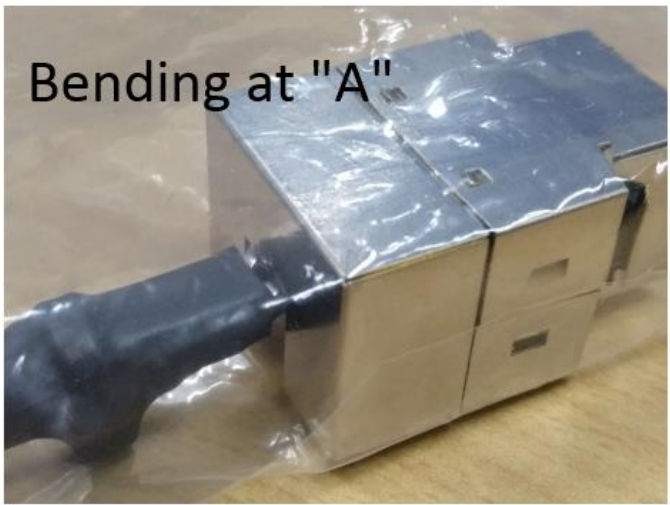
Bending at "A"

1 sample - current method

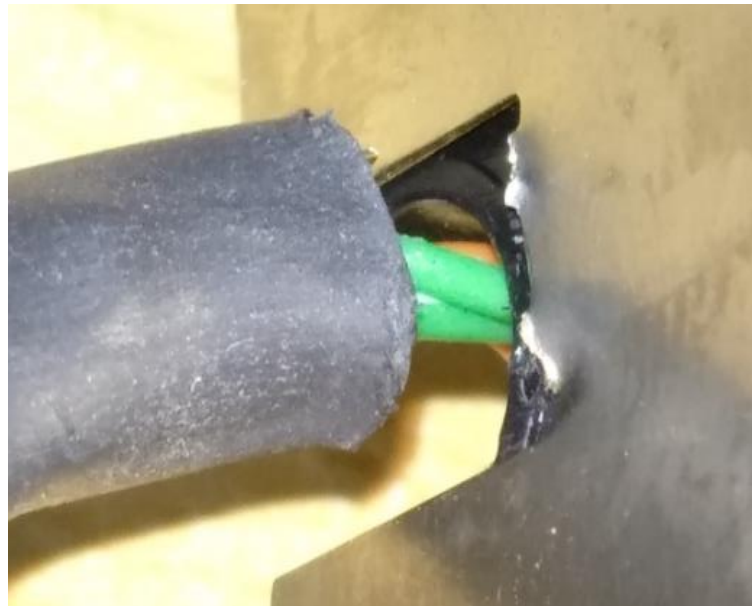
- WW52'18: one instrument (PN 186299800) failed Communication error. Investigation: after replace PN 441001280 (Ethernet Cable), the Instrument has passed.
- Further Investigation: it was found that the Grounding was broken (damaged)

Failed part

- There is no failure in Feb 2018 and Mar 2018 (Total > 600 instrument build)
- As the occurrence (Ethernet cable failing) is low and random, Flex does not recommend to go ahead with this change (Option A).
- Flex recommends to further monitor the yield and keeping this proposal as an option for future discussion.

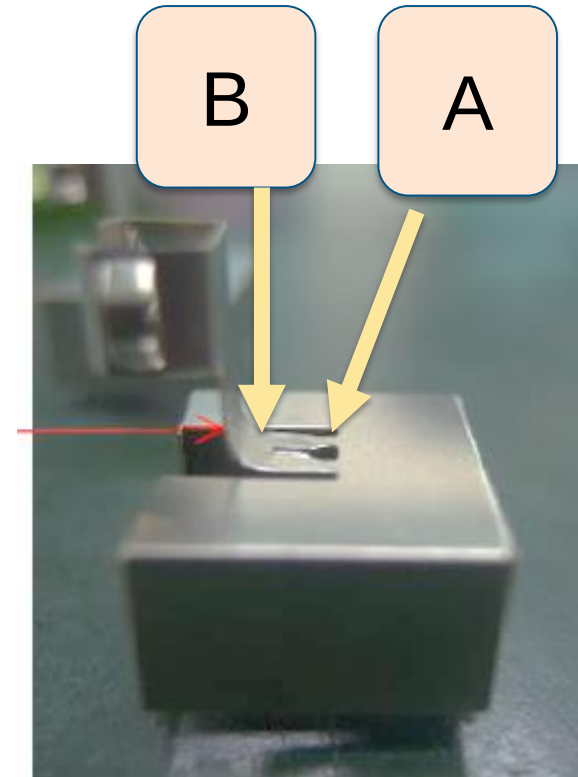
- CMTi reported that there is no failure reported at their outgoing since May 2017 (Qty tested: 9200 pcs)
- CMTi proposed to change the bending point.
- See Appendix A for more detail

A – current bending point  
B – proposed bending point

- Option A – if we were to proceed with this change, CMTi will have to raise a PCN (Process Change Notice). A small qty for trail is proposed before implementation in mass production.
- Option B – no change is needed. Based on the performance the failure rate is relatively low.

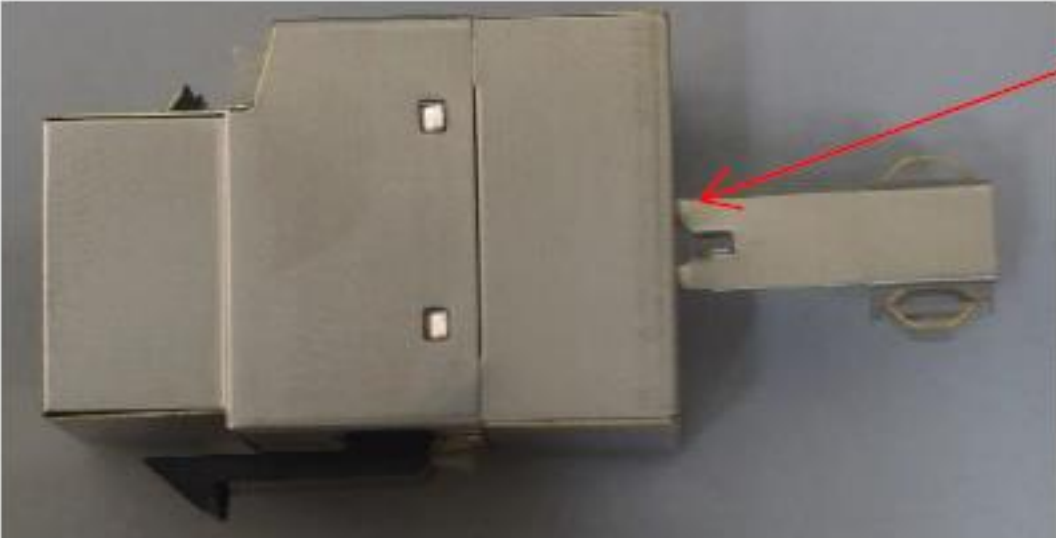
Bend area

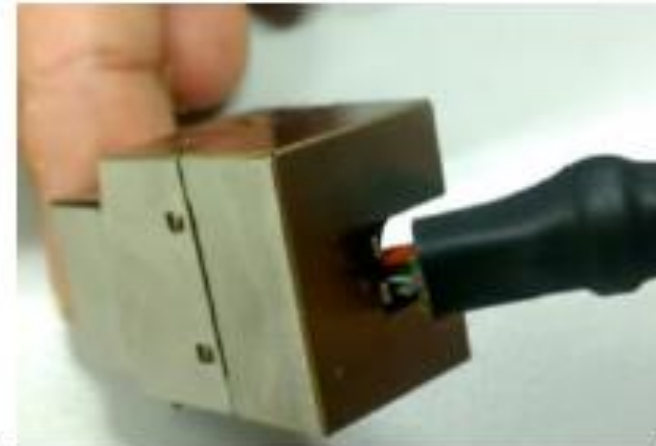
Current bend method

- ✓ Current bending method : Connector broken after 22 times bending
- ✓ Propose bending Method : Connector broken after 64 times bending

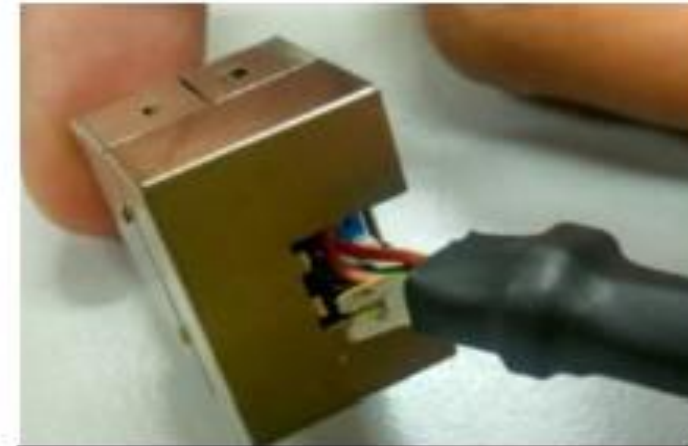
Propose bend method

1. Propose bending method strength result is better than current bending method
2. Cable position of propose bending method is out of connector surface (refer to below picture for comparison)

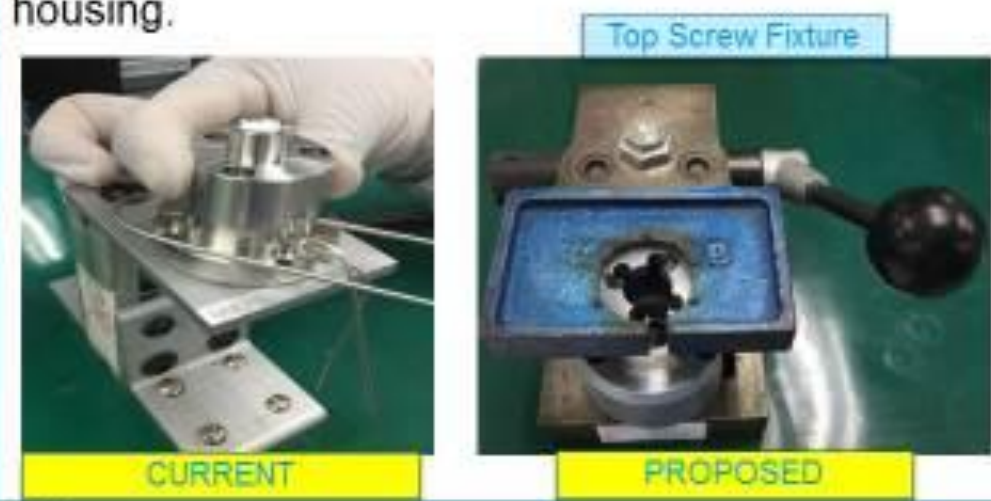
| Category | Possible Causes | Verification | Possible cause ( Y/ N) | Proposed Actions |
|---|---|---|---|---|
| Machine | No manufacturing Aids/Fixtures/Jigs. | 1)Press fixtures were ok and no abnormality found.<br>2)Current Holding Fixture 999044874 does not allow to hold and press down Top, Middle and Bottle housing assembly into holding fixture before screwing assembly. | Y | Propose to purchase new fixture with top cover plate to hold and press down the Top, middle and bottom housing.<br><div data-bbox="2299 1219 3265 1707"> <p>Top Screw Fixture</p> <p>CURRENT PROPOSED</p> </div> |
