## **WATERS Weekly FPY review (WW34 – 2018)**

29 Aug 2018

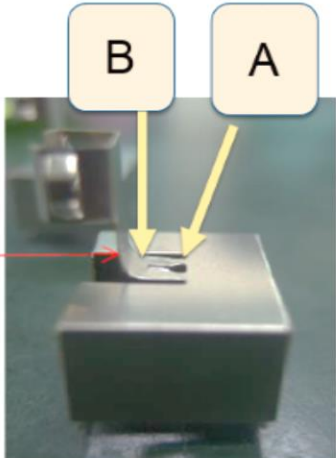
A – current bending point  
B – proposed bending point

- CMTi reported that there is no failure reported at their outgoing since May 2017 (Qty tested: 9200 pcs)
- CMTi proposed to change the bending point.
- See Appendix A for more detail

- Option A – if we were to proceed with this change, CMTi will have to raise a PCN (Process Change Notice). A small qty for trail is proposed before implementation in mass production.
- Option B – no change is needed. Based on the performance the failure rate is relatively low.

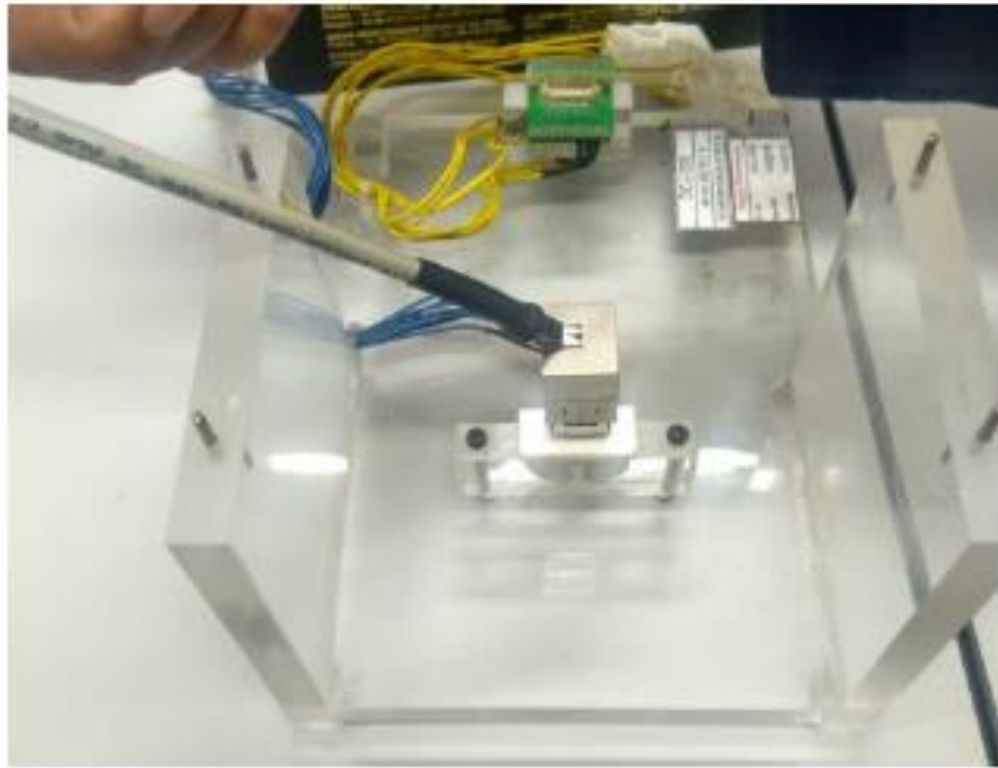
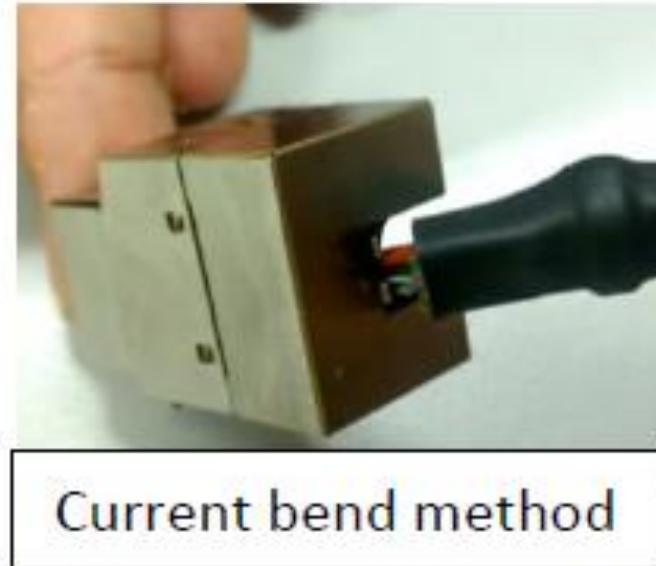
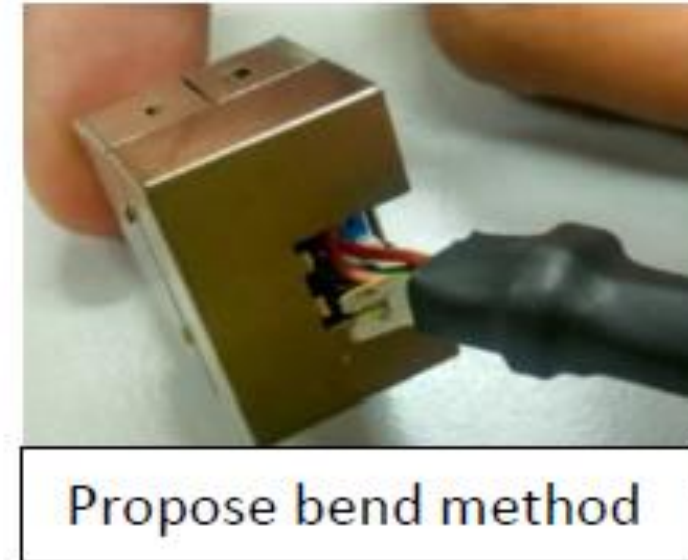
- ✓ Current bending method : Connector broken after 22 times bending
- ✓ Propose bending Method : Connector broken after 64 times bending

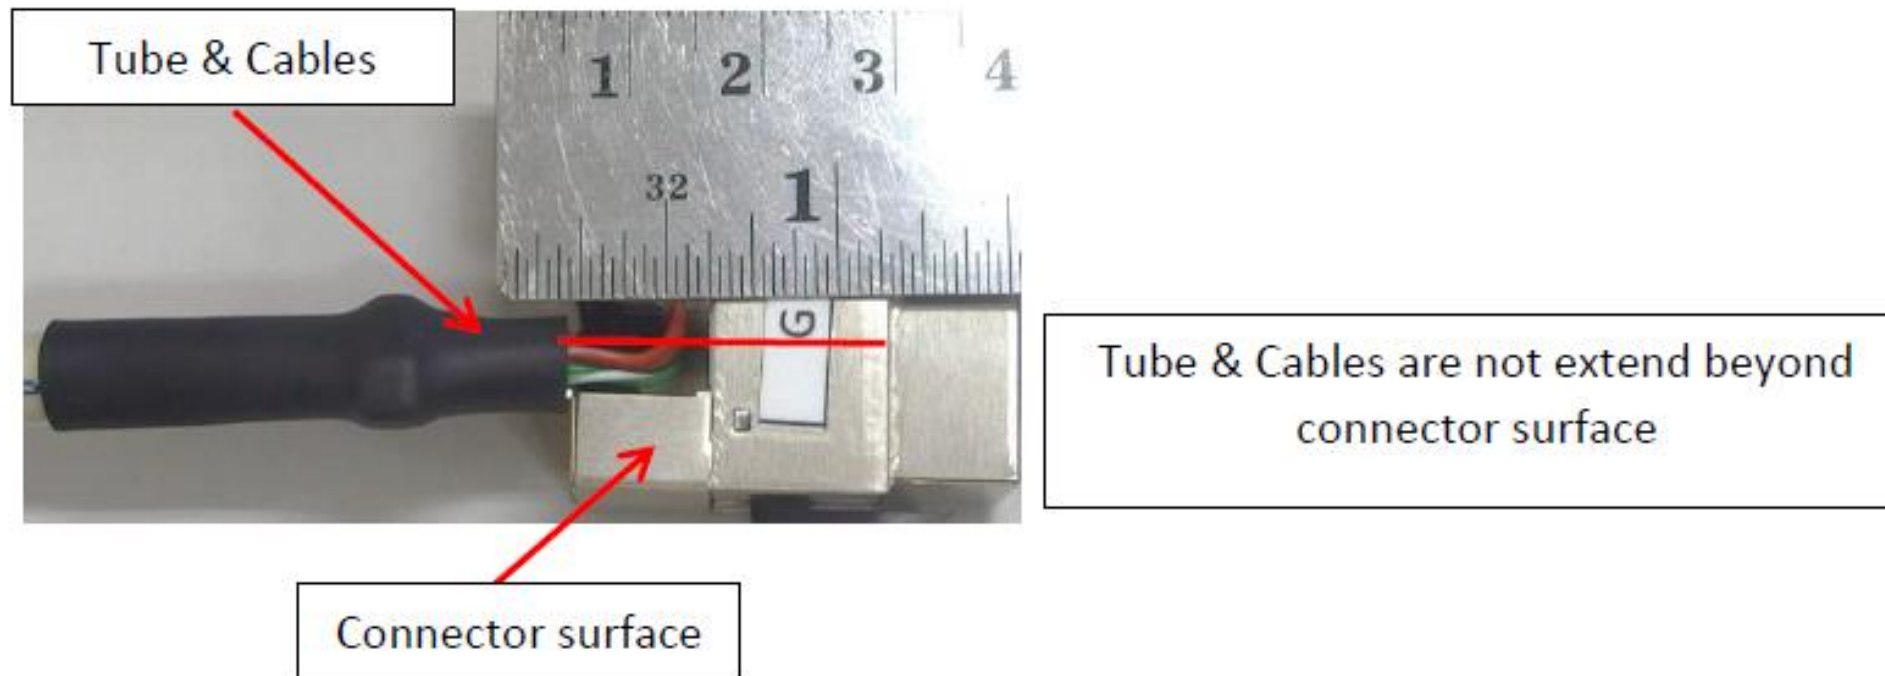
### Current bending method

1. Propose bending method strength result is better than current bending method
2. Cable position of propose bending method is out of connector surface (refer to below picture for comparison)

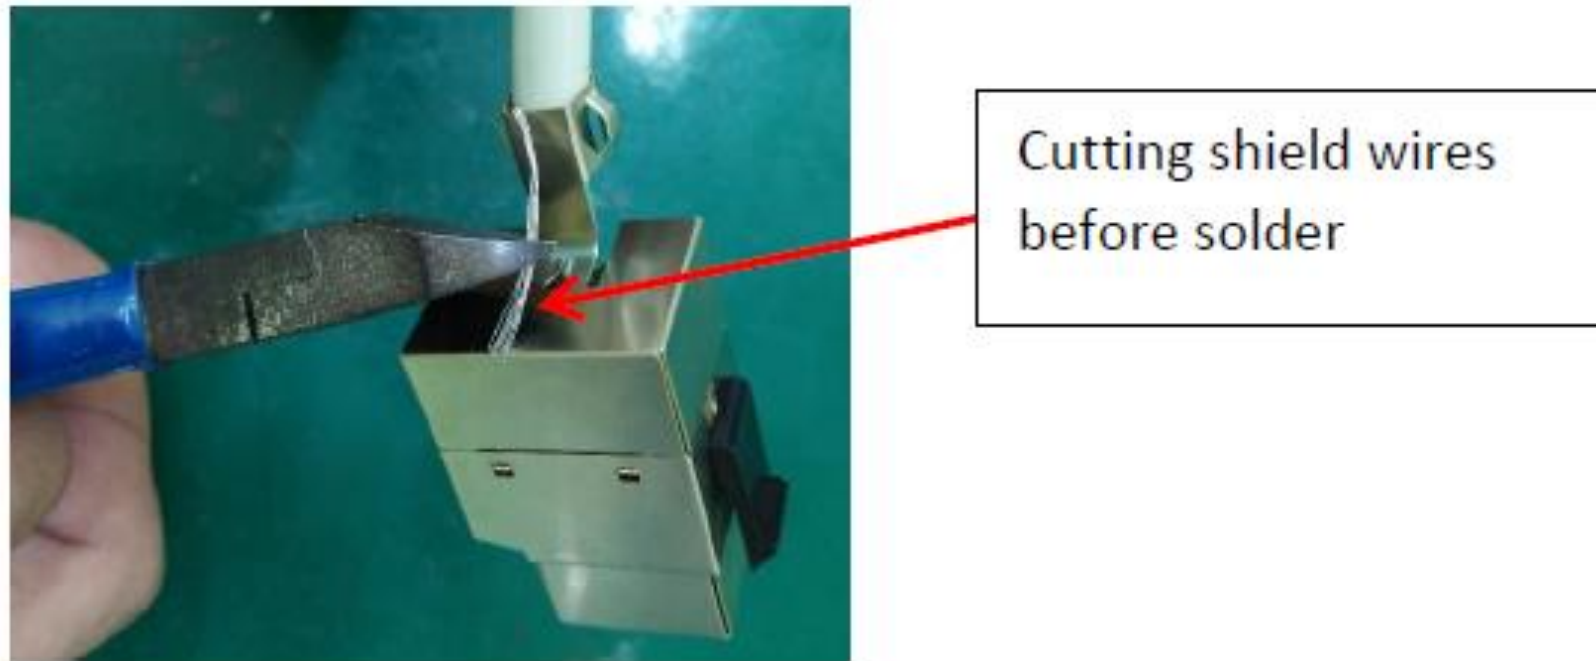
3. There's additional cutting process for shield wire before solder to metal shield

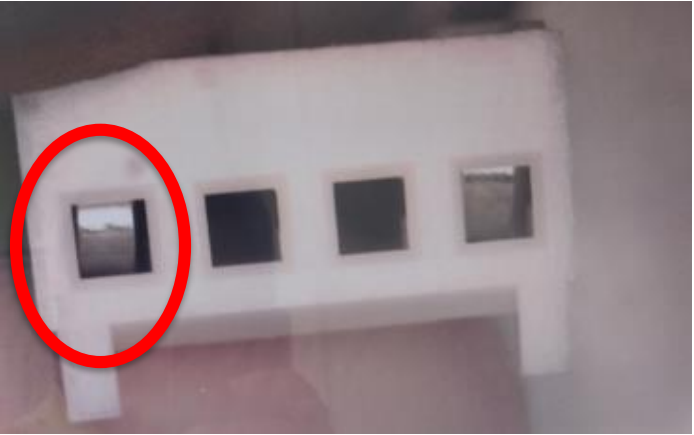
<p>Total affected Qty: 4u</p> <p>Date of Manufactured: Jul 2018</p> <p>WW31 to 34 – No similar failure</p> <p>Reported site: Flex Kallang</p> | Instrument<br>PN                      | Instrument<br>SN                  | Qty<br>failed | 186299800 | G18998864A | 1 | 186015032 | G18UPD547A,<br>G18UPD557A | 2 | 186017003 | G18VPD416A | 1 | <p><b>Investigation:</b><br/>On 20 Jul, Technician visual checked all Connections – no visual issue.</p> <p><b>Containment Actions:</b><br/>On 20 Jul, Technician replaced Cable (PN: 279001846).<br/>Retest Instrument – passed.<br/>Defective part transferred to Non Conformance Area<br/>Performed by: Technician (842185)</p> <p>Defective part subject for further investigation.<br/>On 31 Jul, 2 out of 4 cable offline verified, preliminary investigation result: connectivity OK. (refer to attached video)<br/>Verified by: TE Joel</p> <p><b>Further verification:</b><br/>Observed the deformed pins.</p> <p>Cable Supplier: CMTI</p> <p><b>Root Cause</b><br/>Did not identify the root cause, Refer to CMI and Flex 4M<br/>WW31 to 34 – No similar failure</p>

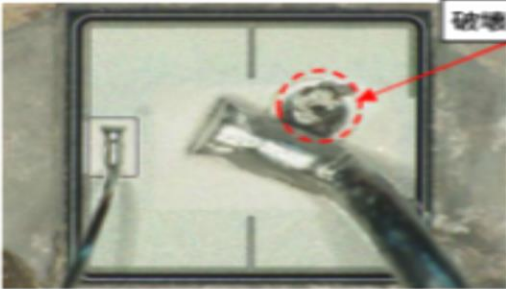
2.3 分解調査  
返却品の分解後の外観観察の結果、チップ表面に破壊部位を確認致しました。

写真1. 返却品(7C2) 破壊部位  
Photo. 1 Damaged portion of returned goods

3. 見解  
返却品は分解後のチップの破壊様相より、SOA(Safe Operation Area)を超えたため素子破壊したものと推定されます。尚、過電圧による素子破壊後に二次的な過電流が流れたため、現状のような破壊様相になったことも考えられます。

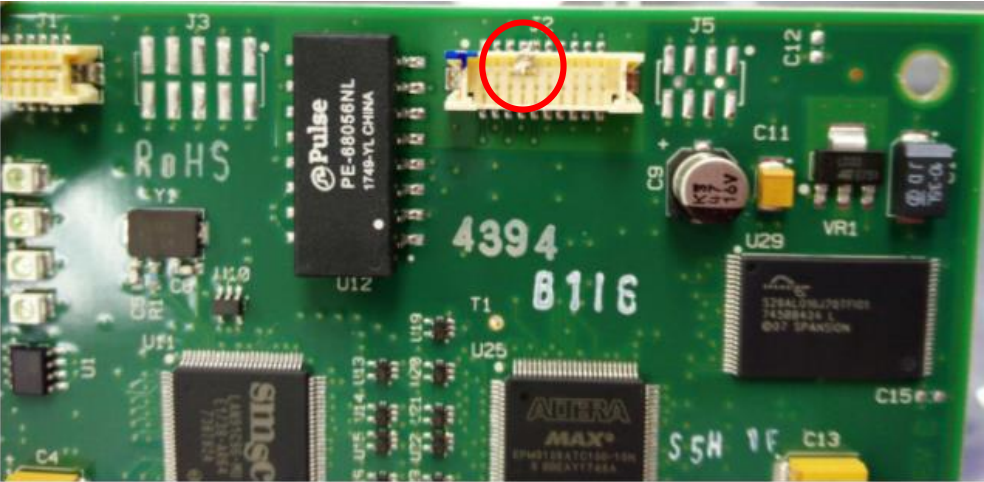
| Problem Statement | Investigation/<br>Possible Root Cause | Corrective Action/<br>Improvement |
|---|---|---|
| <p>Reported Date: 11 Apr 2018</p> <p>Instrument Part Number: 186248900<br/>Instrument SN: D1887E318A<br/>Affected Qty: 1u</p> <p>Problem: Solder residue found at socket pin (J2)</p> <p>Date of Manufactured: Apr 2018</p> <p>Reported site: Flex Kallang</p> | <p><b>Investigation:</b><br/>On 11 Apr: Technician visual checked all Connections – no visual issue.</p> <p><b>Containment Actions:</b><br/>On 11 Apr, Technician replaced one PCB, CPU (PN: 210000520), from SN 160318582C to SN 160318221C.<br/>Retest Instrument – passed.<br/>Defective part transferred to Non Conformance Area<br/>Performed by: Technician (842185)</p> <p>The Defective part is to be RTV to Supplier.<br/>PCB, CPU Supplier: CEI LIMITED</p> <p><b>Root Cause</b><br/>It is confirmed that the Defective part has caused the Instrument to fail Final Test as per stated in the Problem Statement.</p> <p>.</p> | <p><b>Corrective Action:</b><br/>Flex Kallang: NA</p> <p>Supplier:<br/>RMA 25918 received on 4 May 18.<br/>30 May 18 board collected by supplier. FA sent 04 July, board repaired and pending to send back to Flex.</p> <div></div> <div>Move to close</div> |
