## WATERS Weekly FPY review (WW42 – 2018)

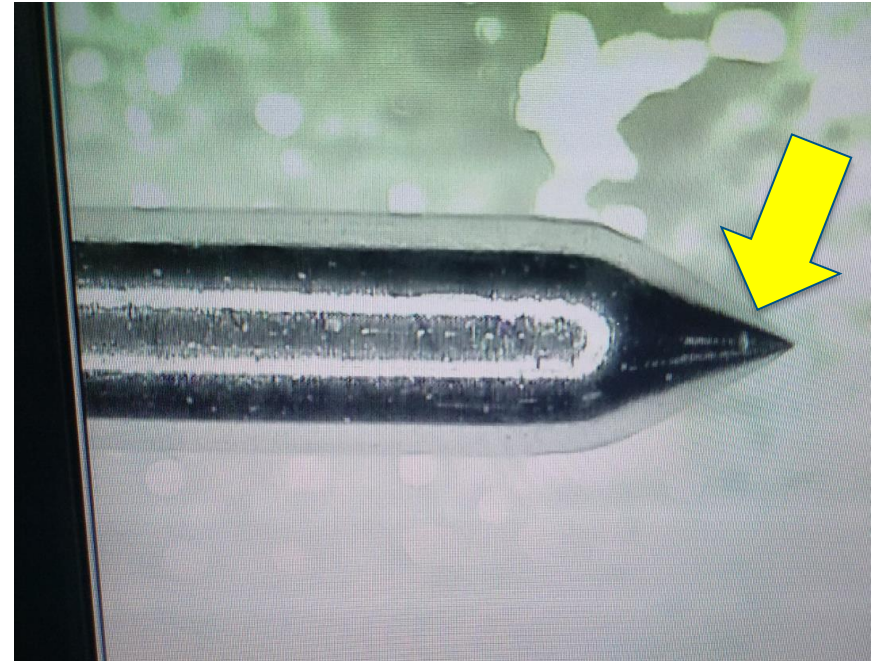
- Needle tip is checked for pit mark. A small pit mark was observed.

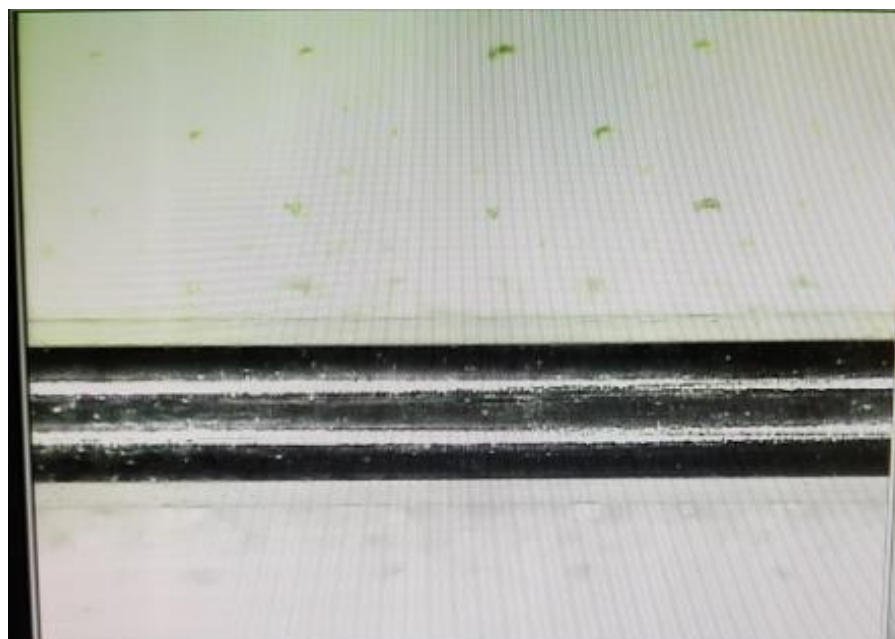
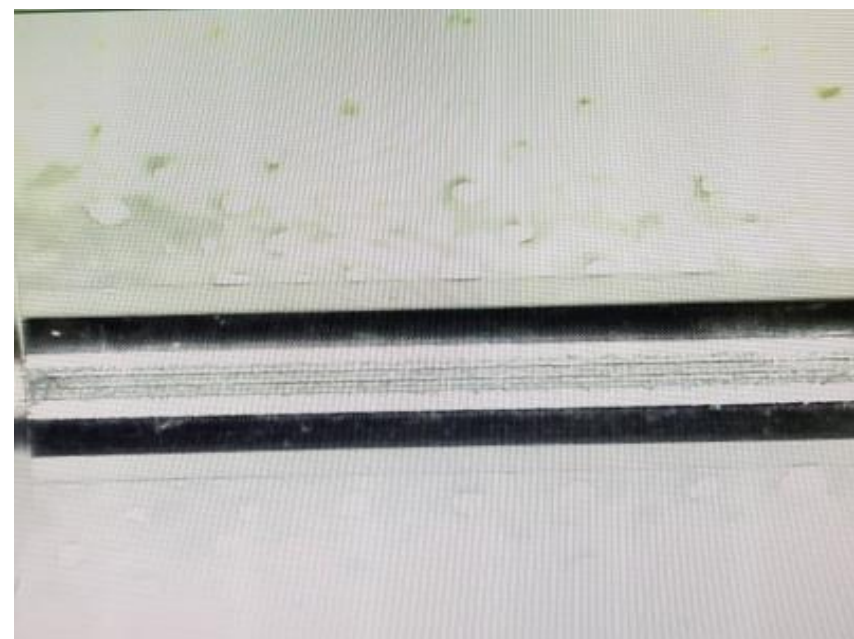
- Needle body is also checked for longitudinal scratches. No scratches found.

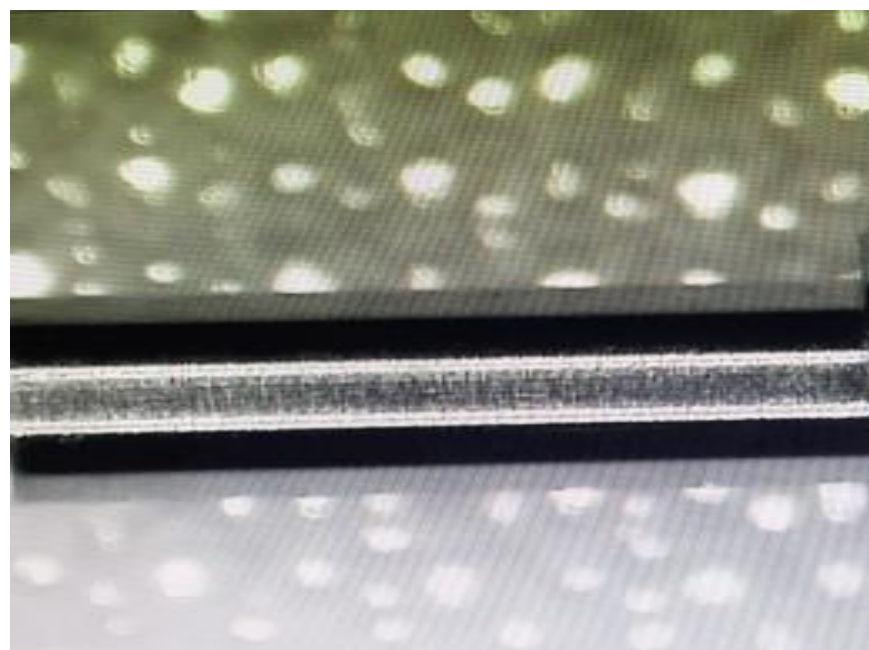
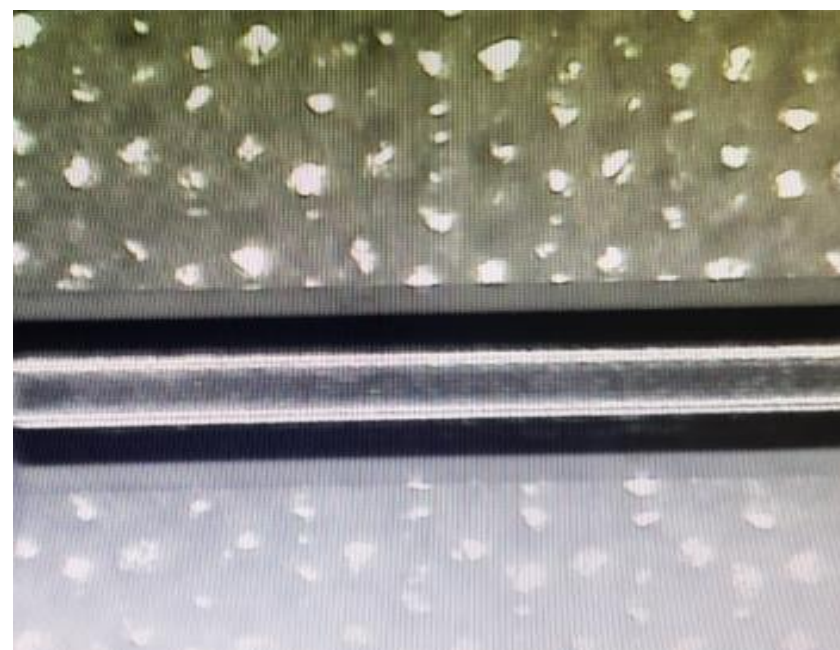
- Needle body is also checked for longitudinal scratches. No scratches found.
