## WATERS Weekly FPY review (WW43 – 2018)

# Scope of review and Alert Level

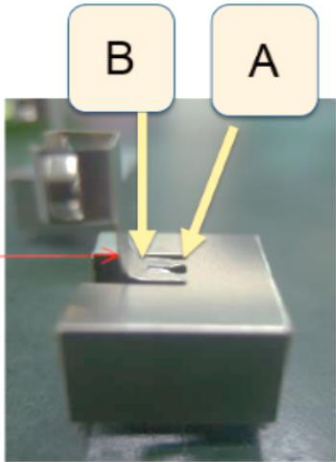
A – current bending point  
B – proposed bending point

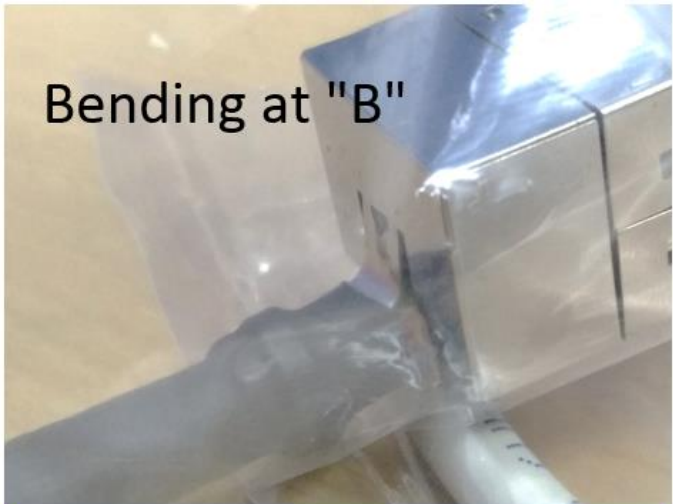
Bending at "B"

2 samples - proposed method

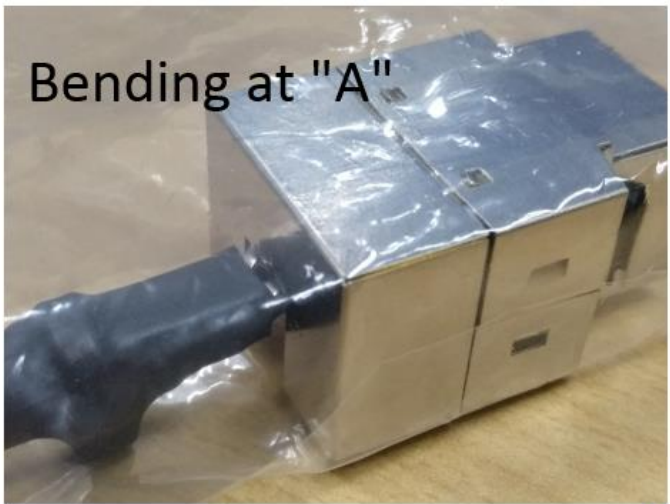
Bending at "A"

1 sample - current method

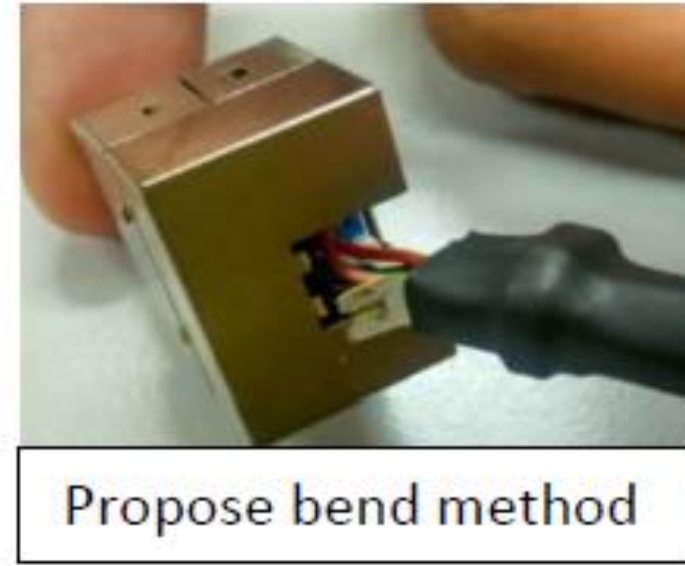
Propose bend method

- ✓ Current bending method : Connector broken after 22 times bending
- ✓ Propose bending Method : Connector broken after 64 times bending

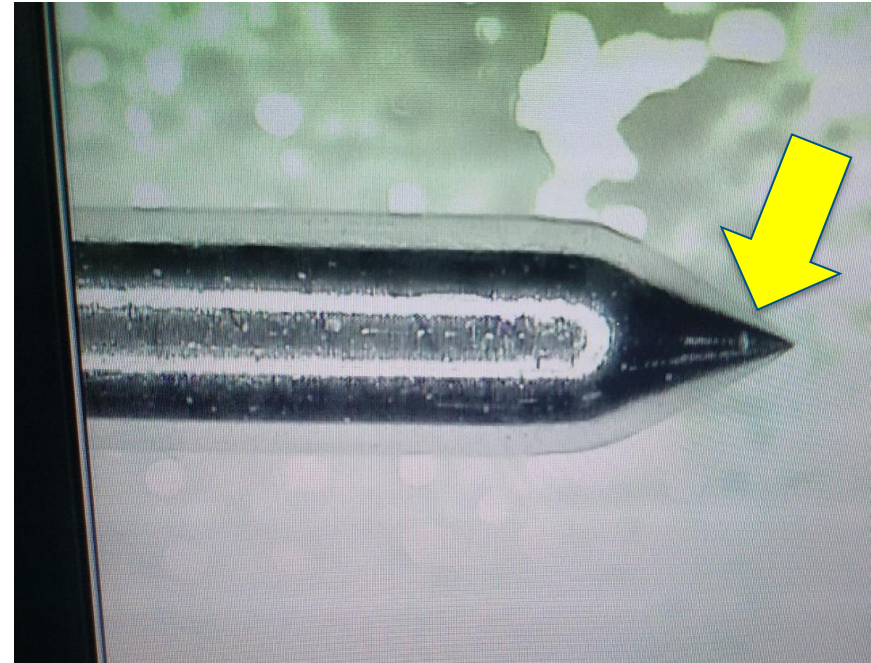
- Needle tip is checked for pit mark. A small pit mark was observed.

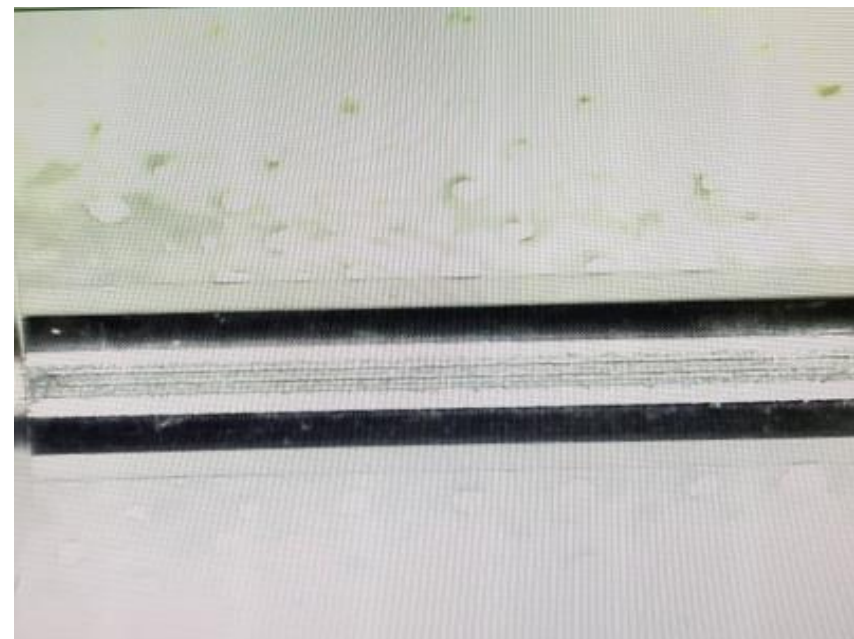
- Needle body is also checked for longitudinal scratches. No scratches found.

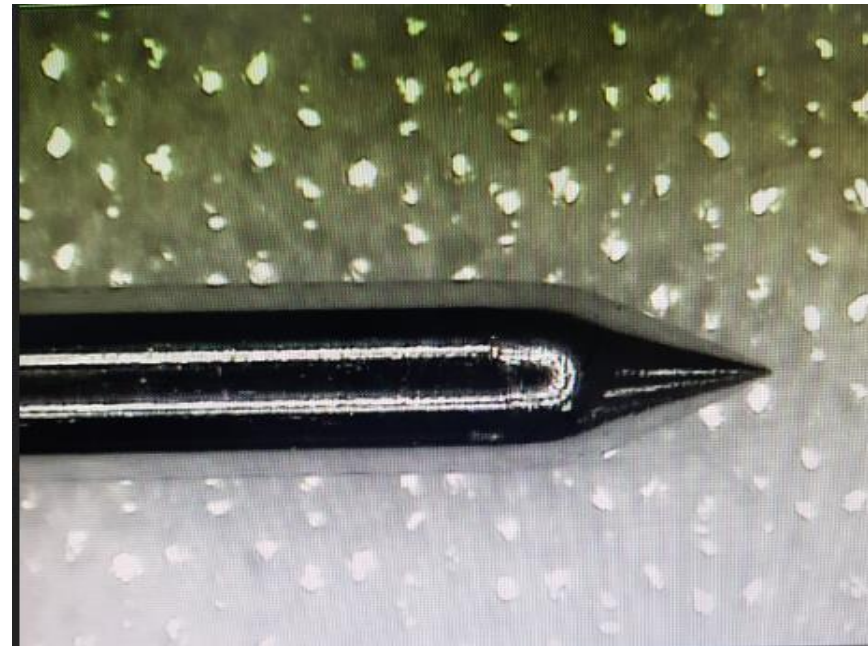
- Needle tip is checked for pit mark Unable to detect pit.
