## WATERS Weekly FPY review (WW44 – 2018)

# Agenda

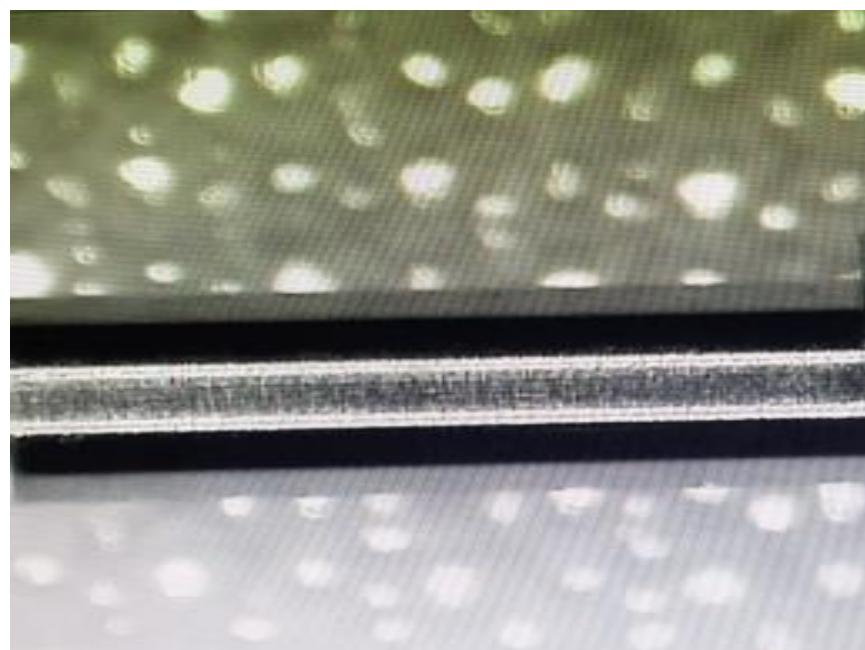
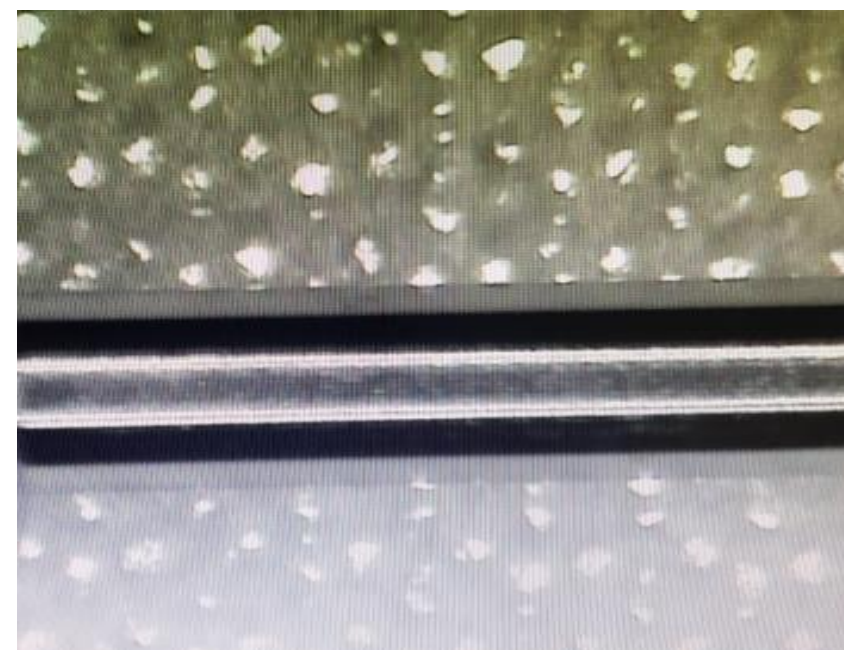
- Needle body is also checked for longitudinal scratches. No scratches found.
