## WATERS Weekly FPY review (WW47 – 2018)

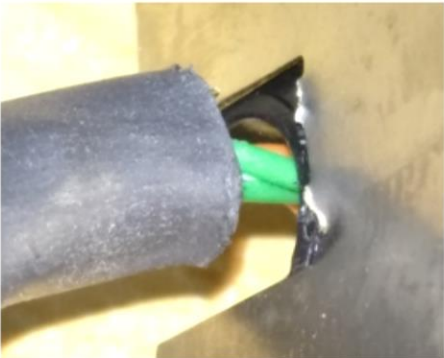
Failed part

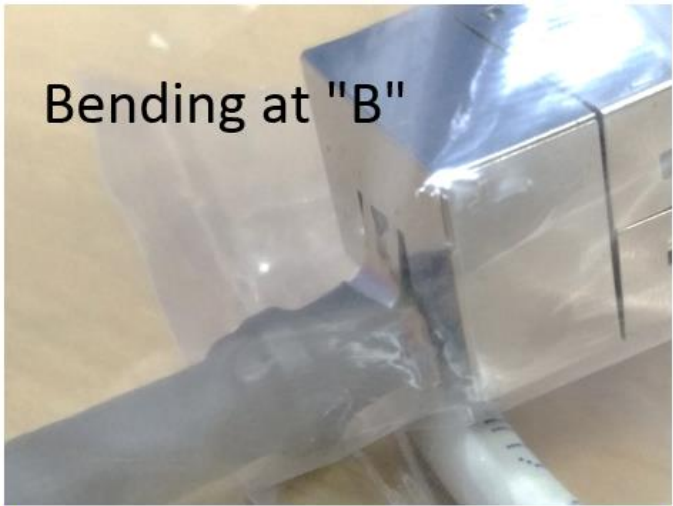
Bending at "B"

2 samples - proposed method

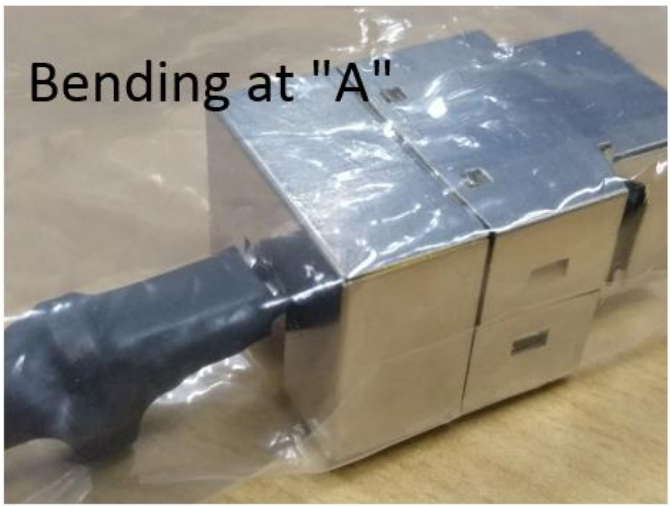
Bending at "A"

1 sample - current method

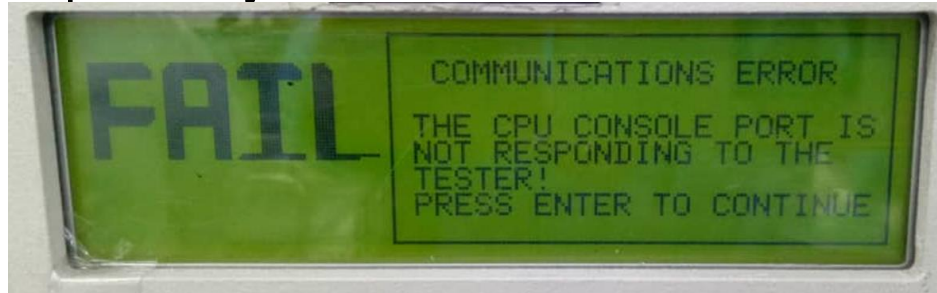
Step3:Verify FCT -Communication error

Step4:Debug-Failed U66 Clk Out at Pin 4, 5 and 6

1. Base from the simulation done, observed that the failed unit’s U66 Clk-out frequency measurement out from the specification.
2. Further evaluation found that the Frequency measurement for the return failed unit and Frequency measurement for the blank U66 part mounted unit are not same. Refer to the yellow highlighted column in the above table.
3. After re-program the U66, the Frequency measurement within specification. Refer to the green highlighted column in the above table.
4. Suspecting the program in the U66, has been corrupted.

Step5:Remove U66 and re-programmed at off-line programming station and mount back on board.

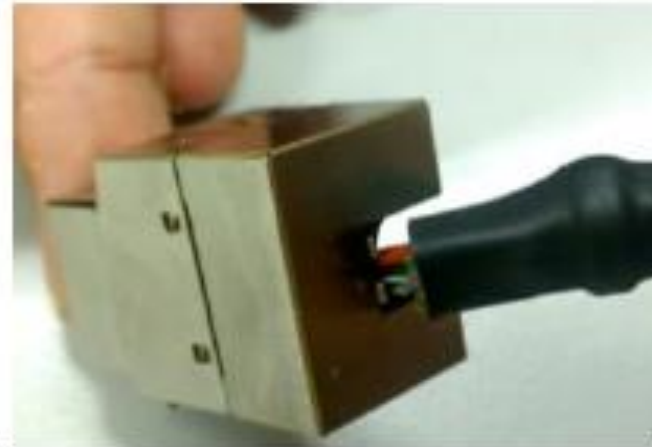
Current bend method

- ✓ Current bending method : Connector broken after 22 times bending
- ✓ Propose bending Method : Connector broken after 64 times bending

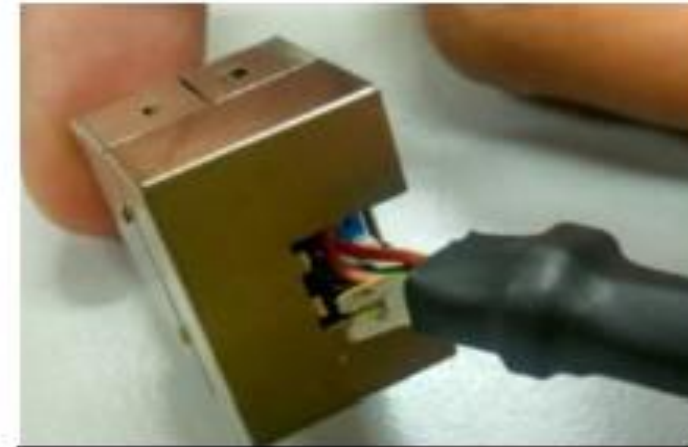
Propose bend method

1. Propose bending method strength result is better than current bending method
2. Cable position of propose bending method is out of connector surface (refer to below picture for comparison)

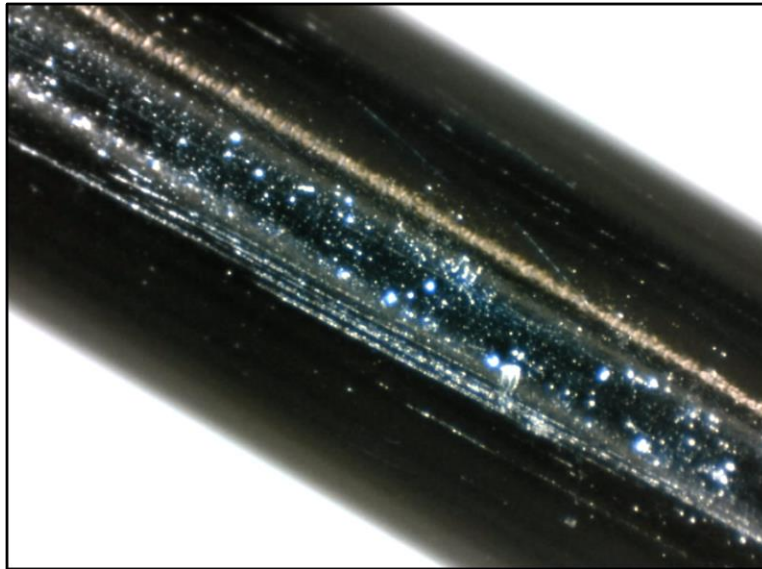
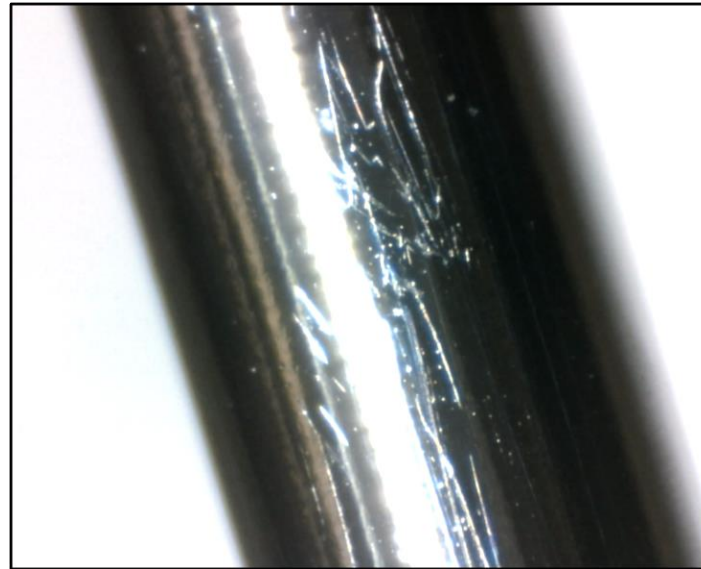
Scratches

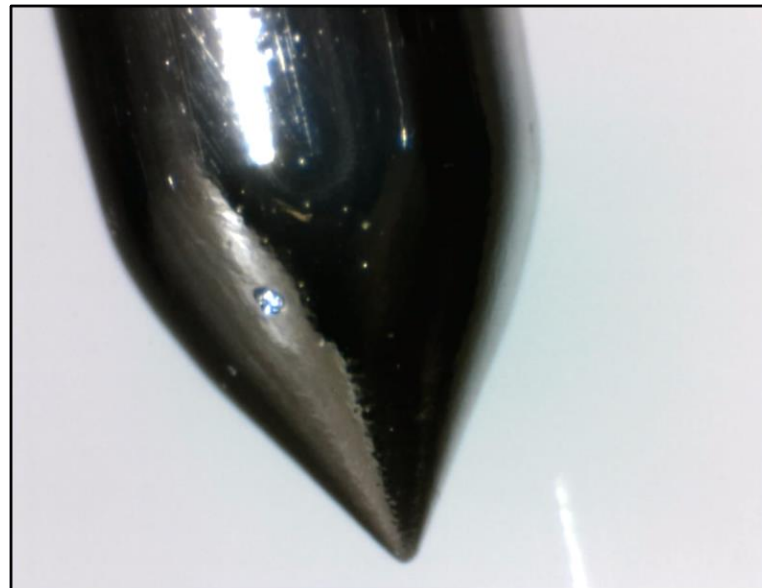
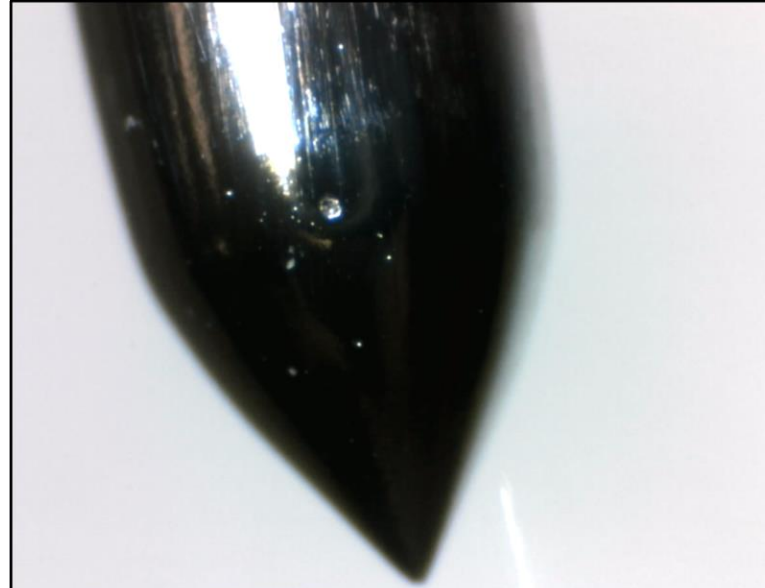
Pits

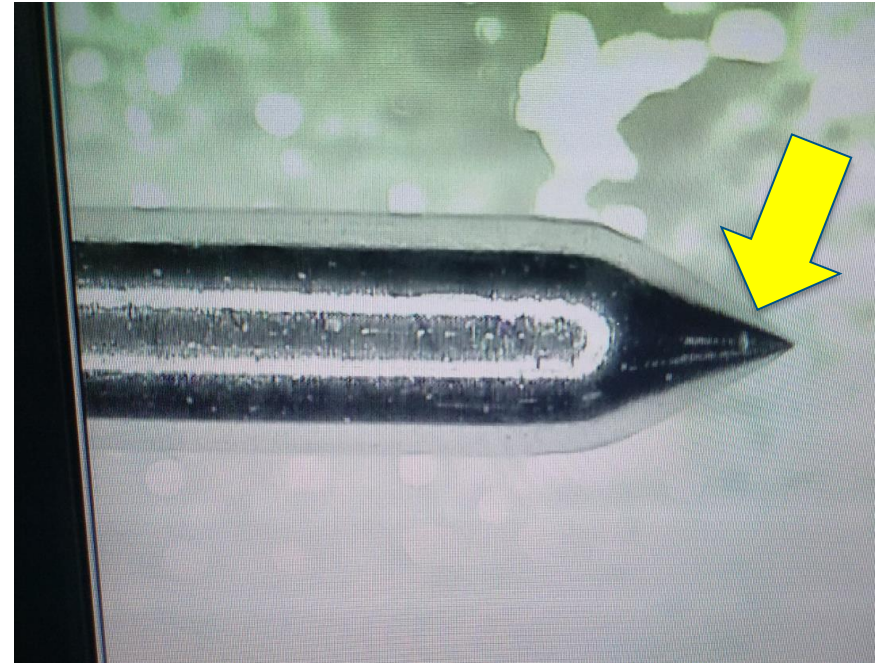
# Sample 1 (20x magnification)

- Needle tip is checked for pit mark. A small pit mark was observed.

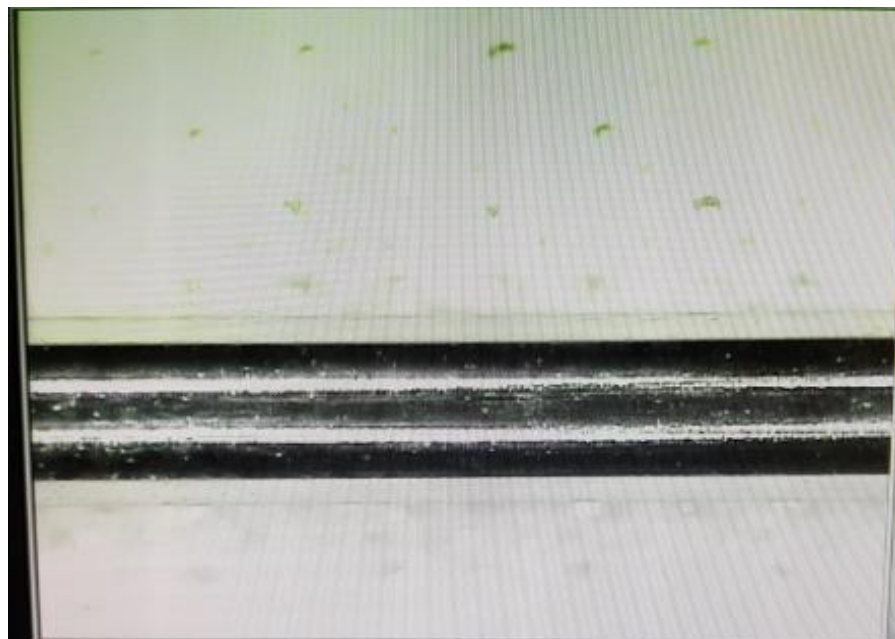
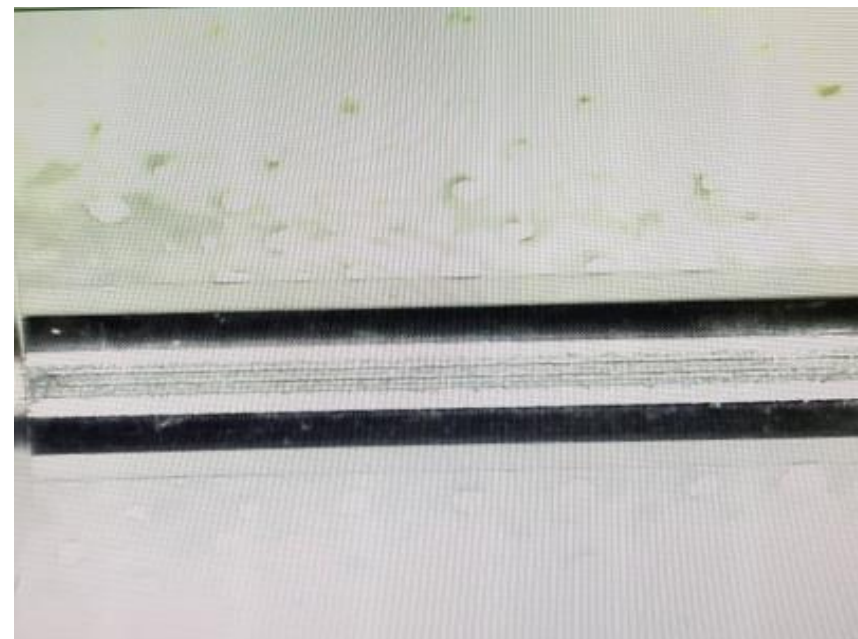
- Needle body is also checked for longitudinal scratches. No scratches found.

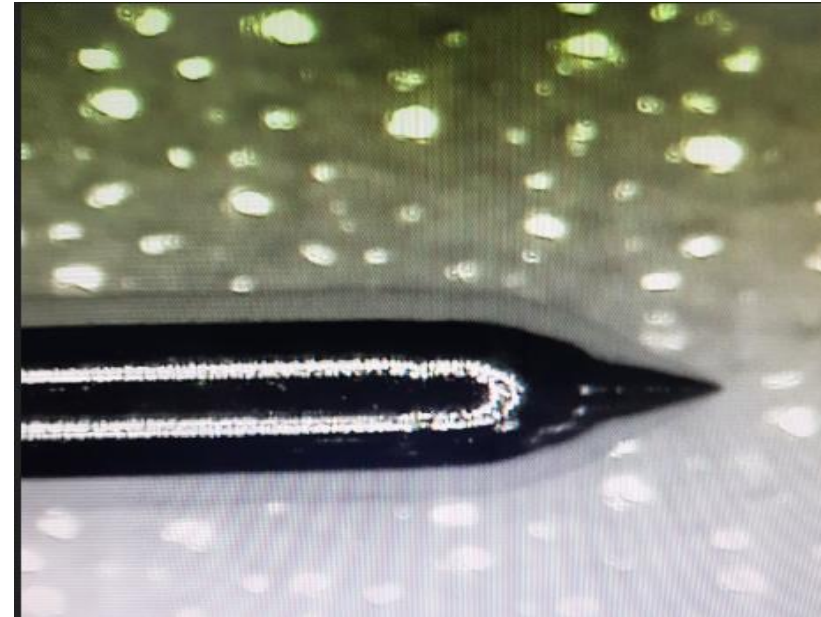
## Sample 2 (20x magnification)

- Needle tip is checked for pit mark. Unable to detect pit.

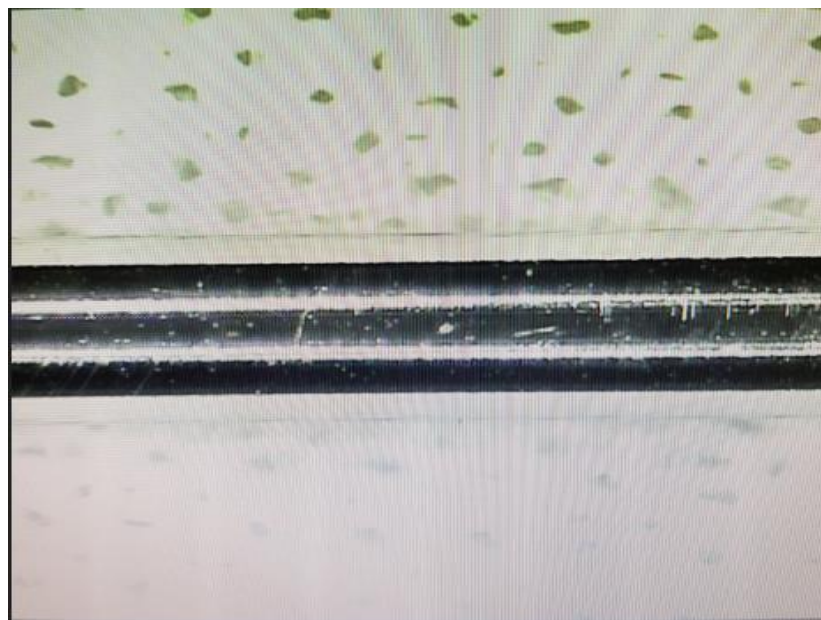
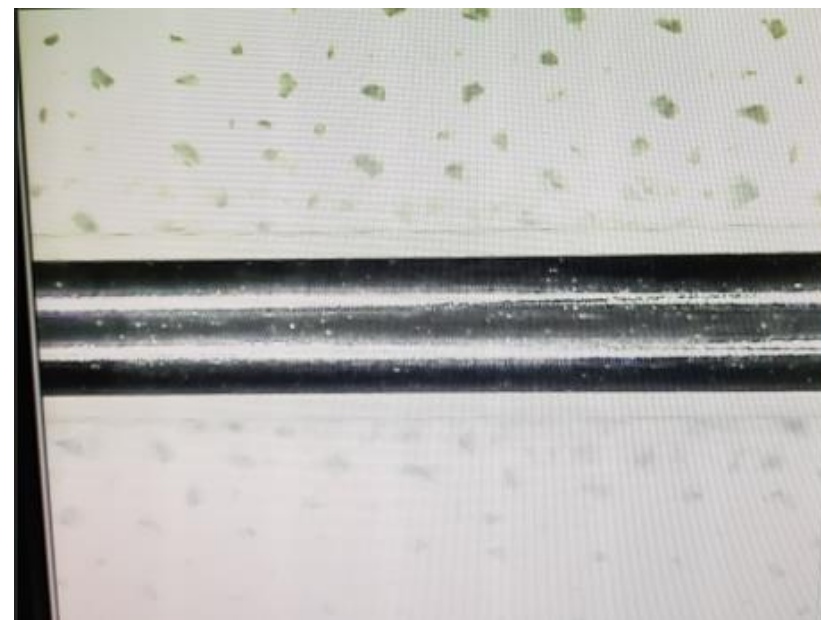
- Needle body is also checked for longitudinal scratches. No scratches found.

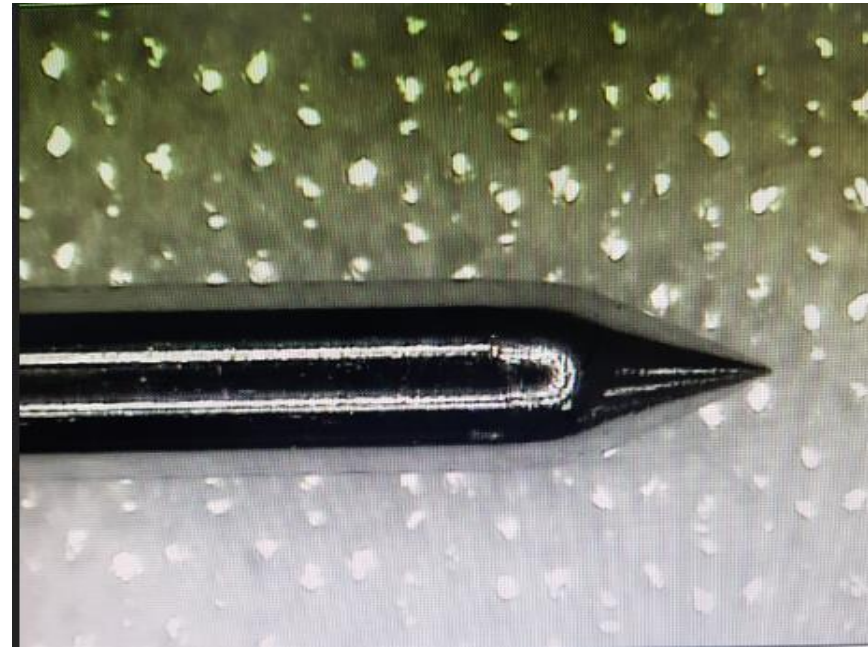
## Sample 3 (20x magnification)

- Needle tip is checked for pit mark Unable to detect pit.

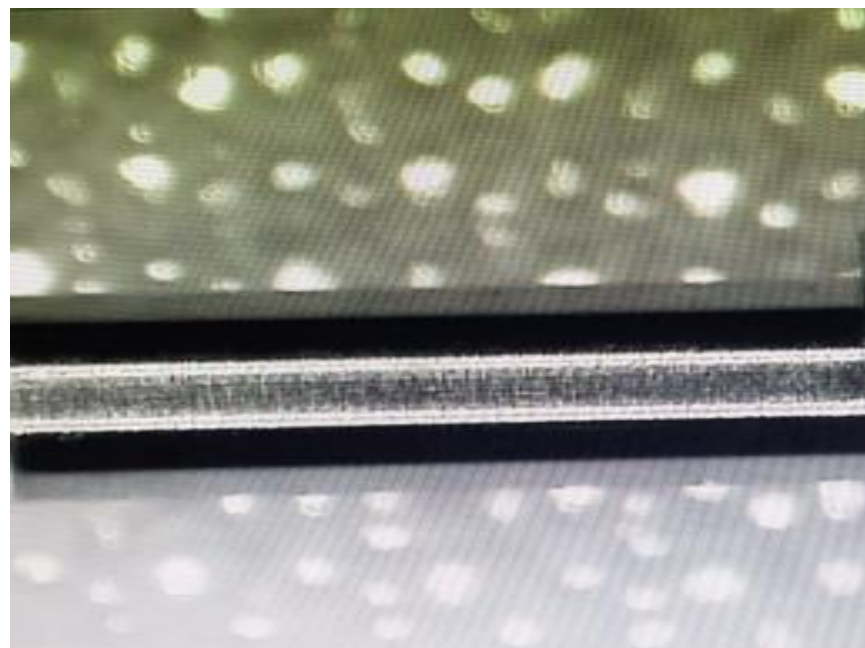
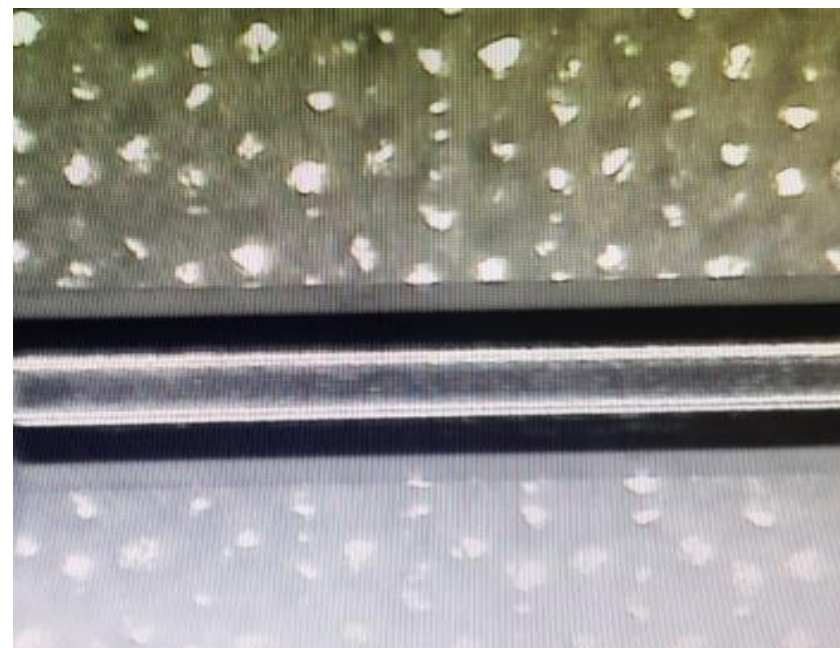
- Needle body is also checked for longitudinal scratches. No scratches found.

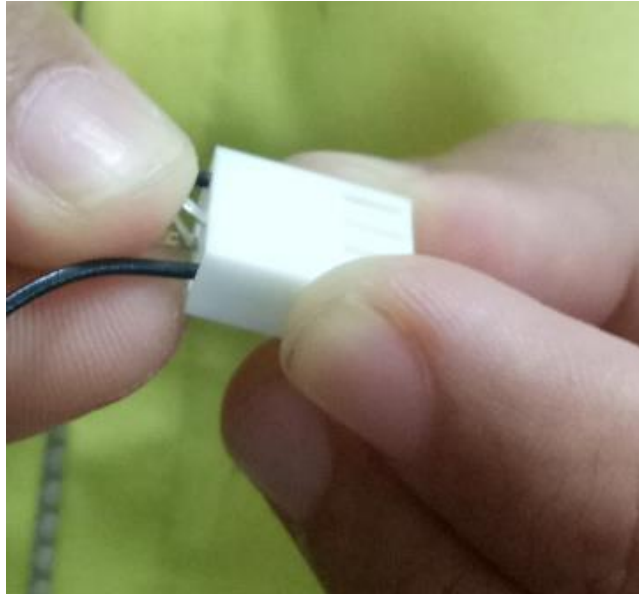
**Terminal unable to insert at the holding position and operator difficult to hold this area**

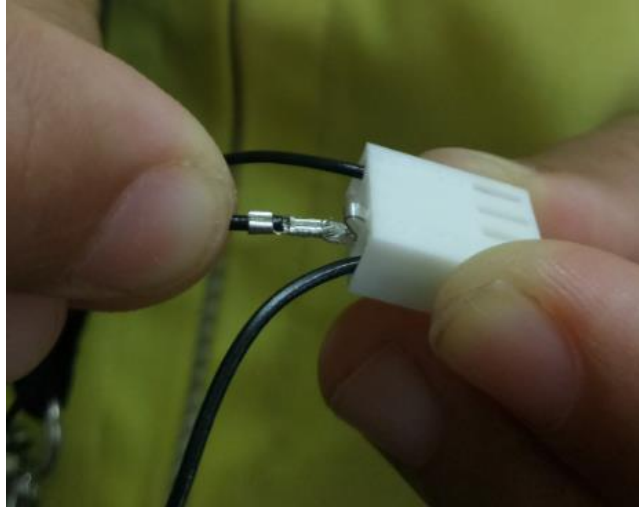
**Correct holding position**

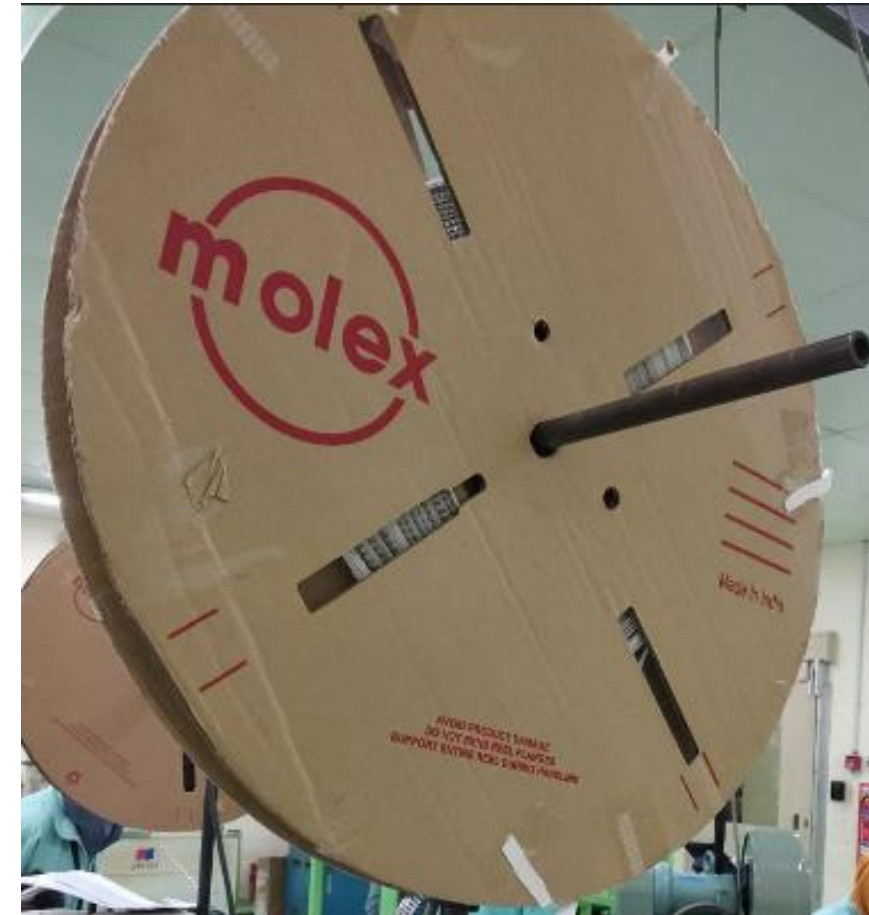
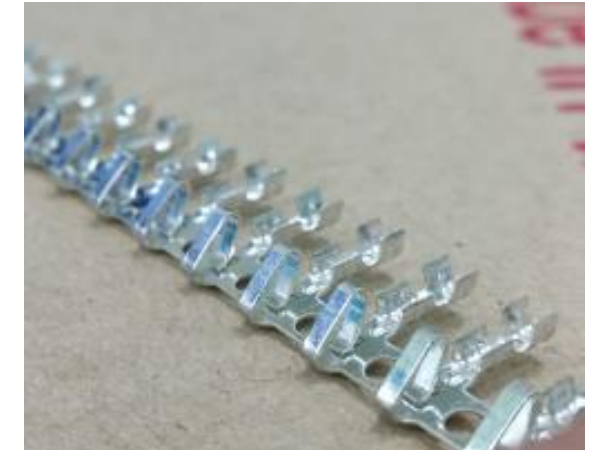
**Original Material Condition in reel type and there is carton pad to protect**

| | Possible Causes | Verification | Possible Cause<br>( Y / N) | Proposed Actions |
|---|---|---|---|---|
| Material | It might cause Original Material been deformed before process | NO deformed terminal been found <b>(there is carton pad to protect)</b> | YES | Conduct 100% visual inspection for 3 lots after terminal insertion. |

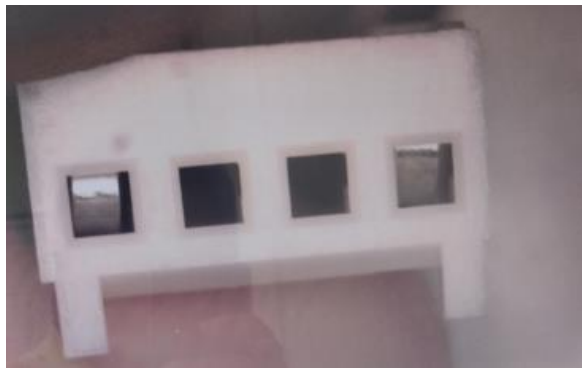
**Simulation result for 5X plug into Mating jig. Result : NO Deformation terminal cause by mating jig (100% continuity test conducted by factory)**

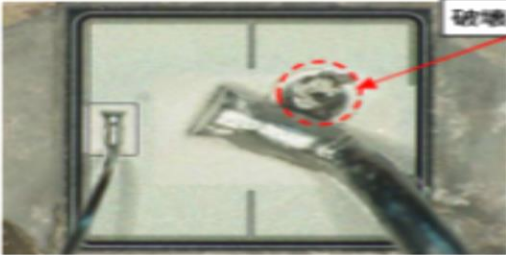
2.2 電気的特性  
返却品の電気的特性調査の結果、VDSS及びVGSSショートを確認致しました。

2.3 分解調査  
返却品の分解後の外観観察の結果、チップ表面に破壊部位を確認致しました。

写真1. 返却品(7C2) 破壊部位  
Photo. 1 Damaged portion of retuned goods
