# Evaluation of 20u 405001338 Needle

17 Jan 2019

- On 11 Jan 2019 evening, Eugene provided a base (guideline), to evaluate on the 10% failures reported at Alliance Injector Sub-assy in WW01-2019.

- About 50% of the needles found with scratches when checked under 40x magnification.
- Majority of the known good (no scratches) fresh needle are found with longitudinal scratches after testing.
- It may be a concern to observed longitudinal scratches on the known good (no scratches) fresh needle after testing. WPPL and Flex may need to look into this concern.
- As of to date 17 Jan 2019, it is still not known whether the needles themselves and/or possibly other associated mechanisms or parts, is/are causing the high reject rate (10% fallout) in Pressure Decay test .

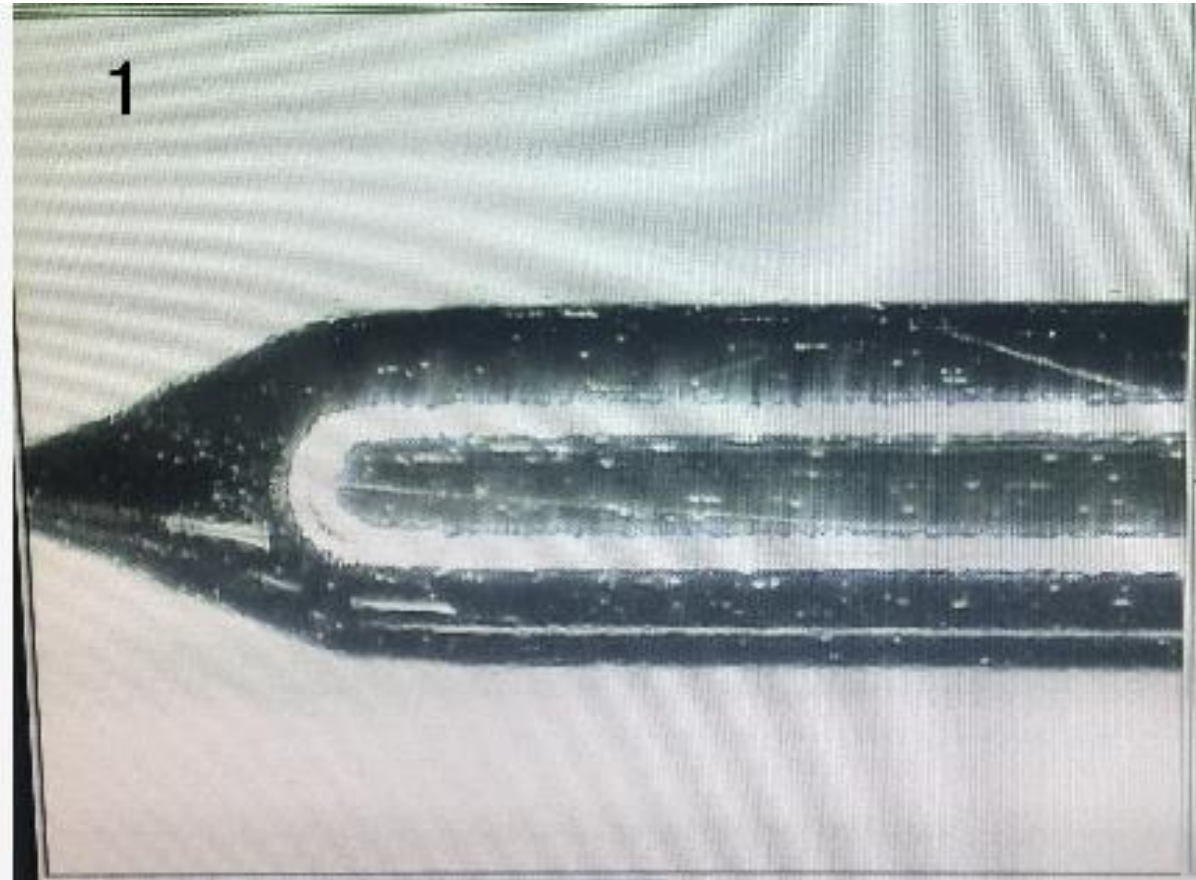
Longitudinal scratches observed

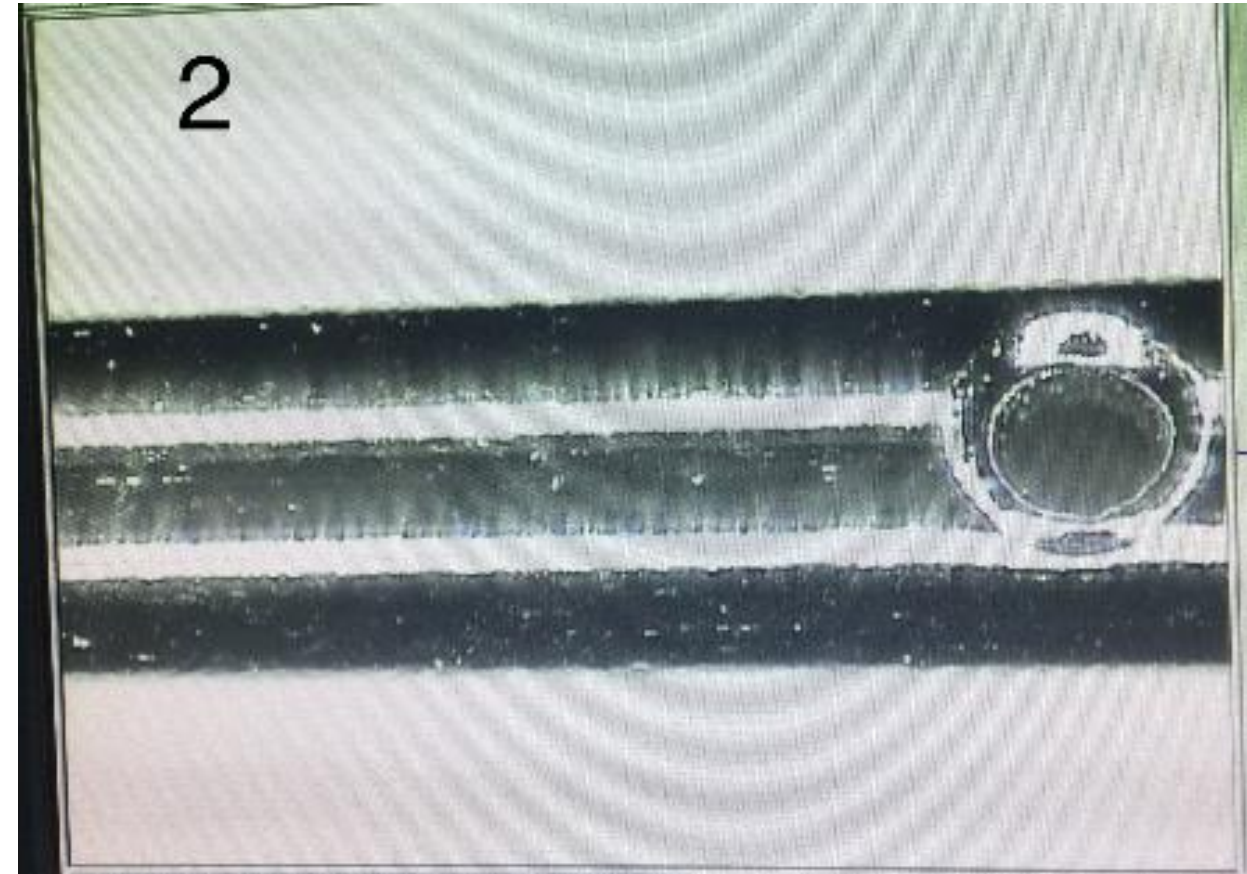
No longitudinal scratches observed

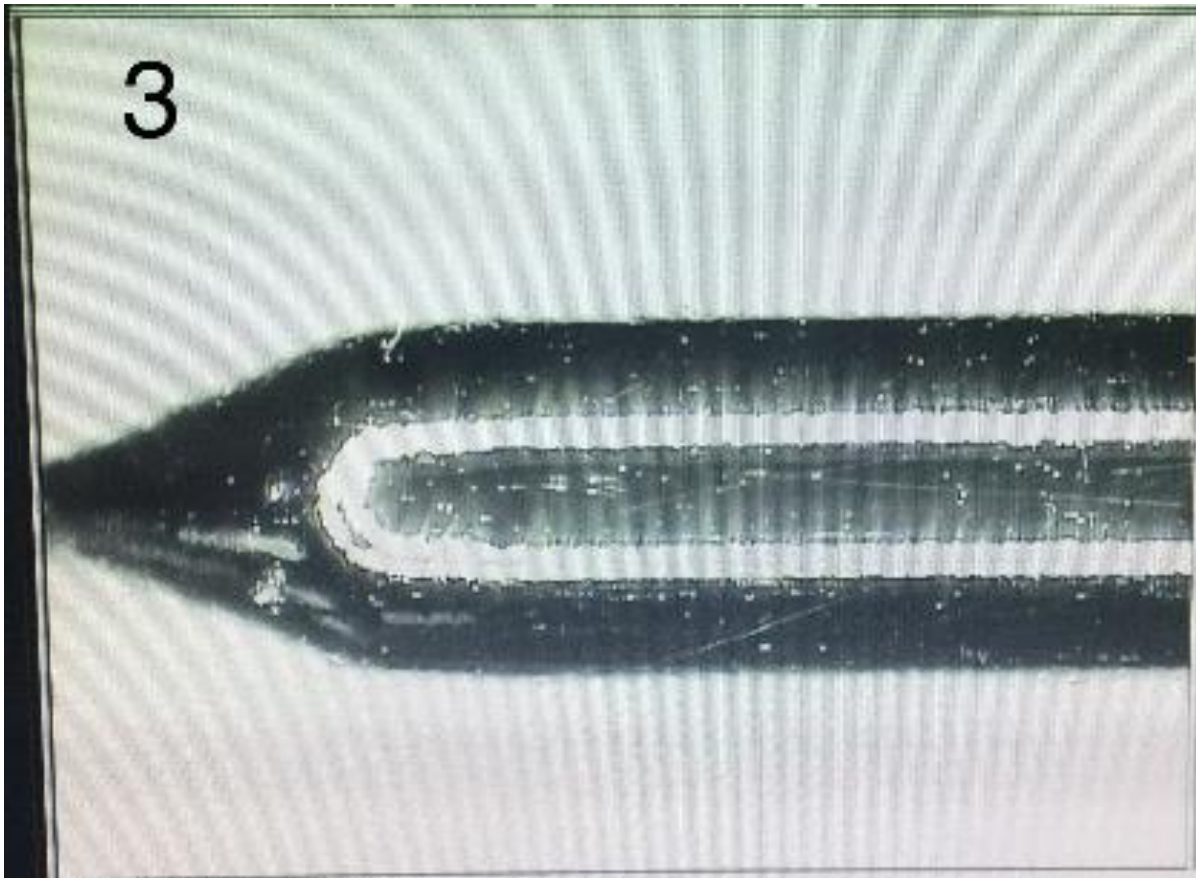
Longitudinal scratches observed

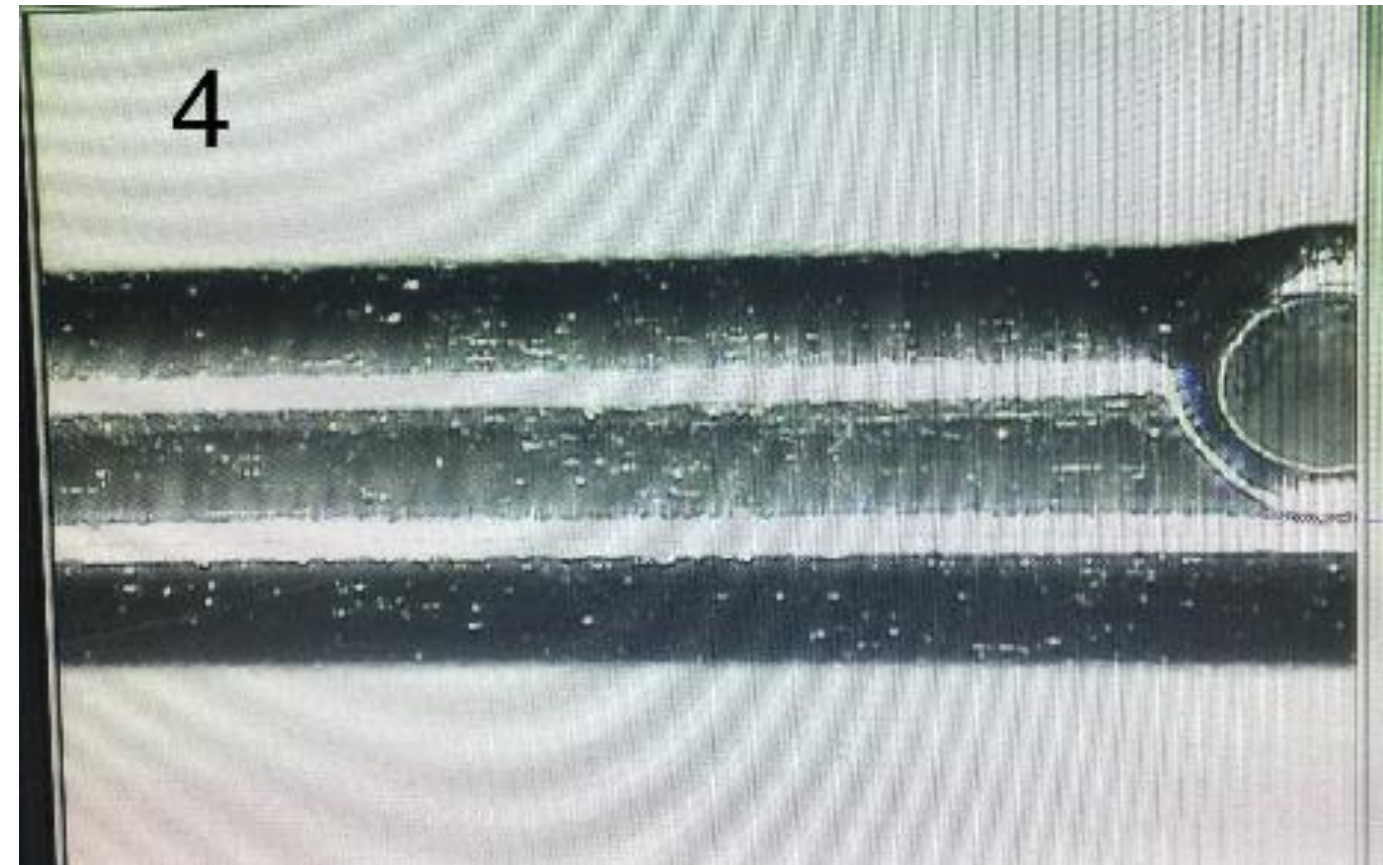
No longitudinal scratches observed

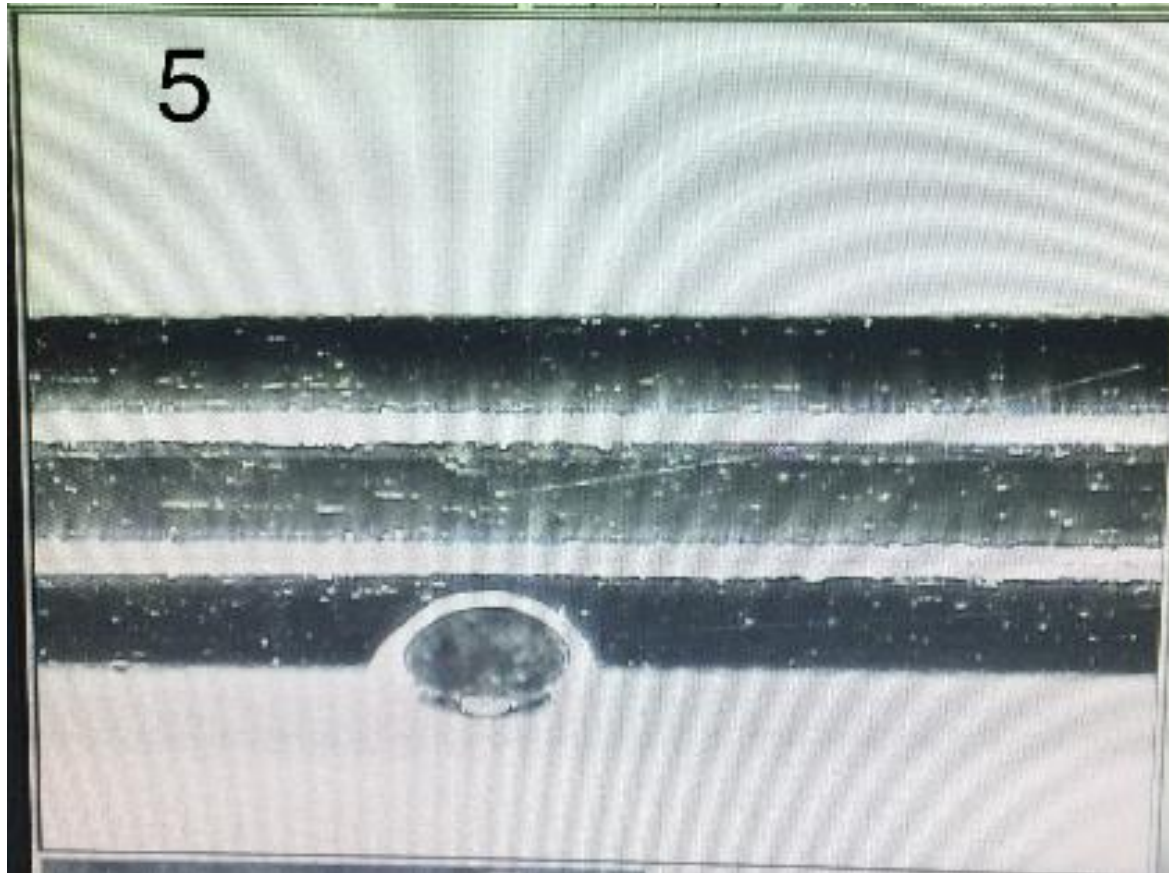
Longitudinal scratches observed

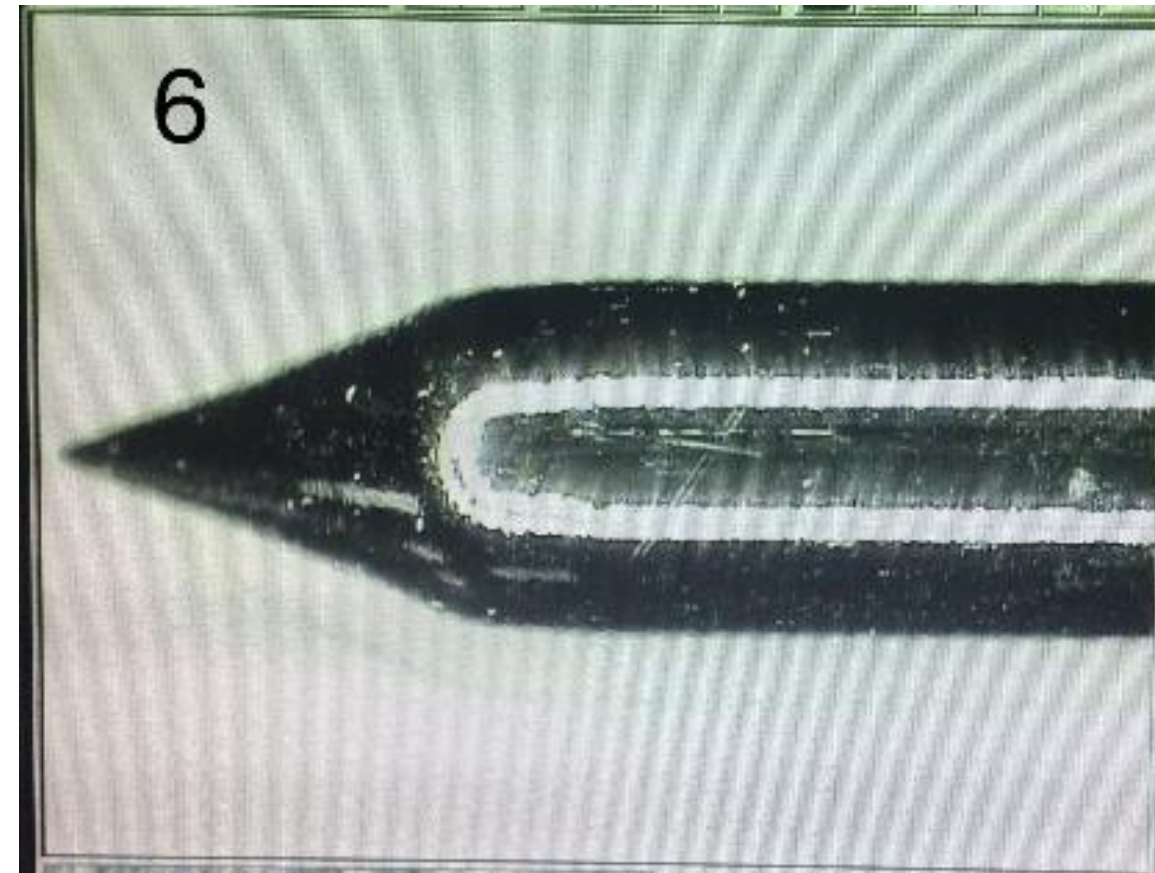
No longitudinal scratches observed but scratches observed

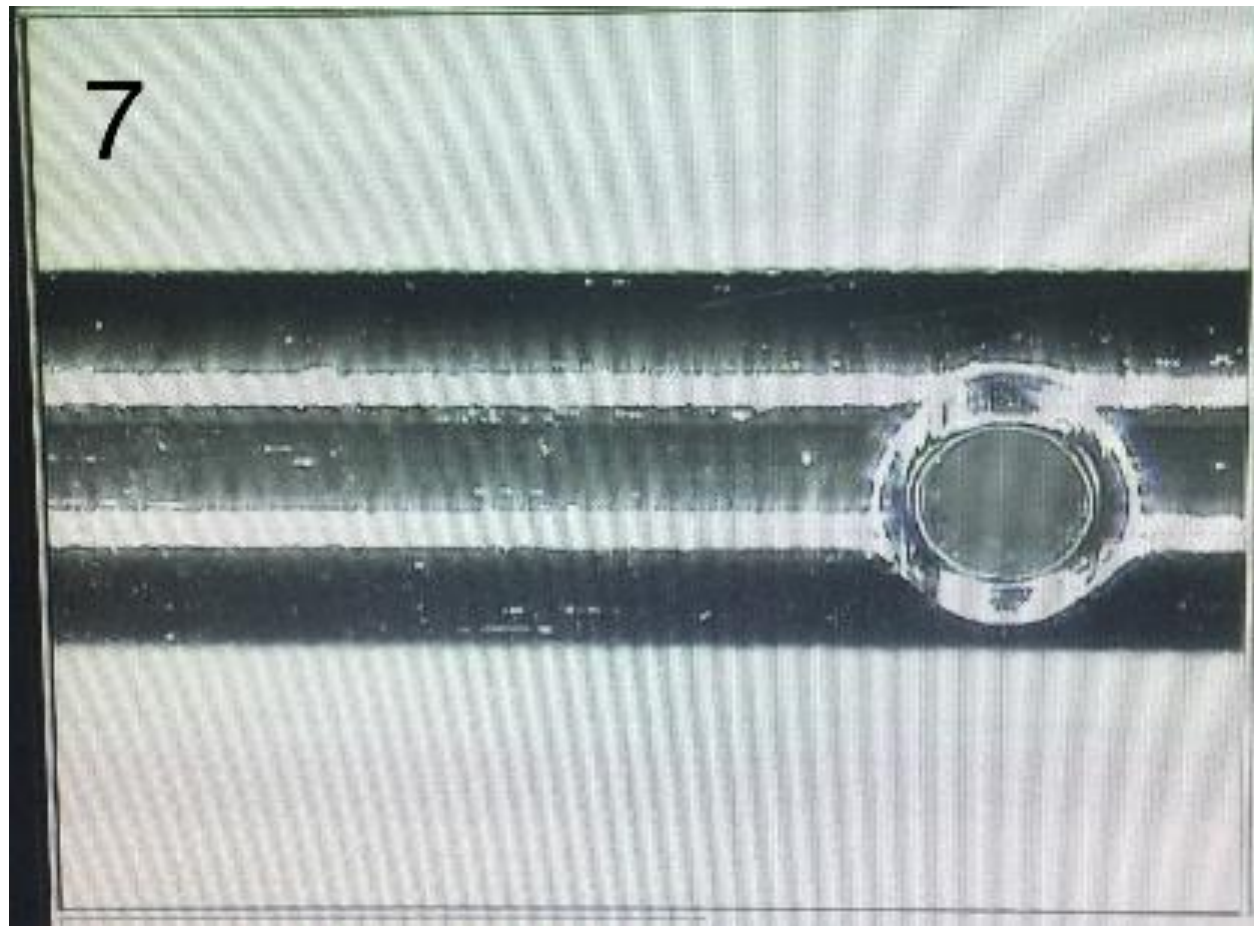
No longitudinal scratches observed

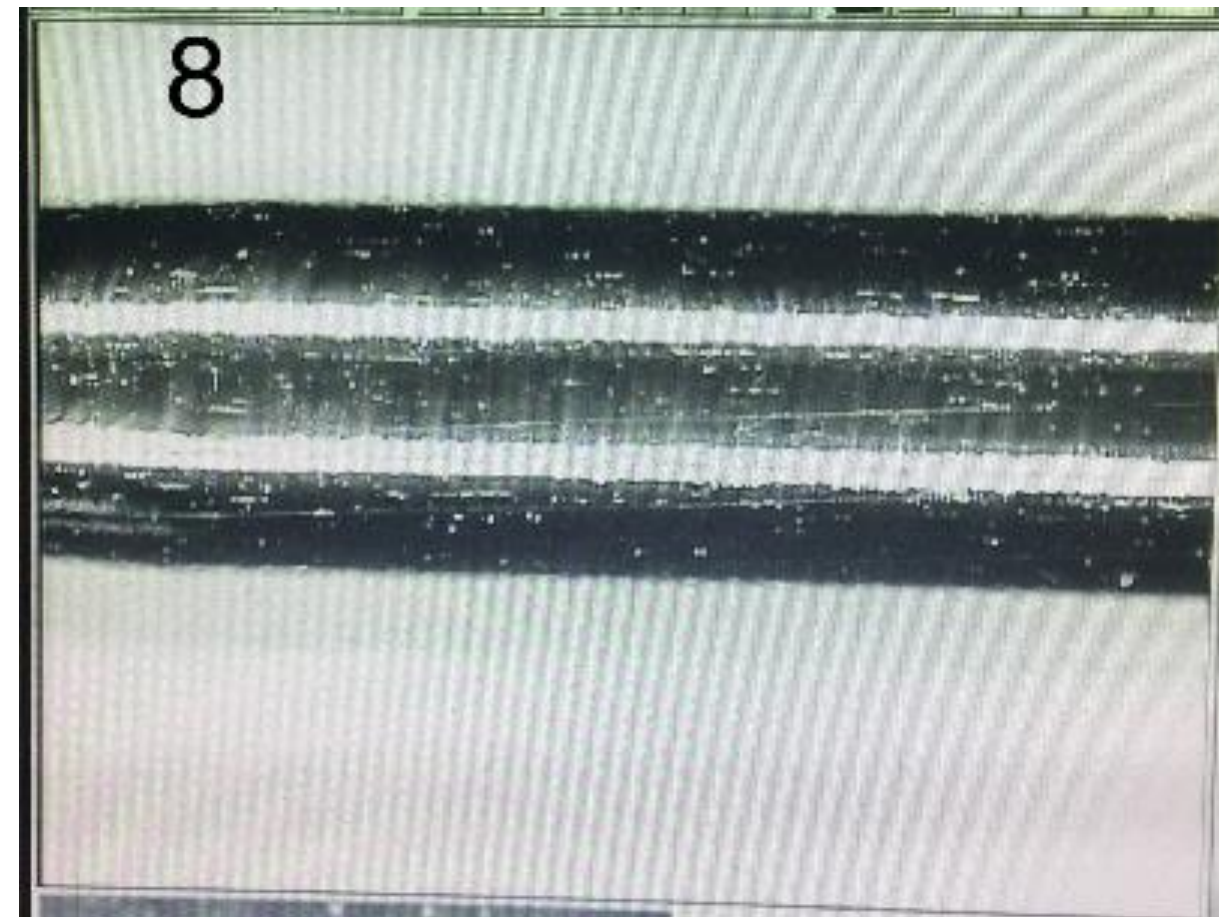
Longitudinal scratches observed

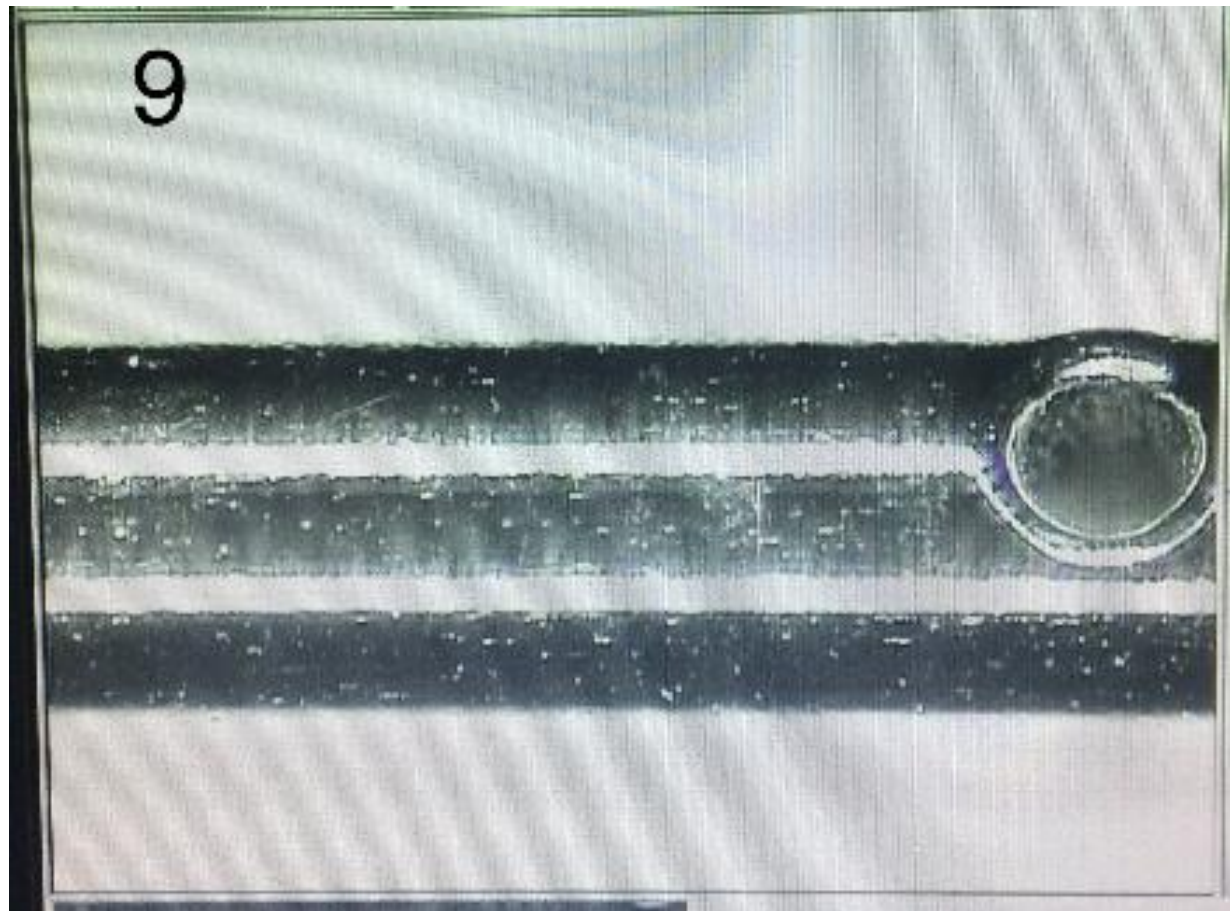
No longitudinal scratches observed

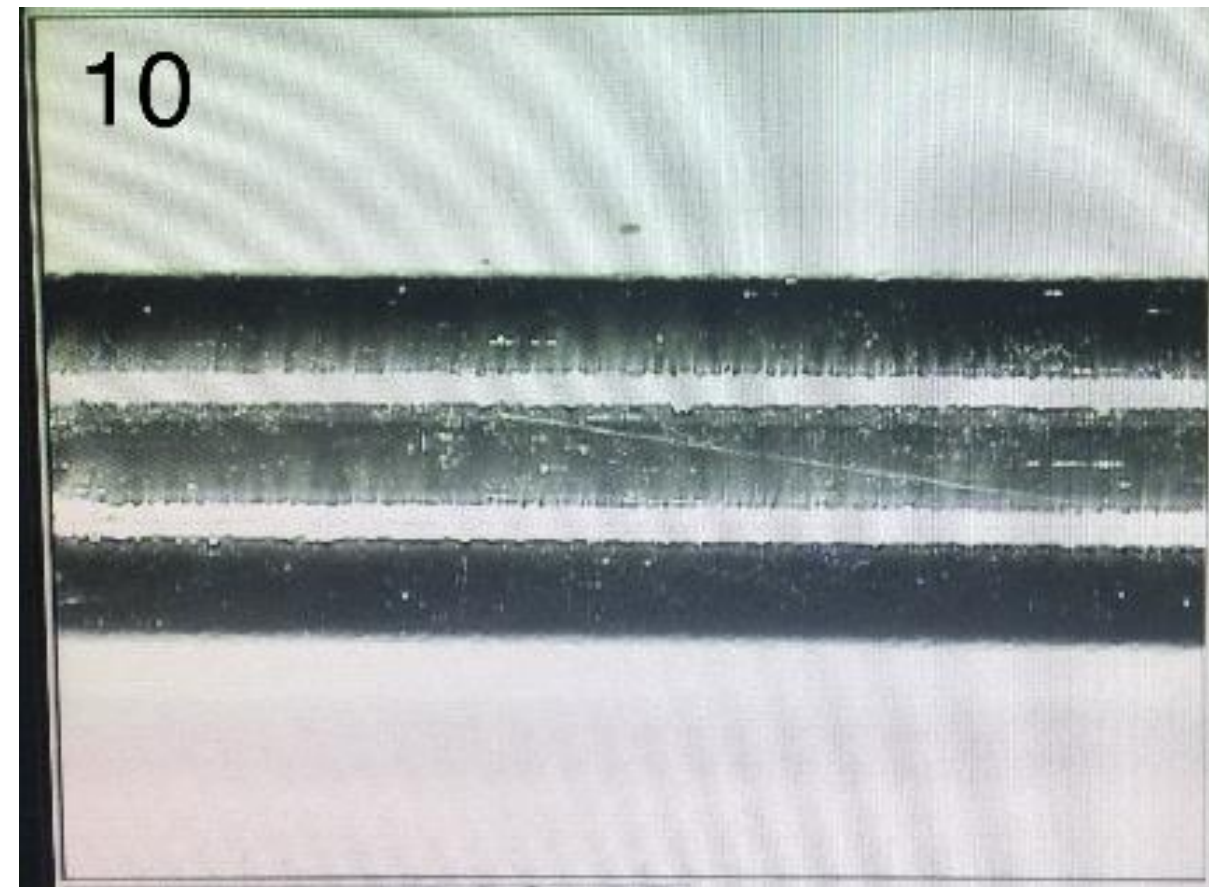
Longitudinal scratches observed

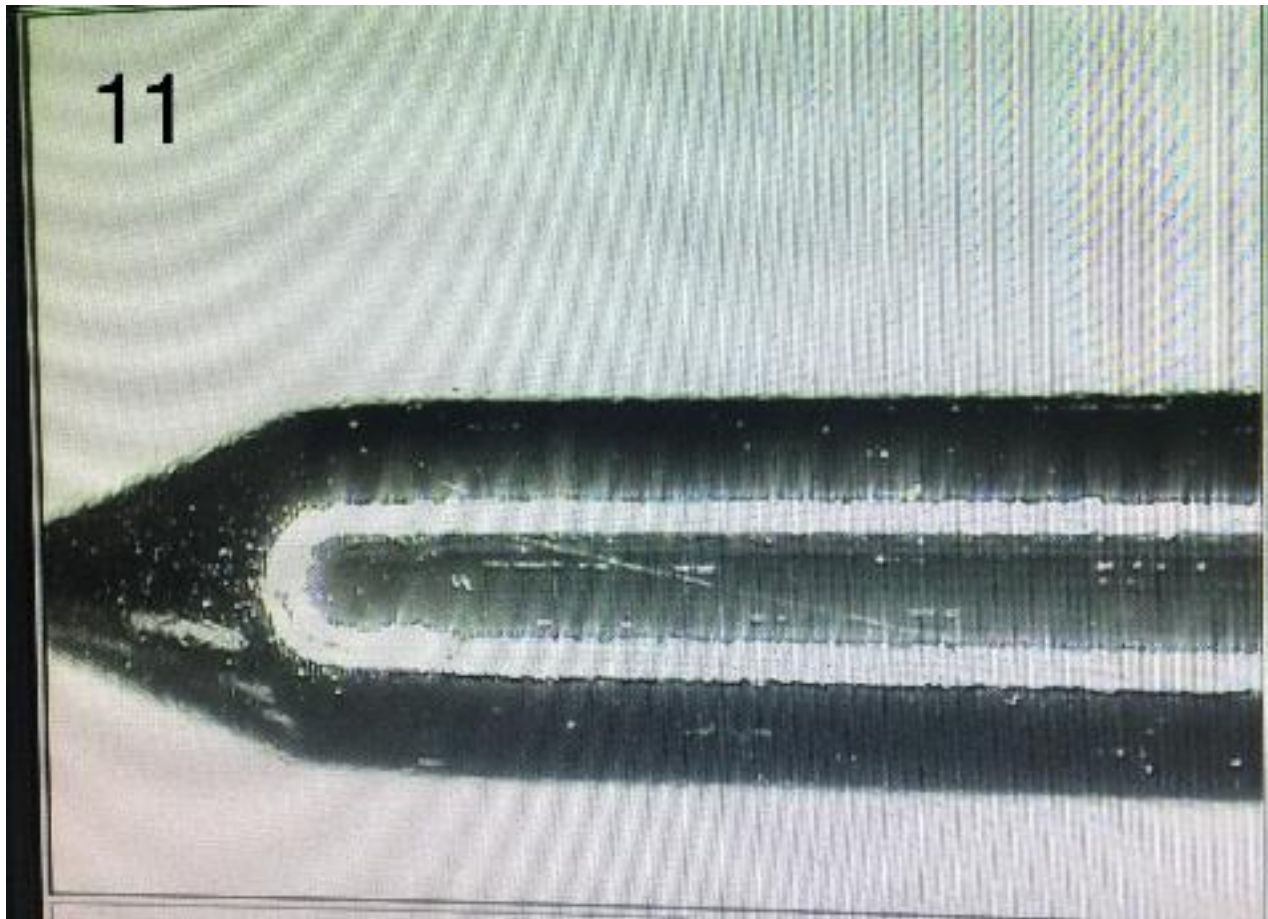
Longitudinal scratches observed

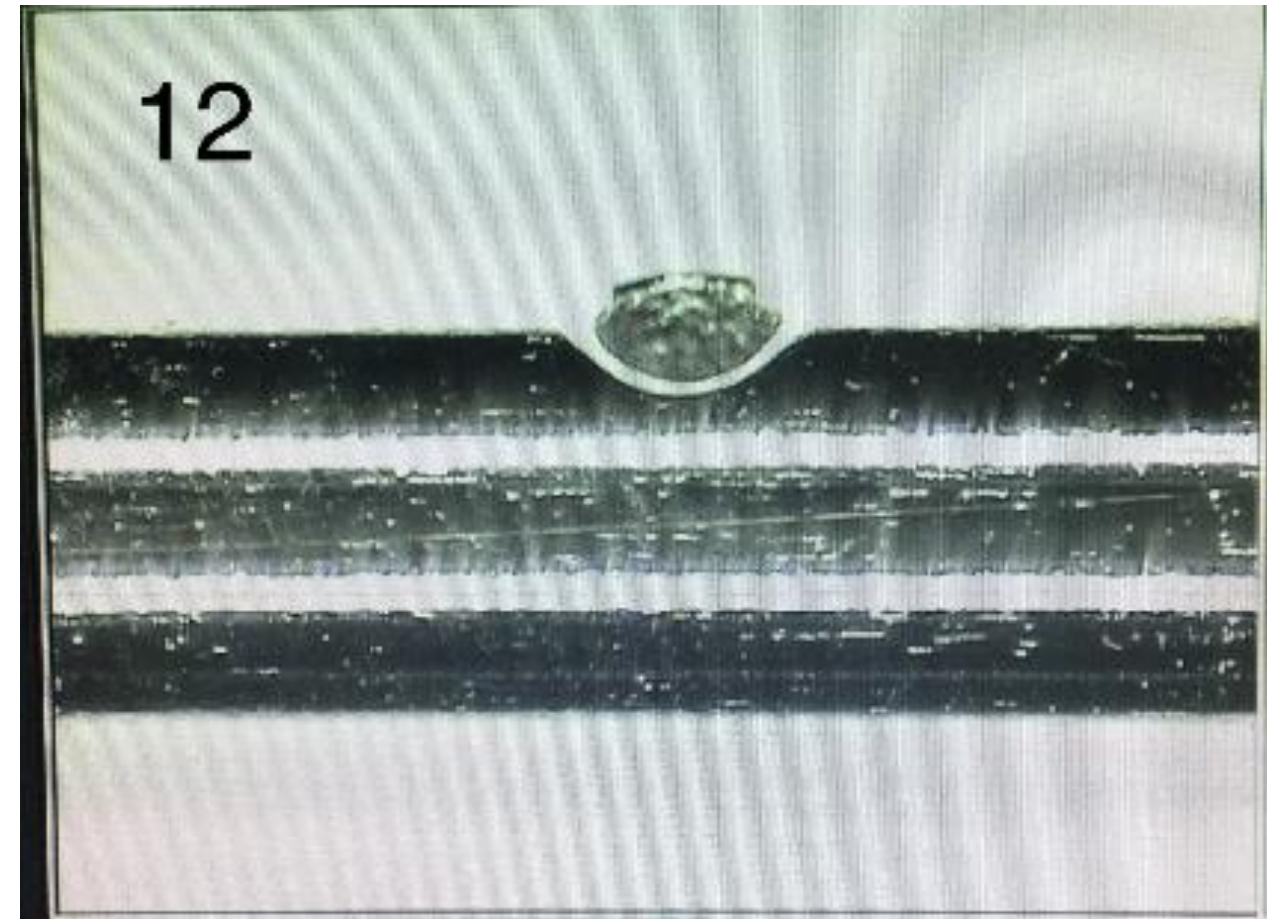
Longitudinal scratches observed

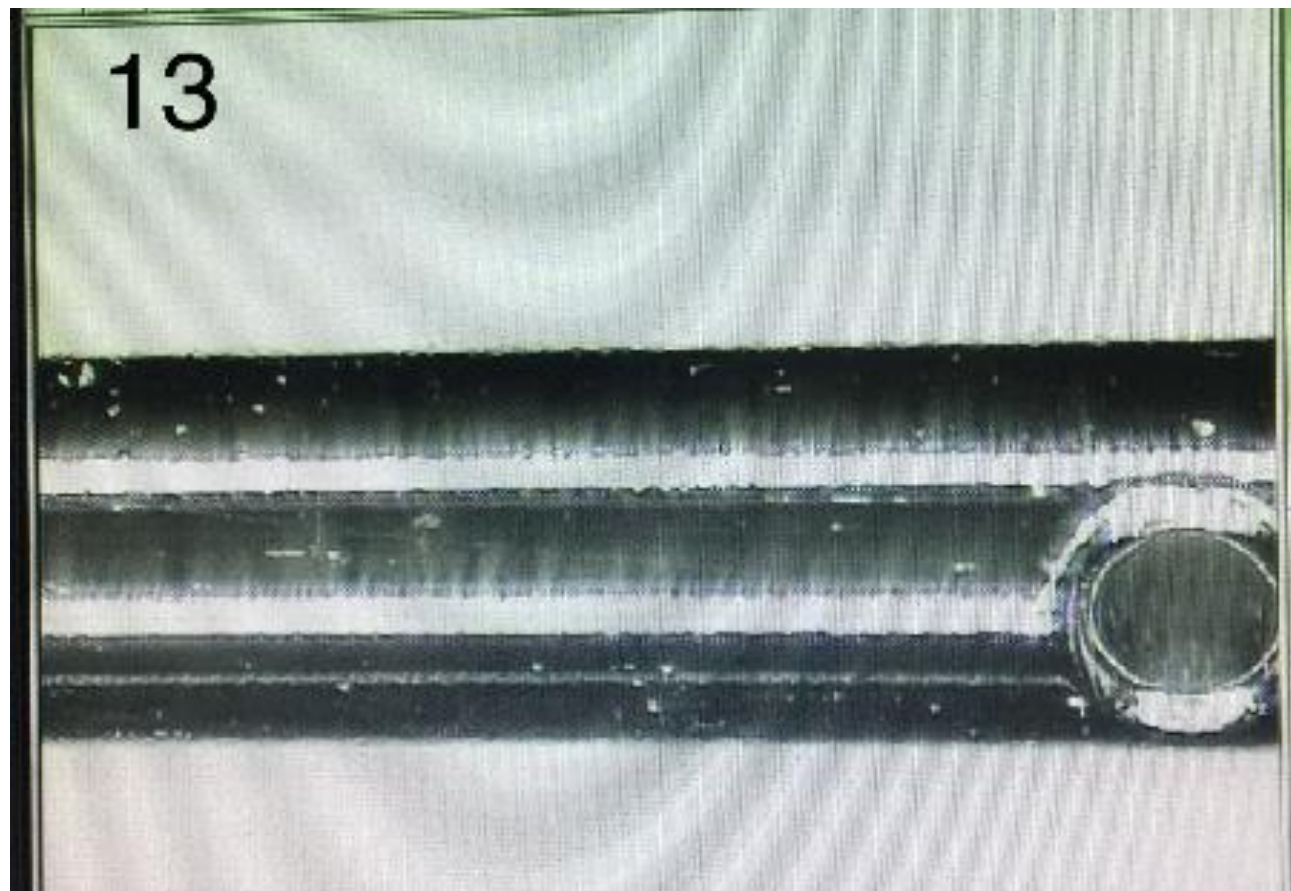
No longitudinal scratches observed

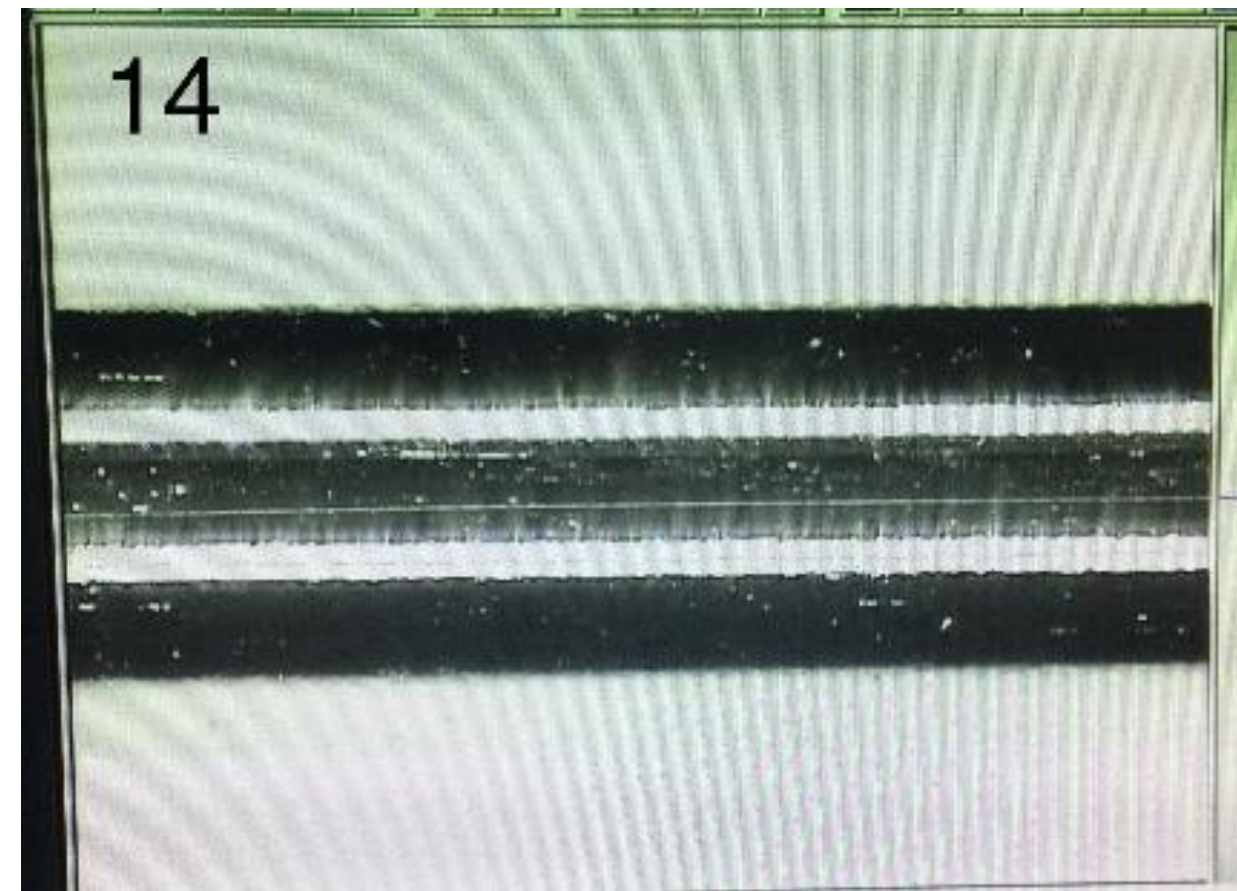
Longitudinal scratches observed

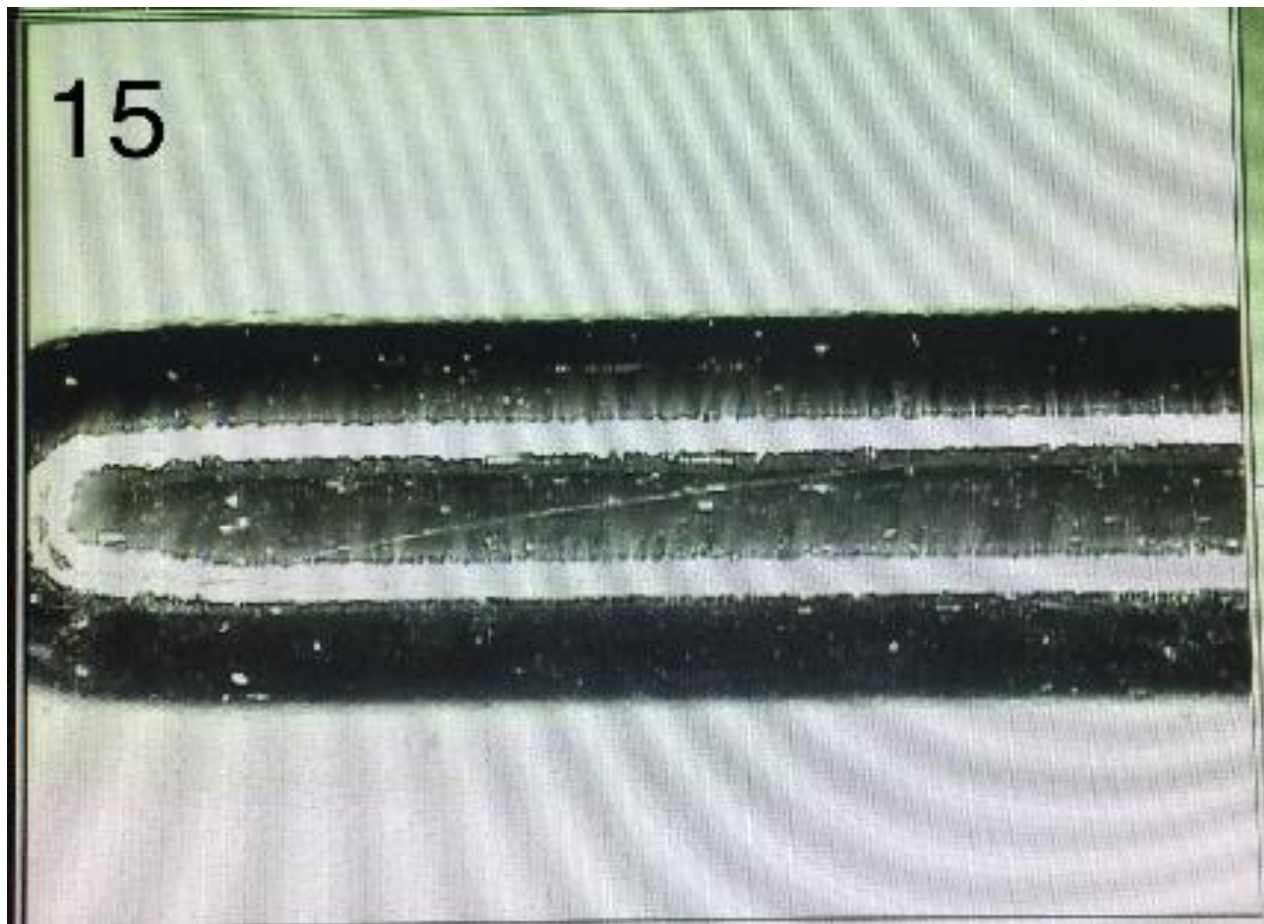
Longitudinal scratches observed

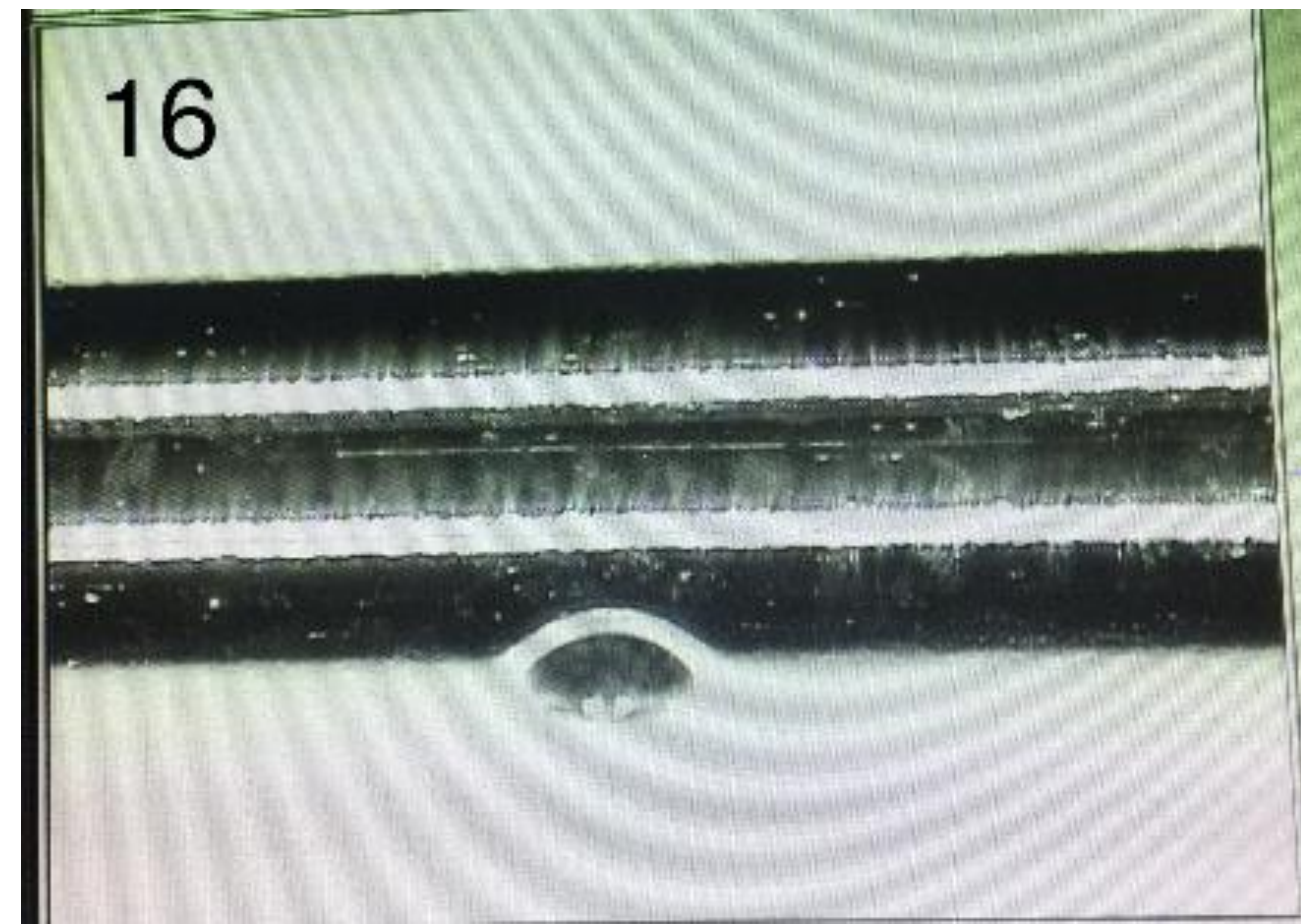
Longitudinal scratches observed

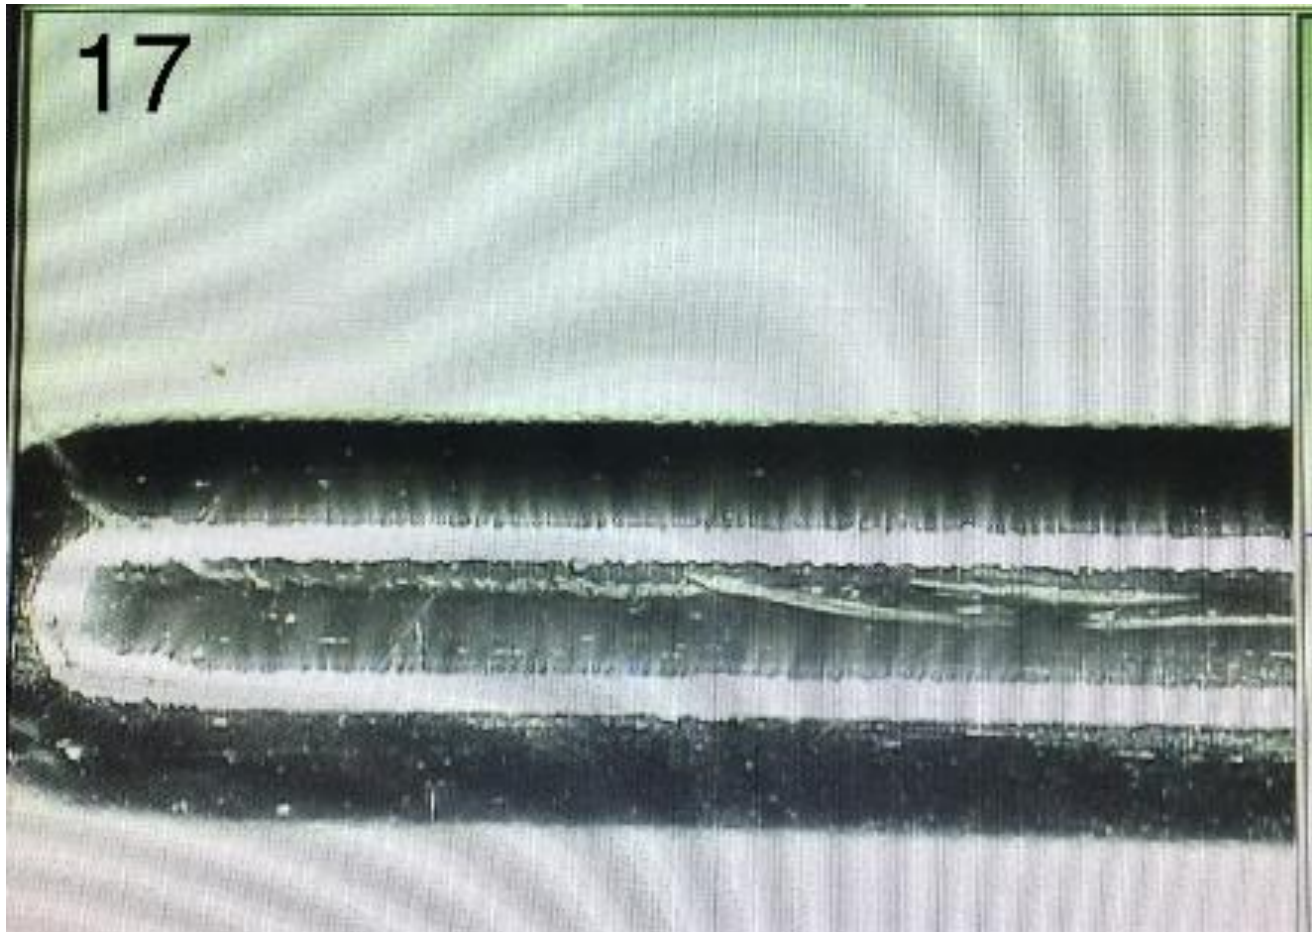
Longitudinal scratches observed

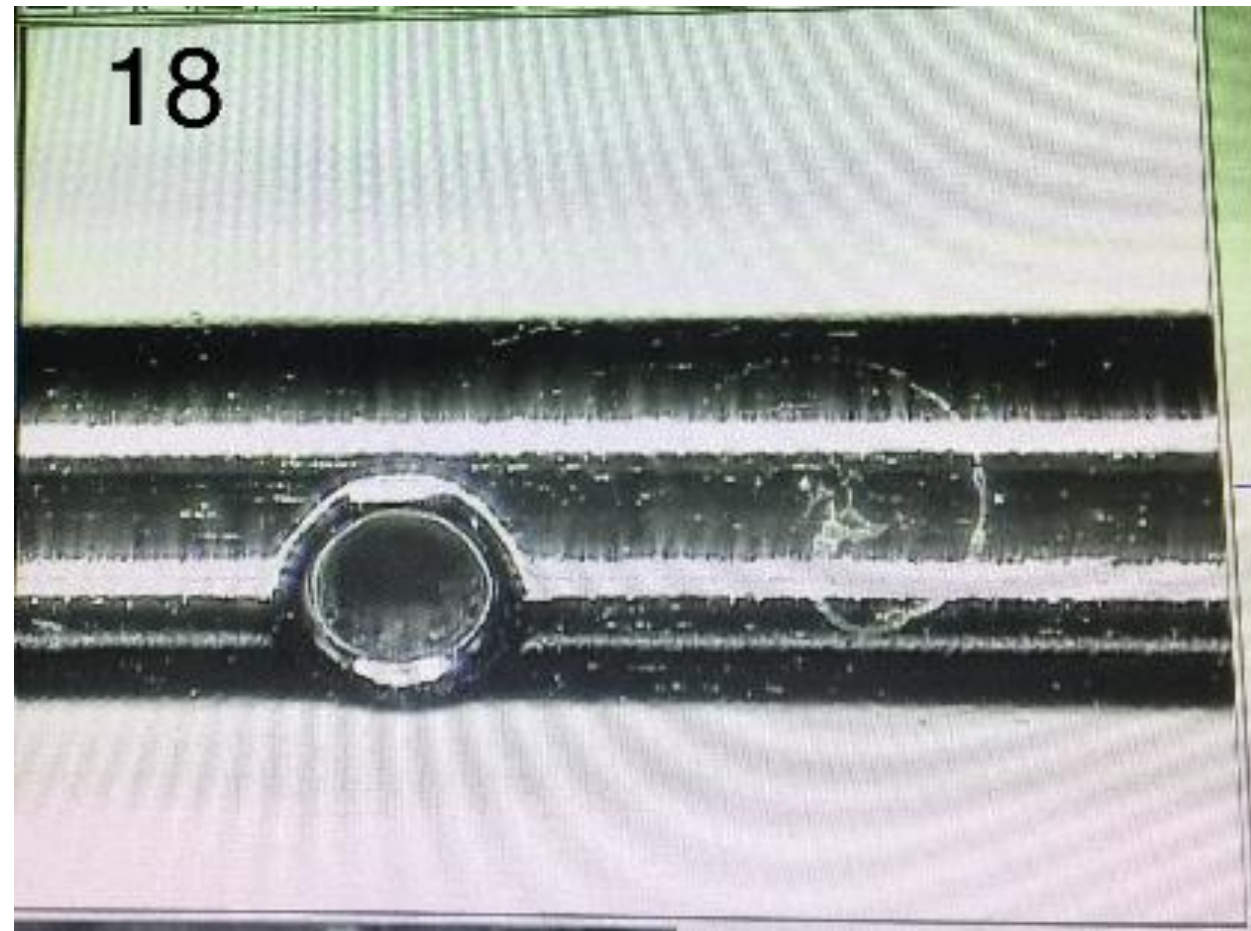
No longitudinal scratches observed, but scratches observed

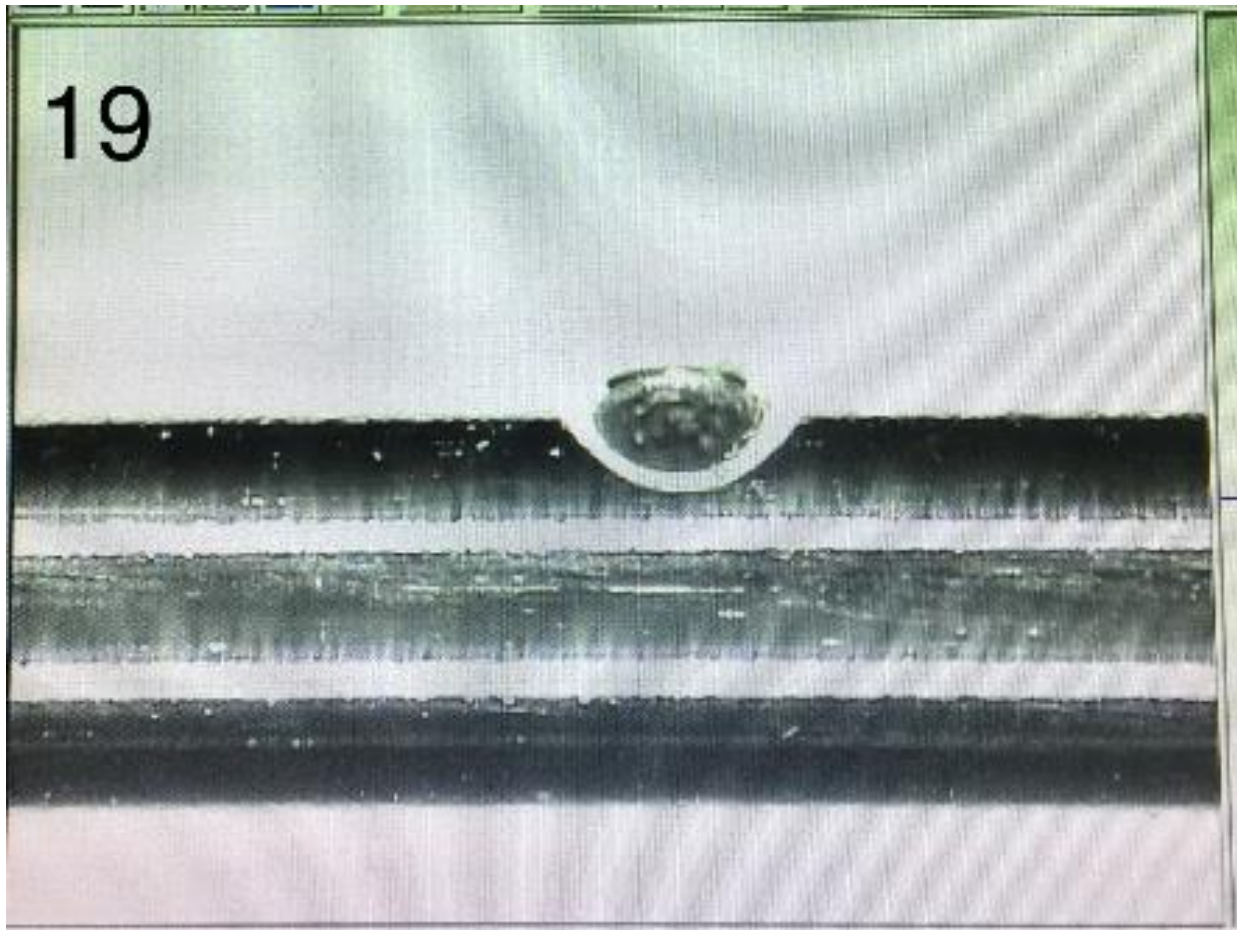
Longitudinal scratches observed

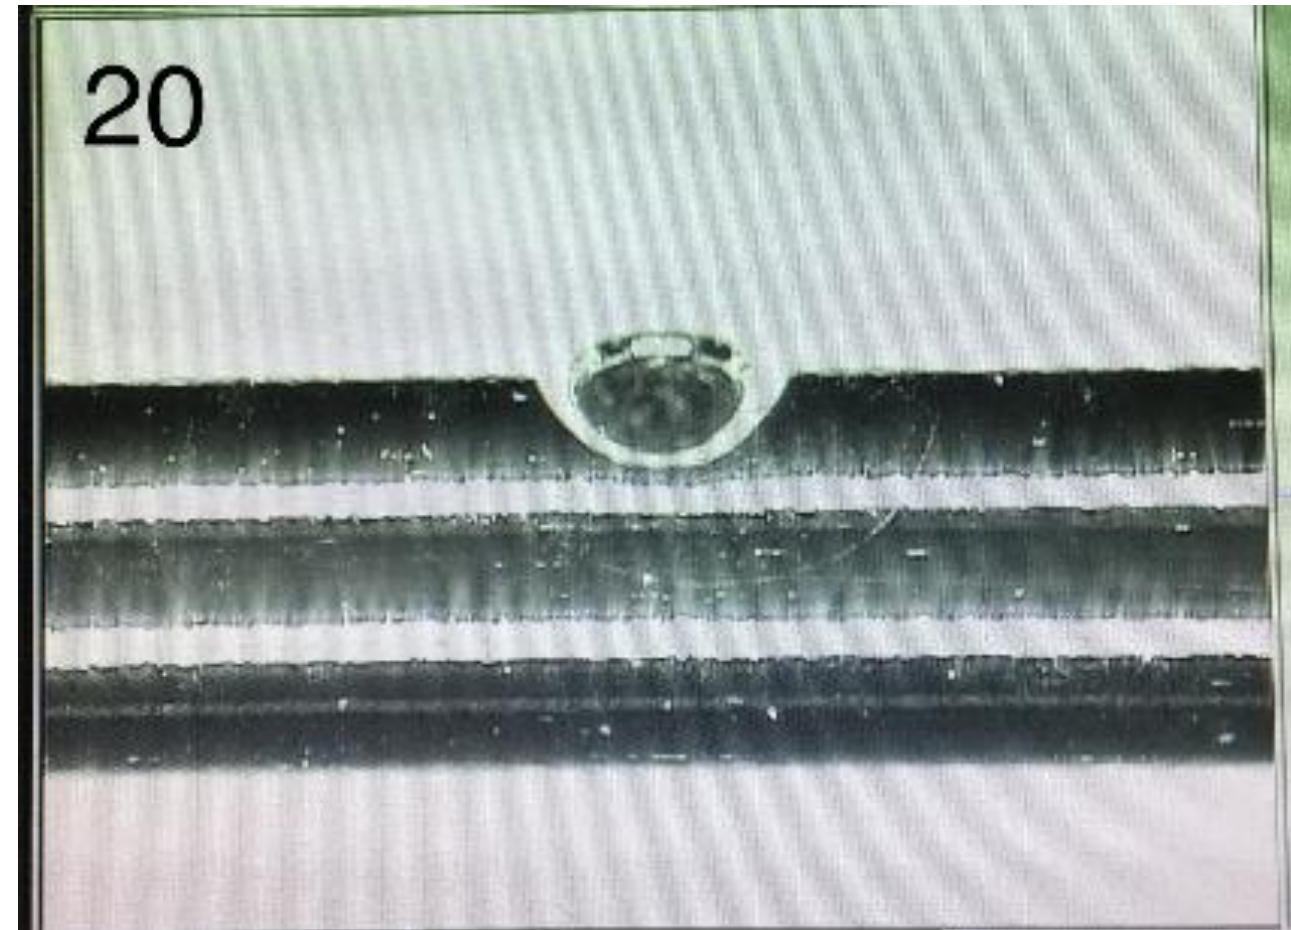
No longitudinal scratches observed, but scratches observed
