# Evaluation of 20u 405001338 Needle

17 Jan 2019

- On 11 Jan 2019 evening, Eugene provided a base (guideline), to evaluate on the 10% failures reported at Alliance Injector Sub-assy in WW01-2019.

- About 50% of the needles found with scratches when checked under 40x magnification.
- Majority of the known good (no scratches) fresh needle are found with longitudinal scratches after testing.
- It may be a concern to observed longitudinal scratches on the known good (no scratches) fresh needle after testing. WPPL and Flex may need to look into this concern.
- As of to date 17 Jan 2019, it is still not known whether the needles themselves and/or possibly other associated mechanisms or parts, is/are causing the high reject rate (10% fallout) in Pressure Decay test .

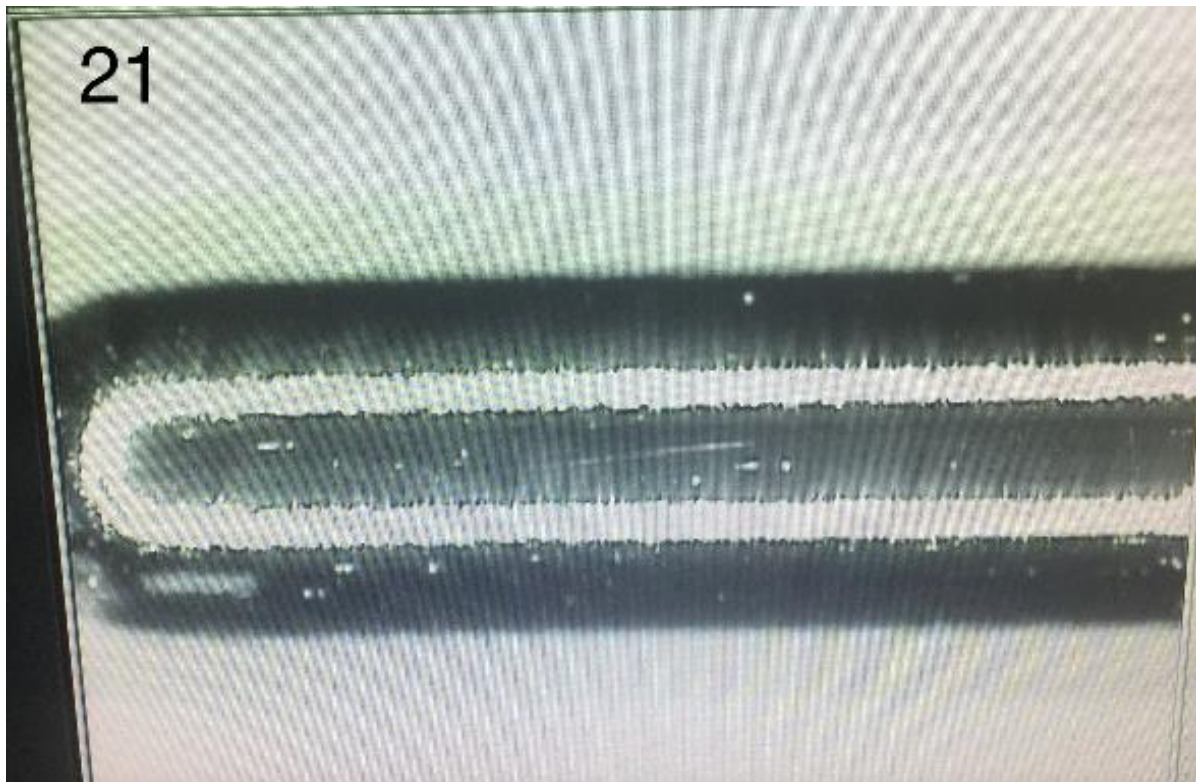
No longitudinal scratches observed,  
but scratches observed

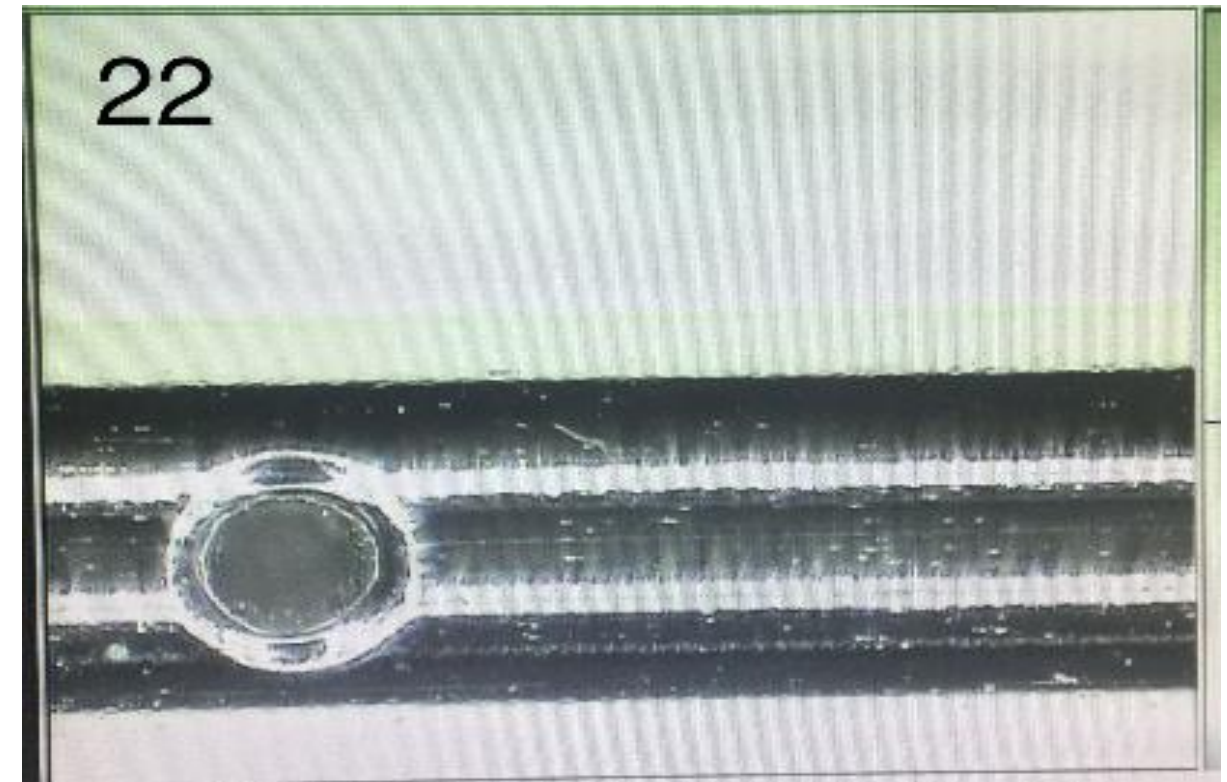
Longitudinal scratches observed

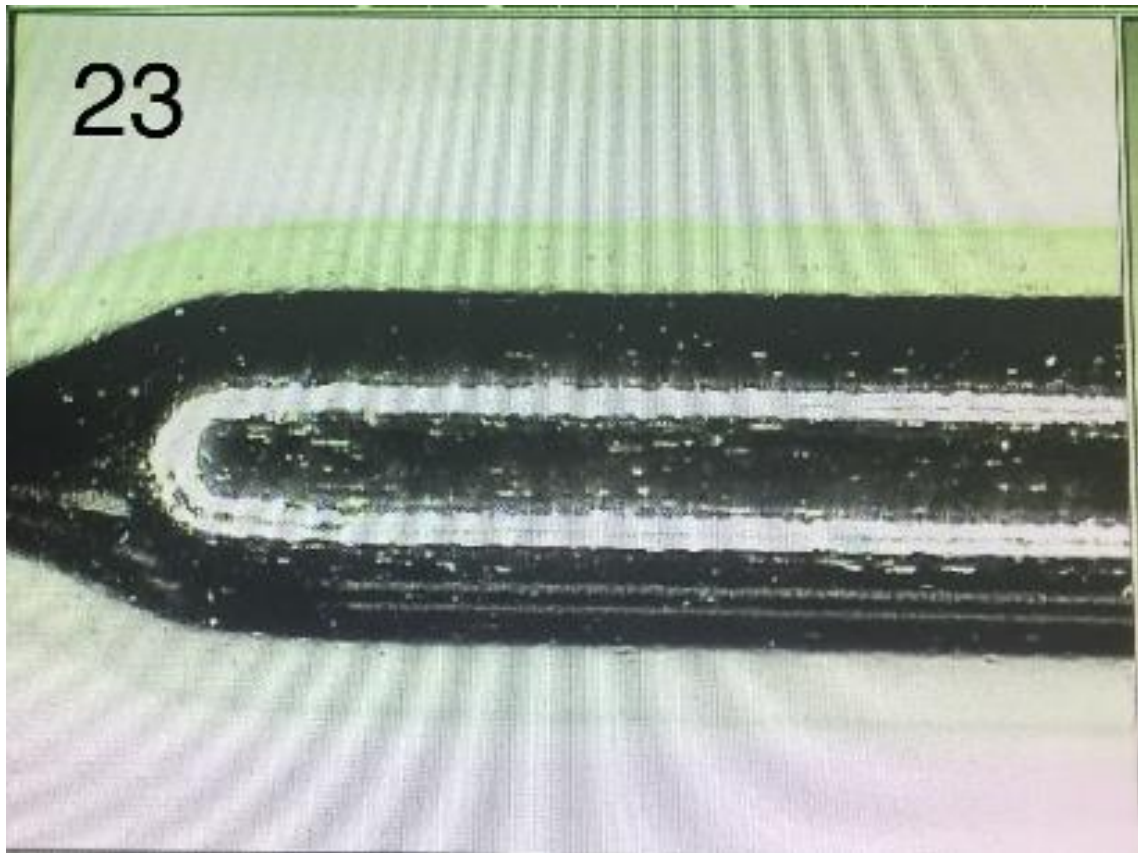
No longitudinal scratches observed,  
but scratches observed

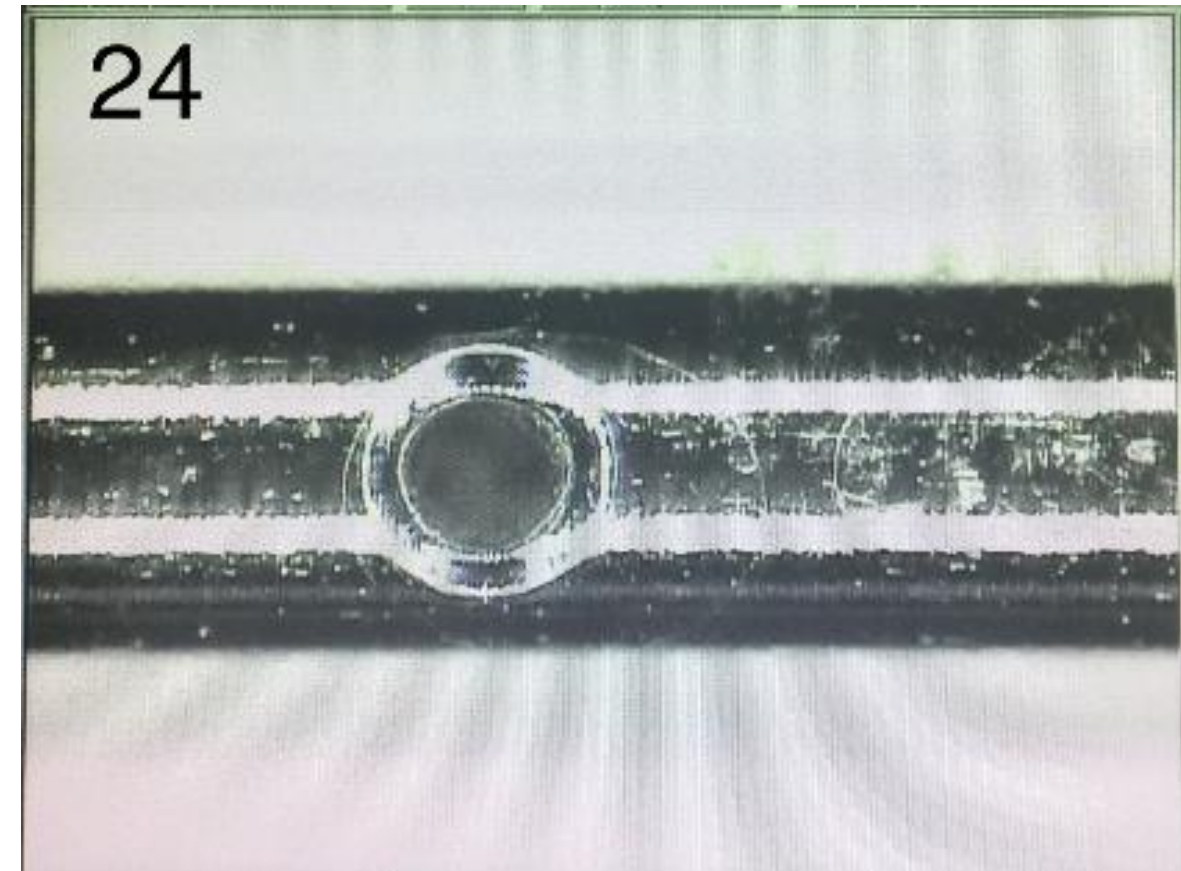
No longitudinal scratches observed,  
but scratches observed

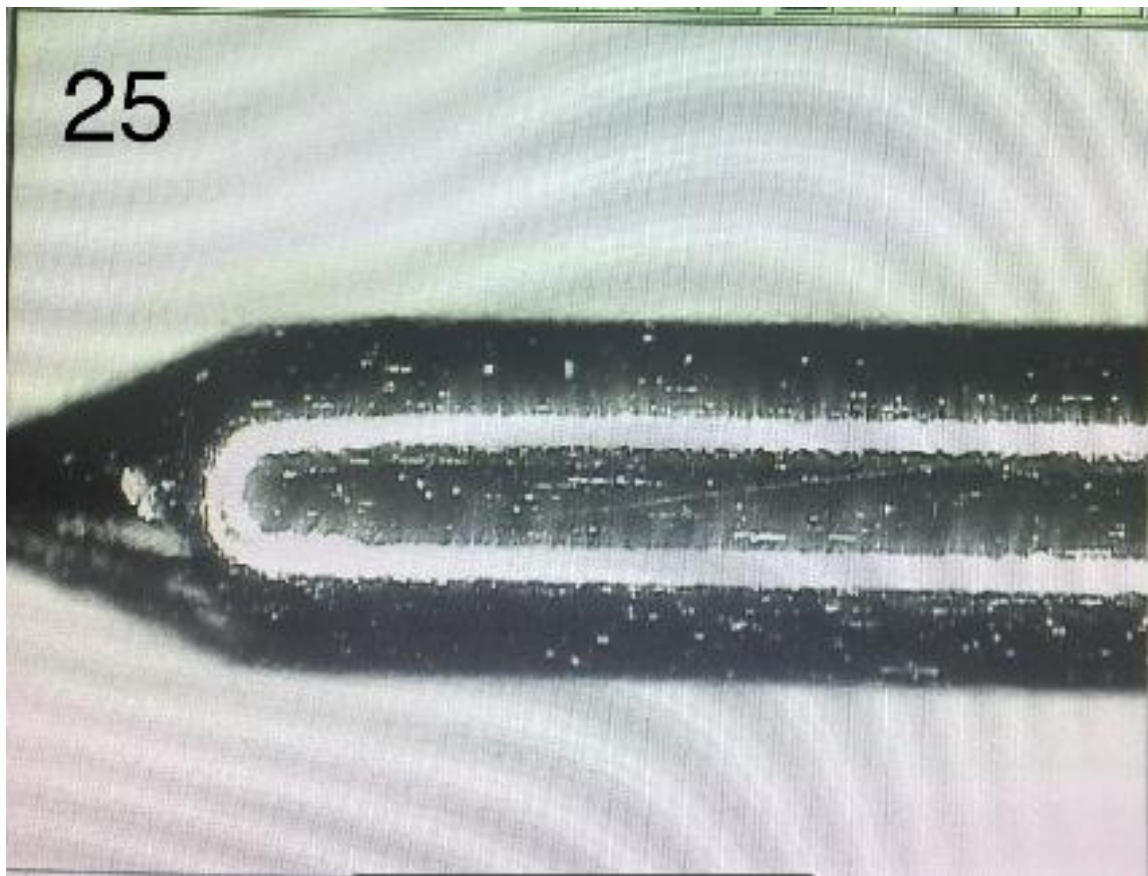
No longitudinal scratches observed,  
but scratches observed

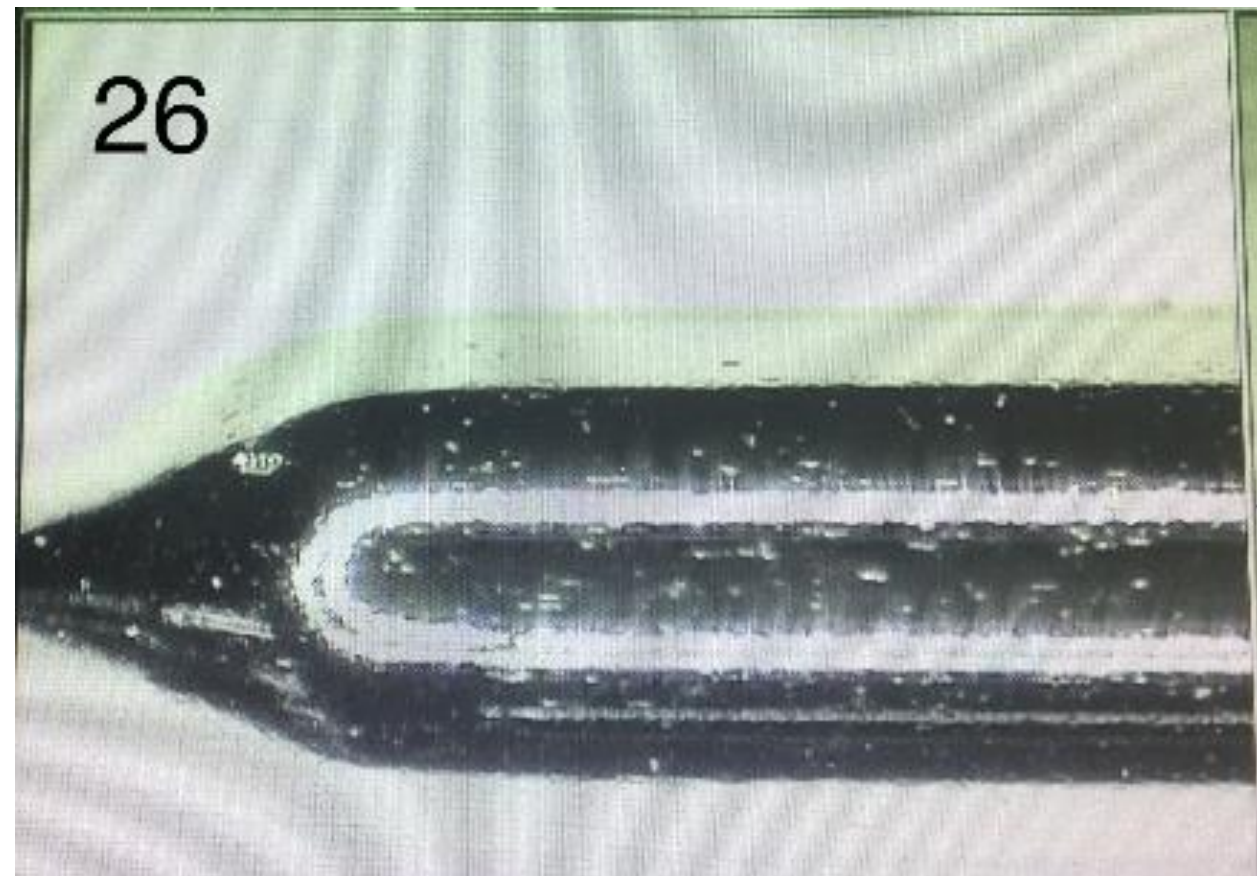
No longitudinal scratches observed,  
but scratches observed

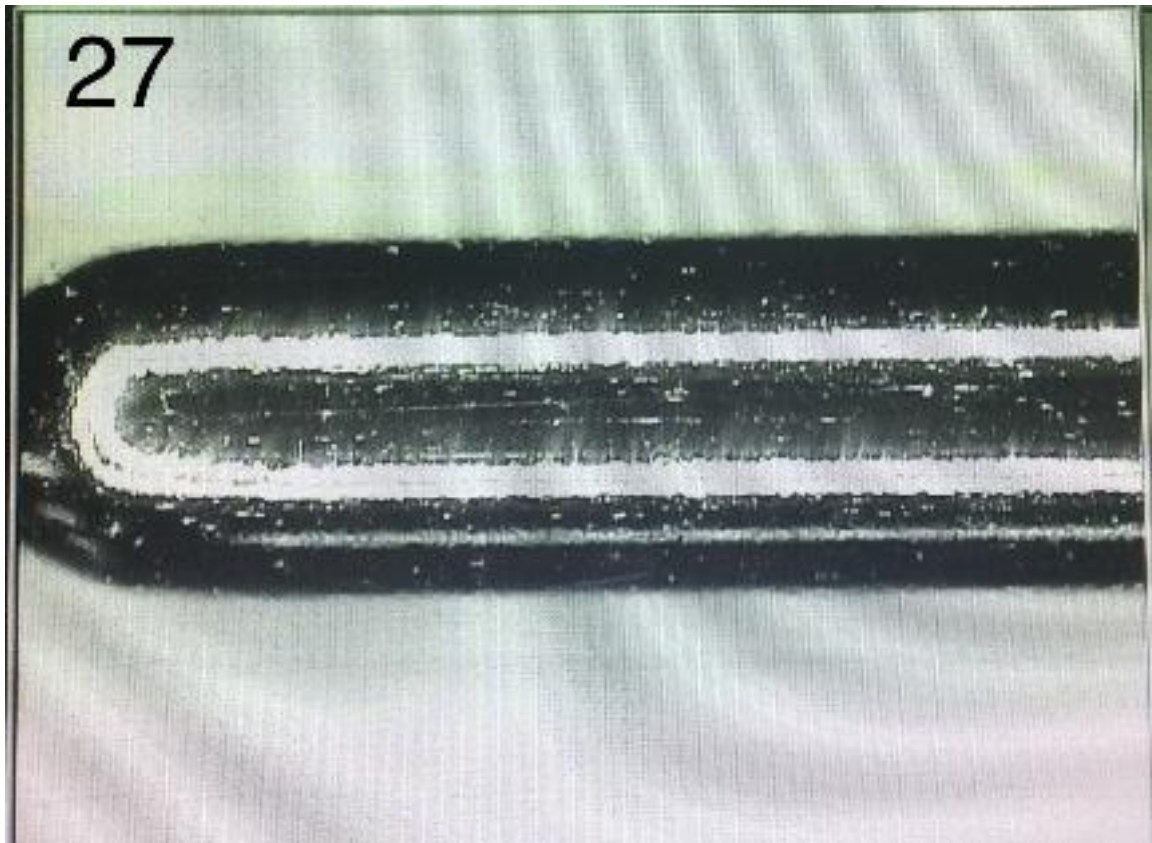
No longitudinal scratches observed,  
but scratches observed

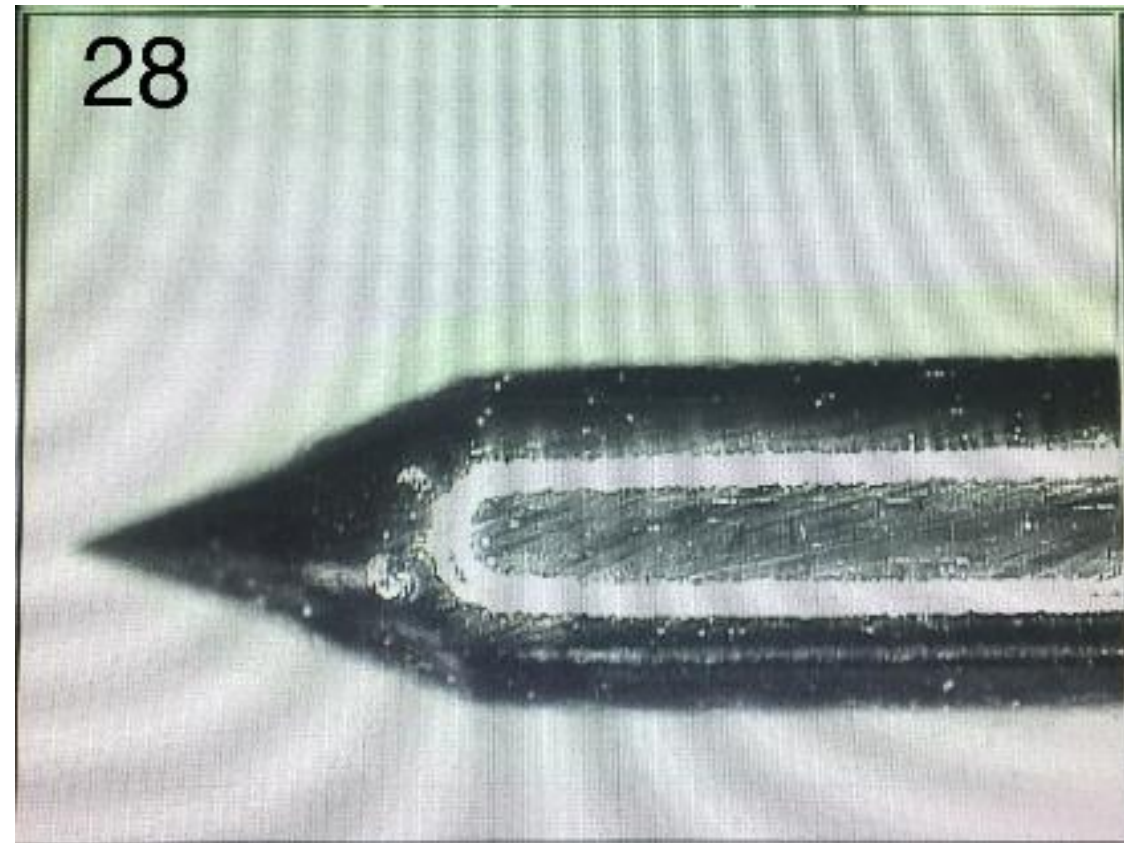
No longitudinal scratches observed

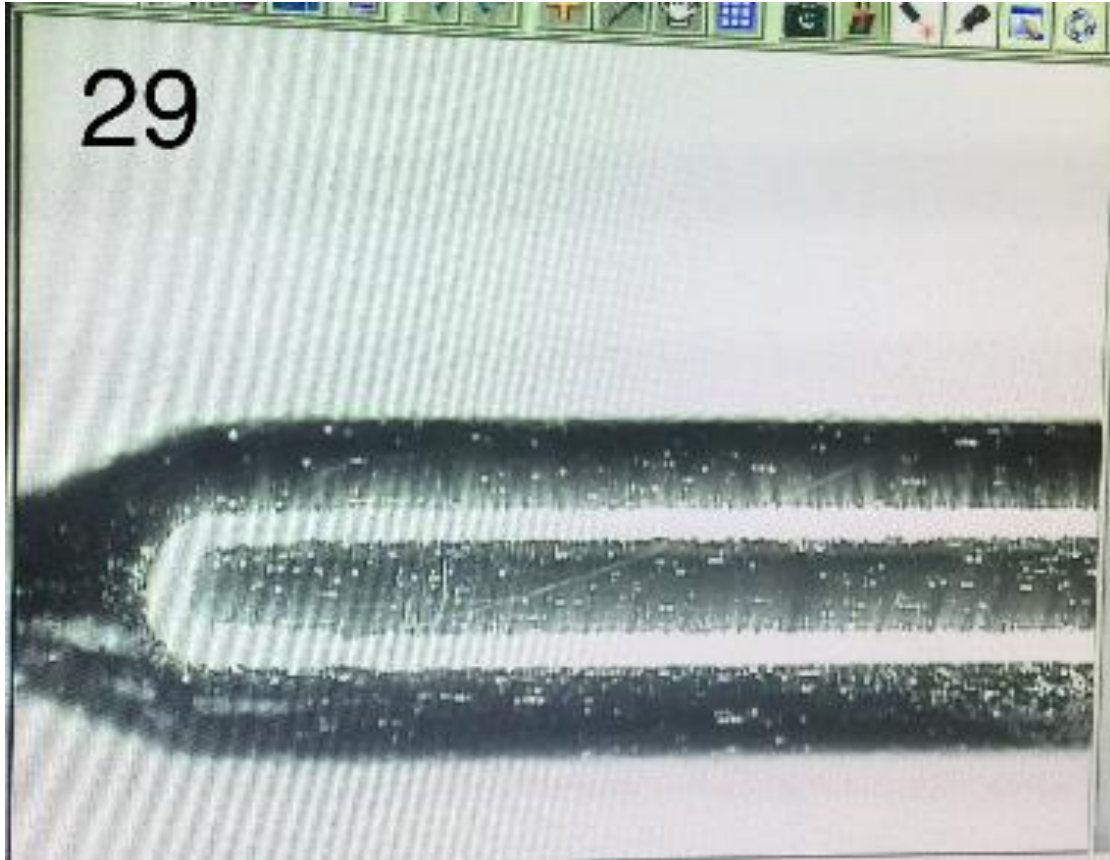
Longitudinal scratches observed

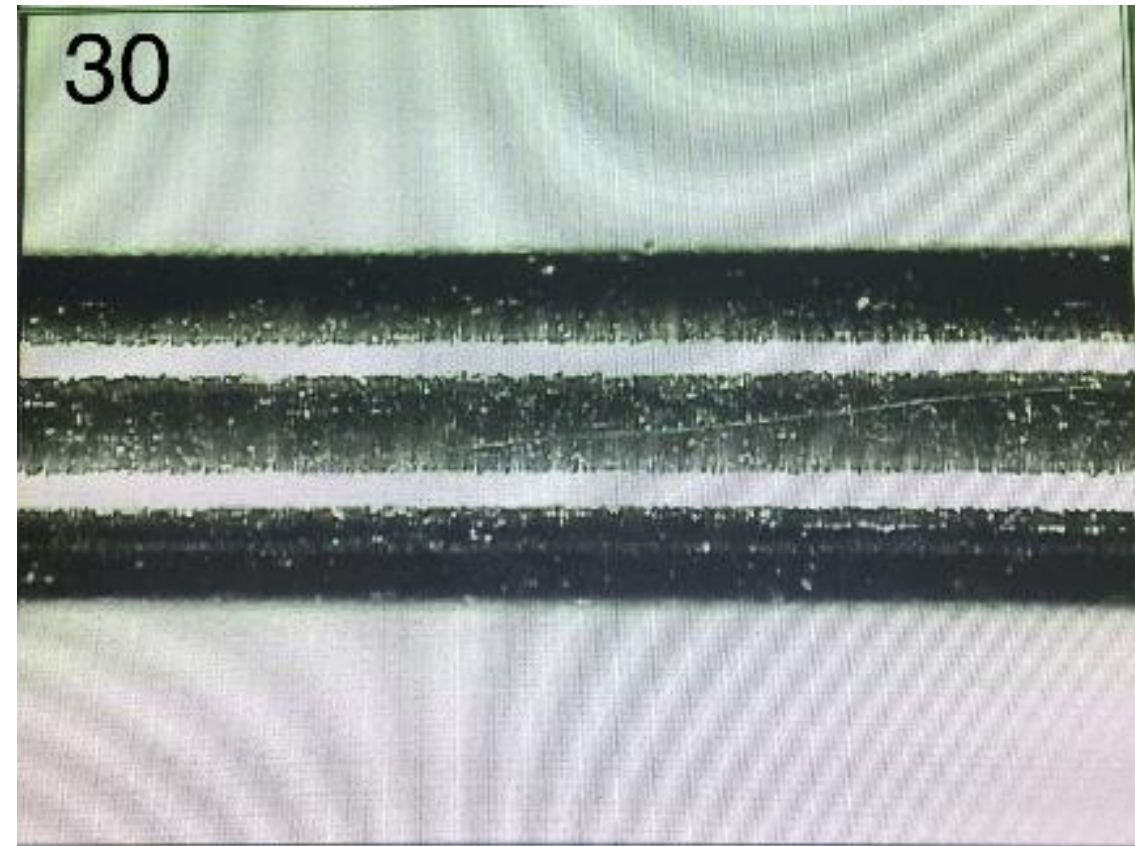
Longitudinal scratches observed

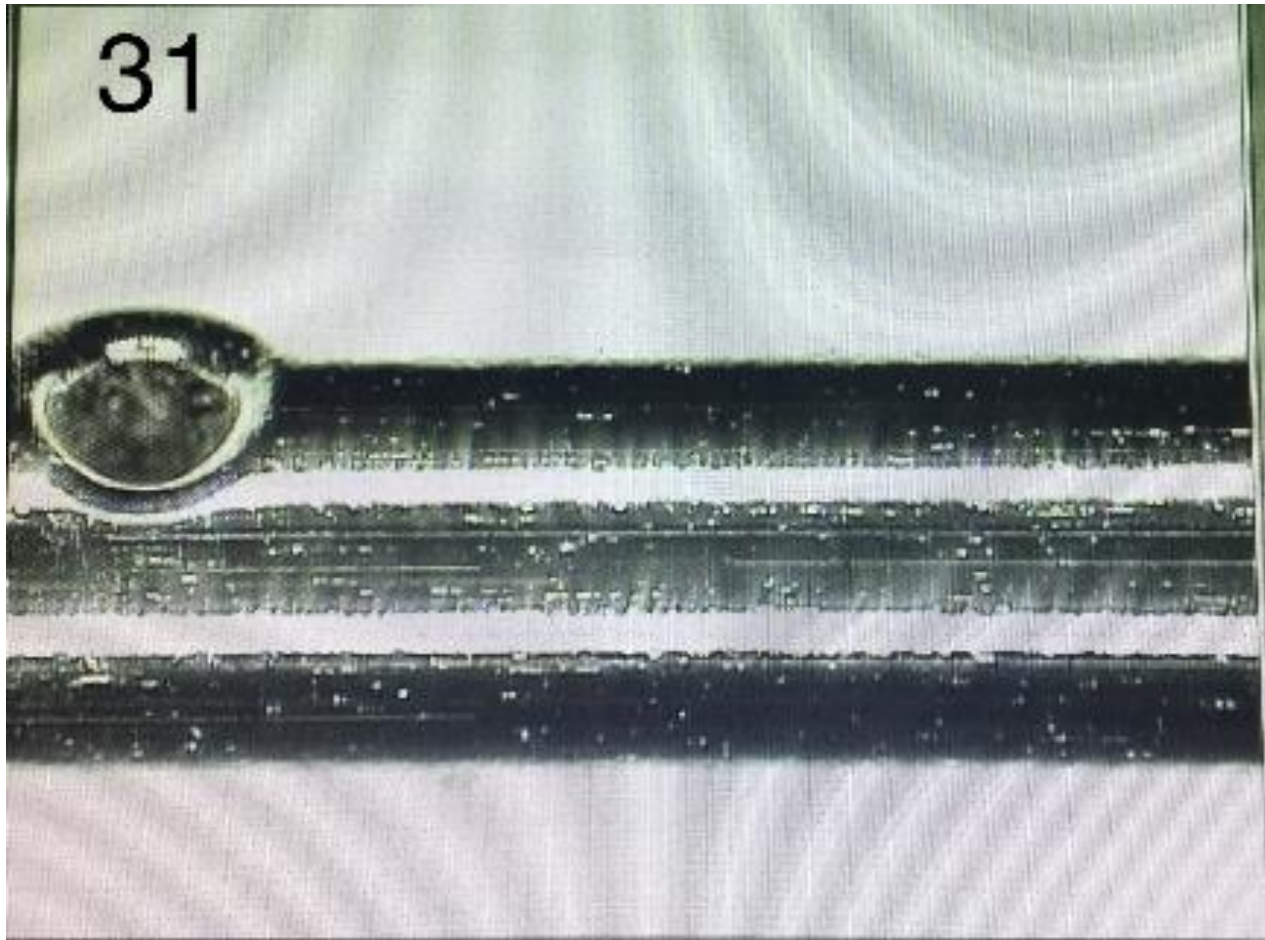
Longitudinal scratches observed

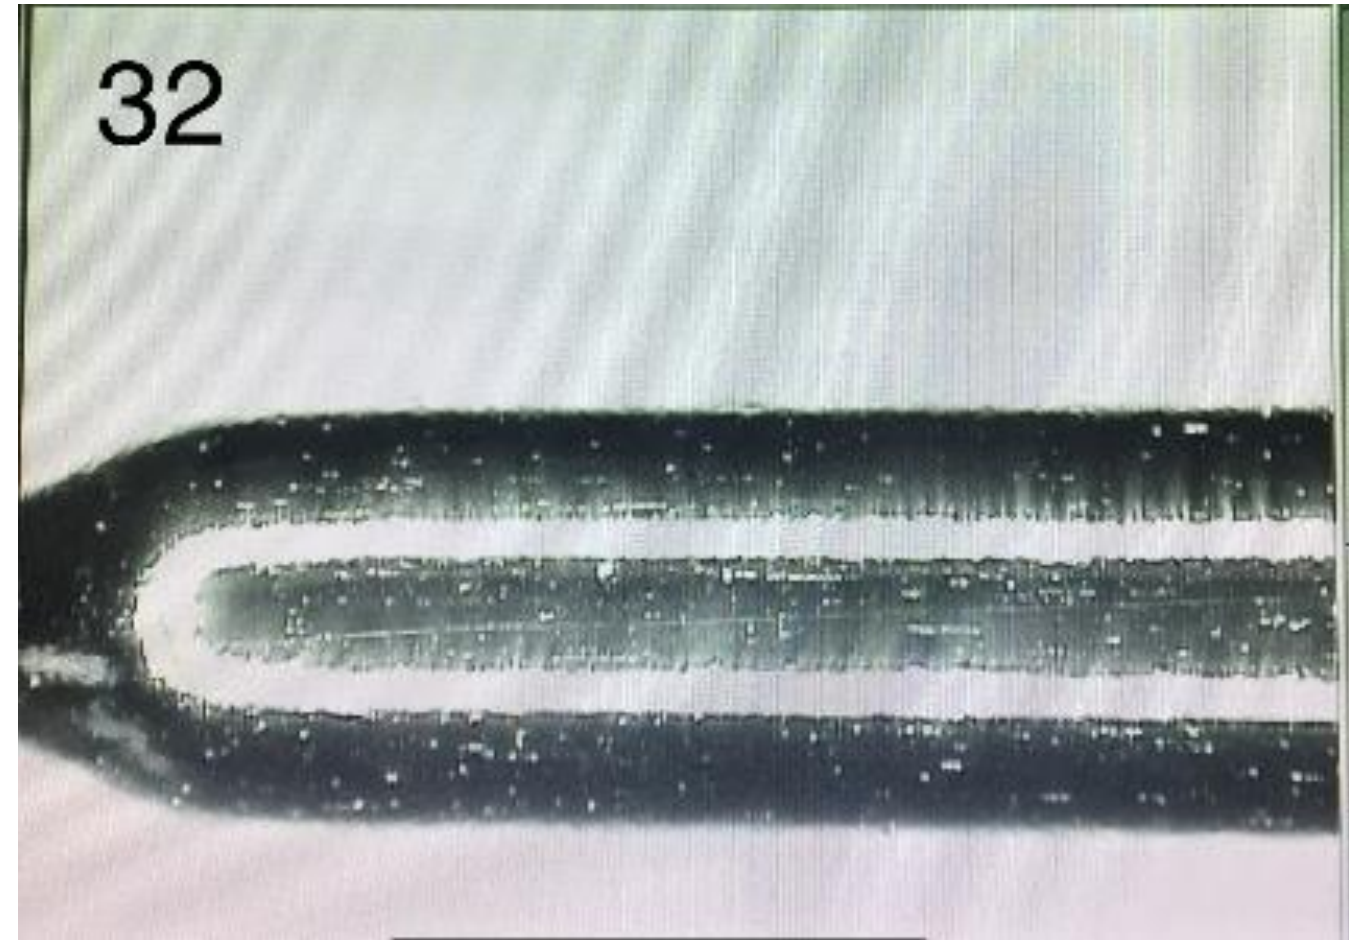
Longitudinal scratches observed

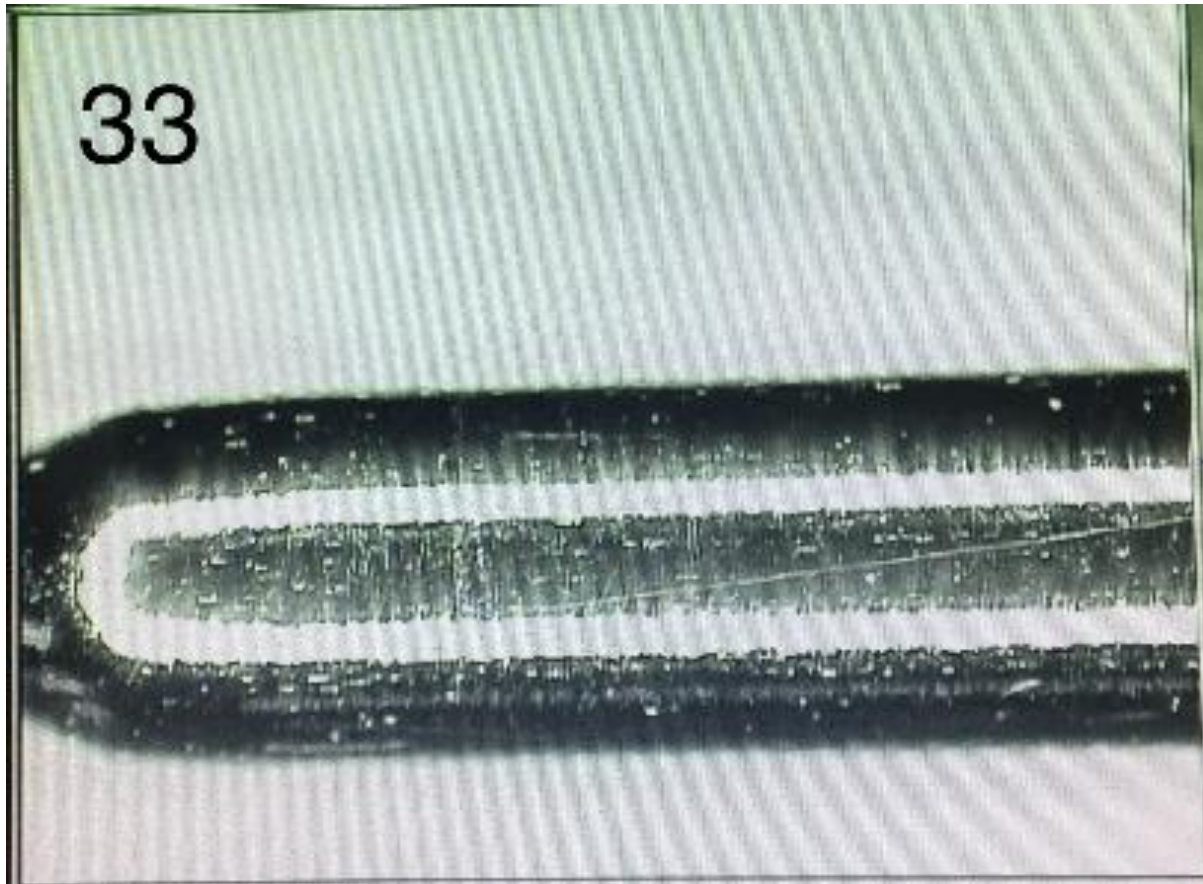
Longitudinal scratches observed

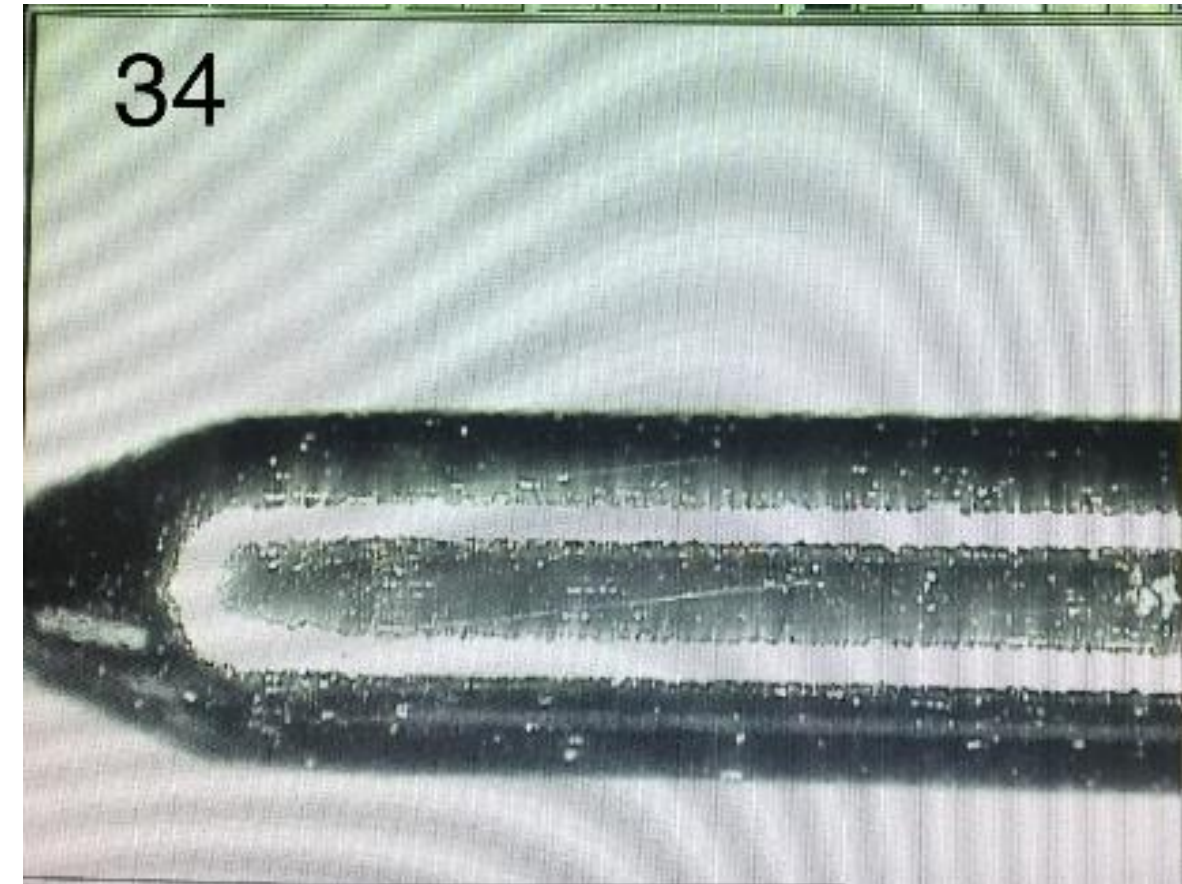
Longitudinal scratches observed

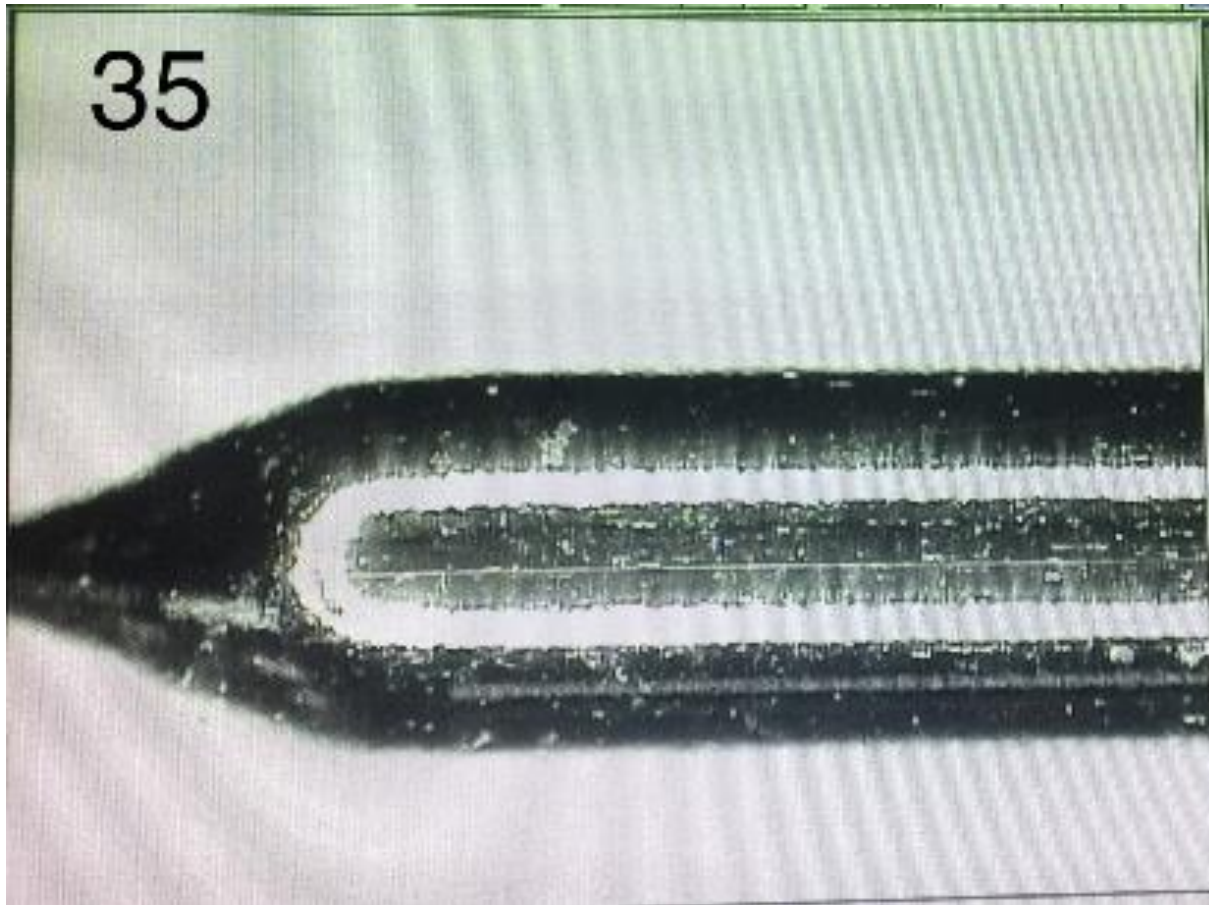
Longitudinal scratches observed

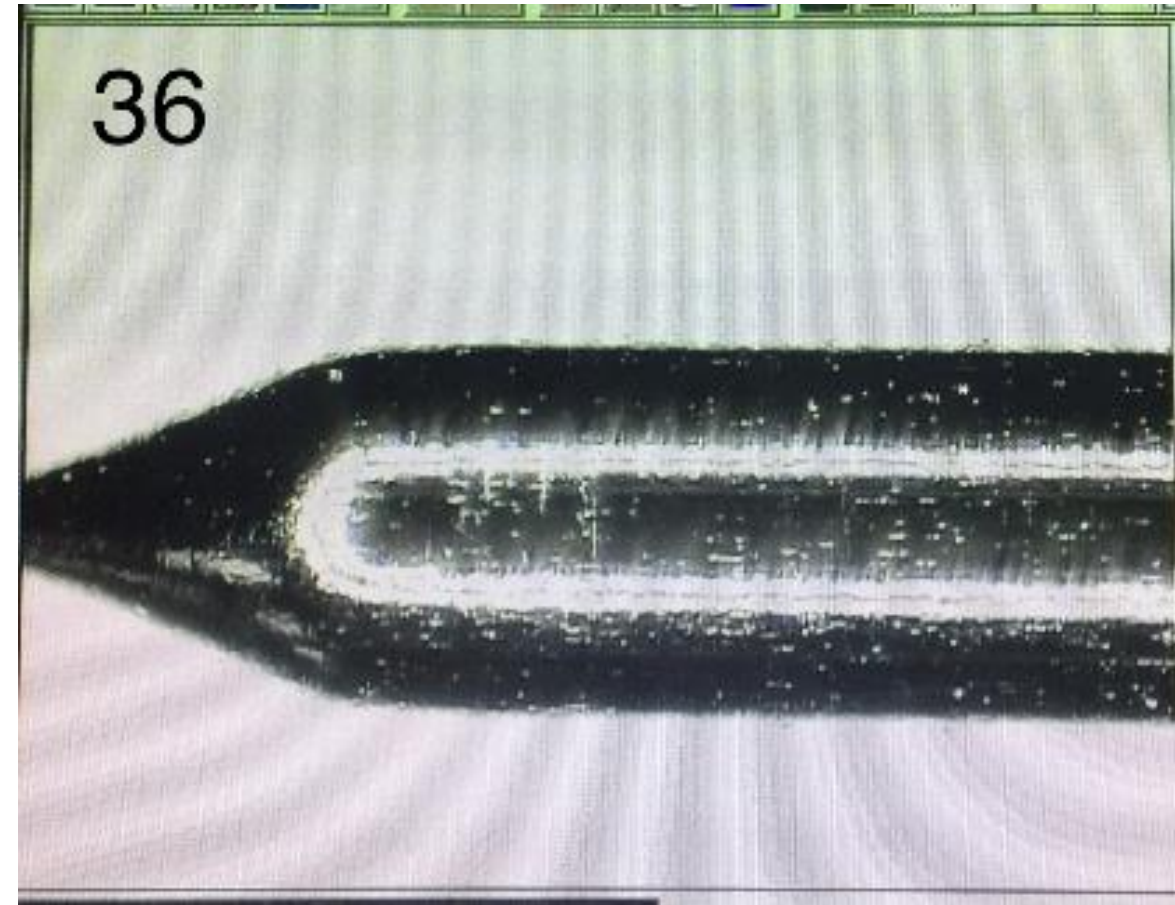
No longitudinal scratches observed

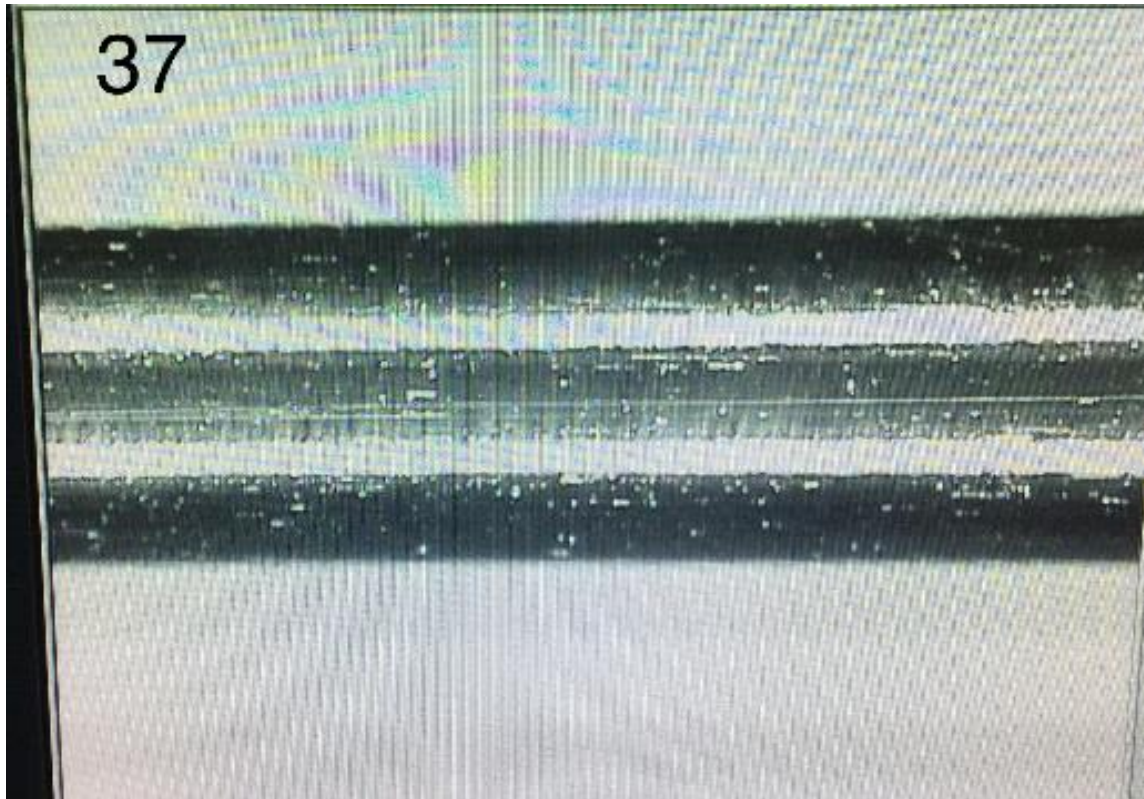
Longitudinal scratches observed

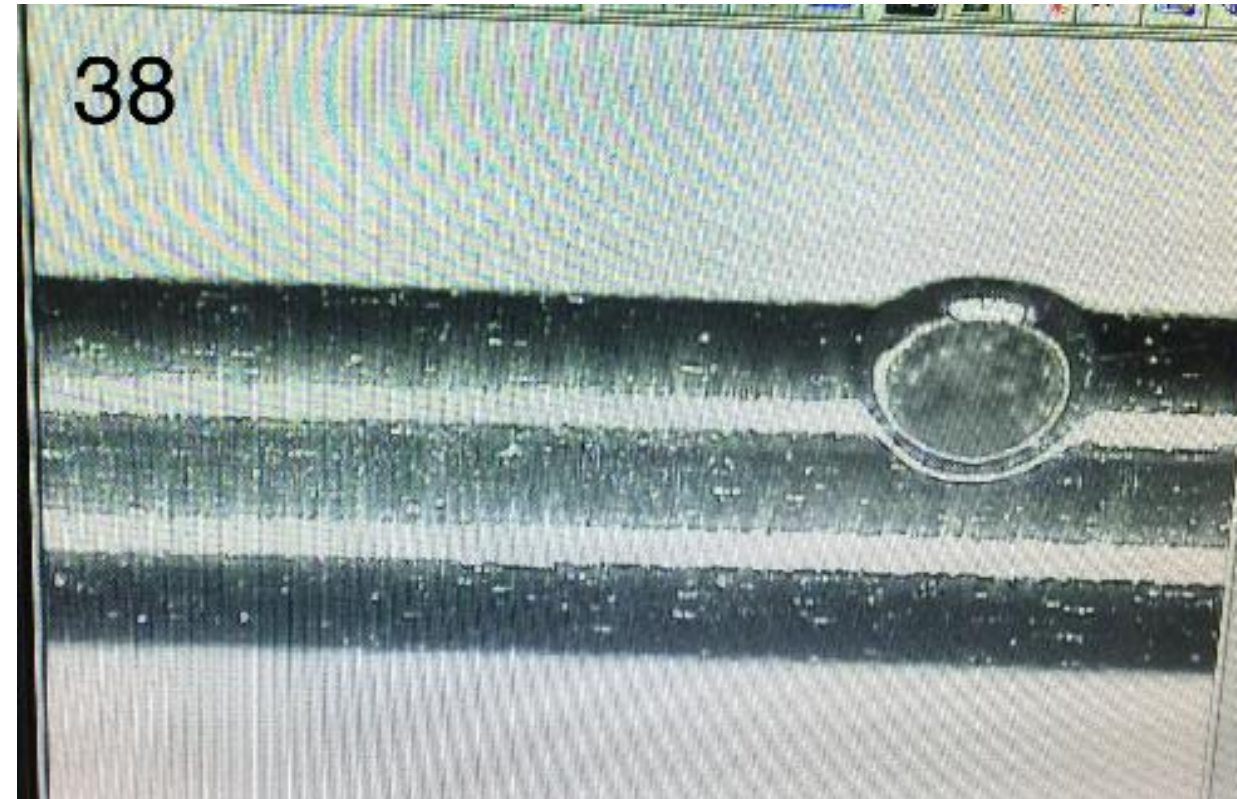
No longitudinal scratches observed

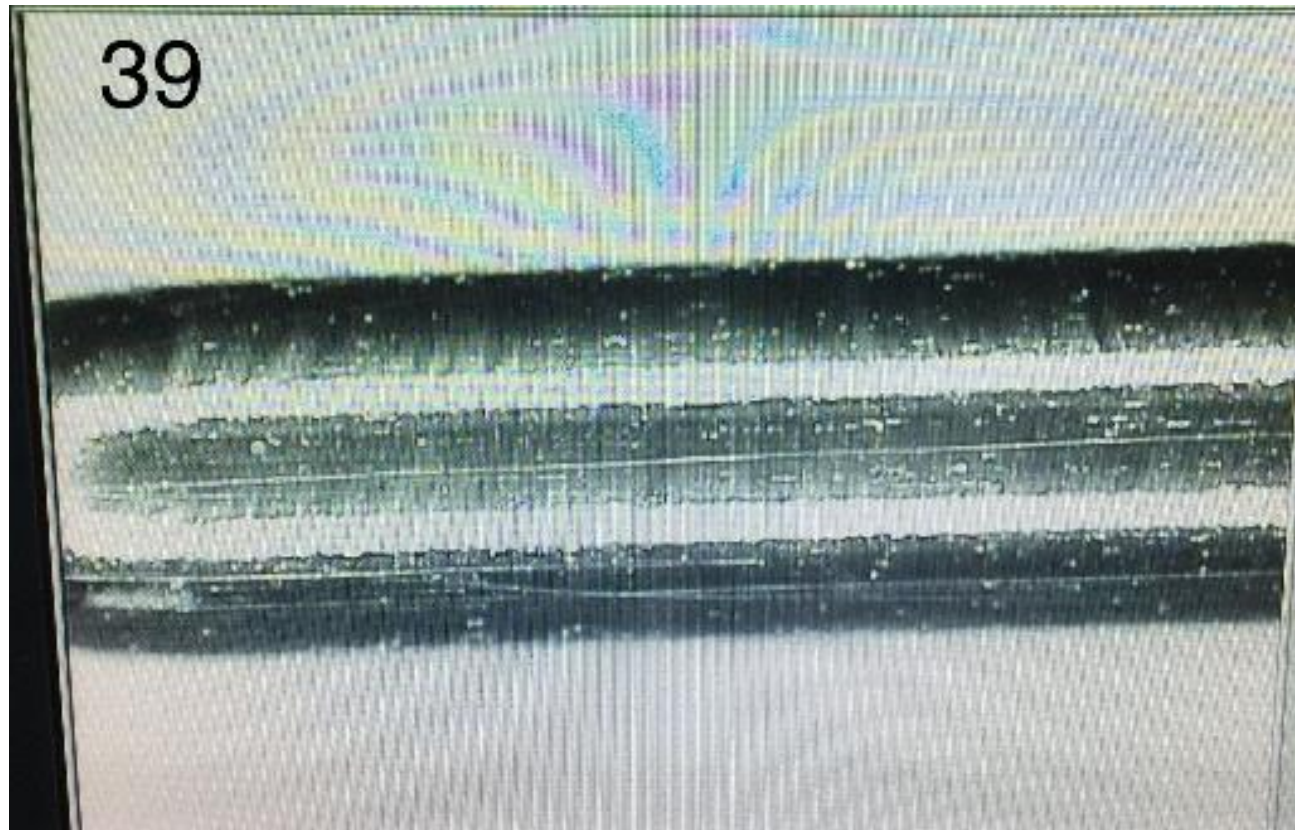
Longitudinal scratches observed

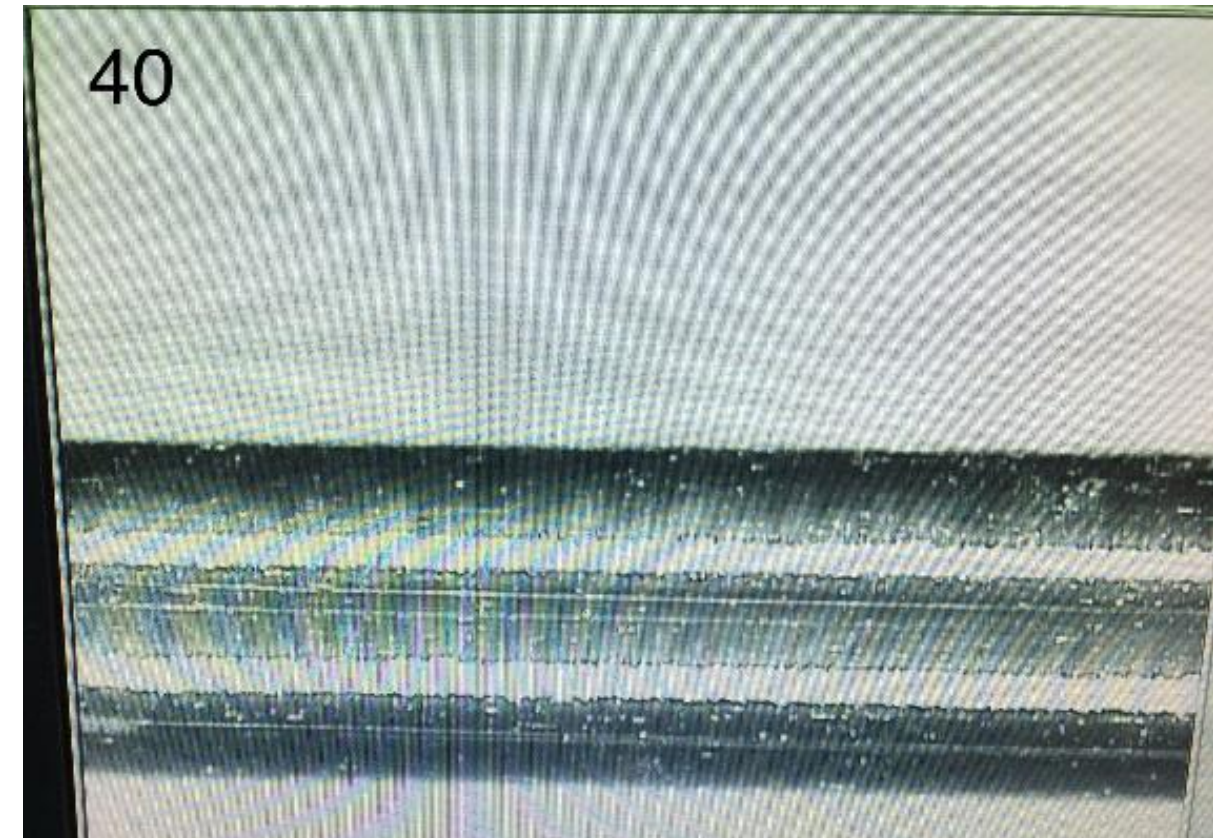
Longitudinal scratches observed

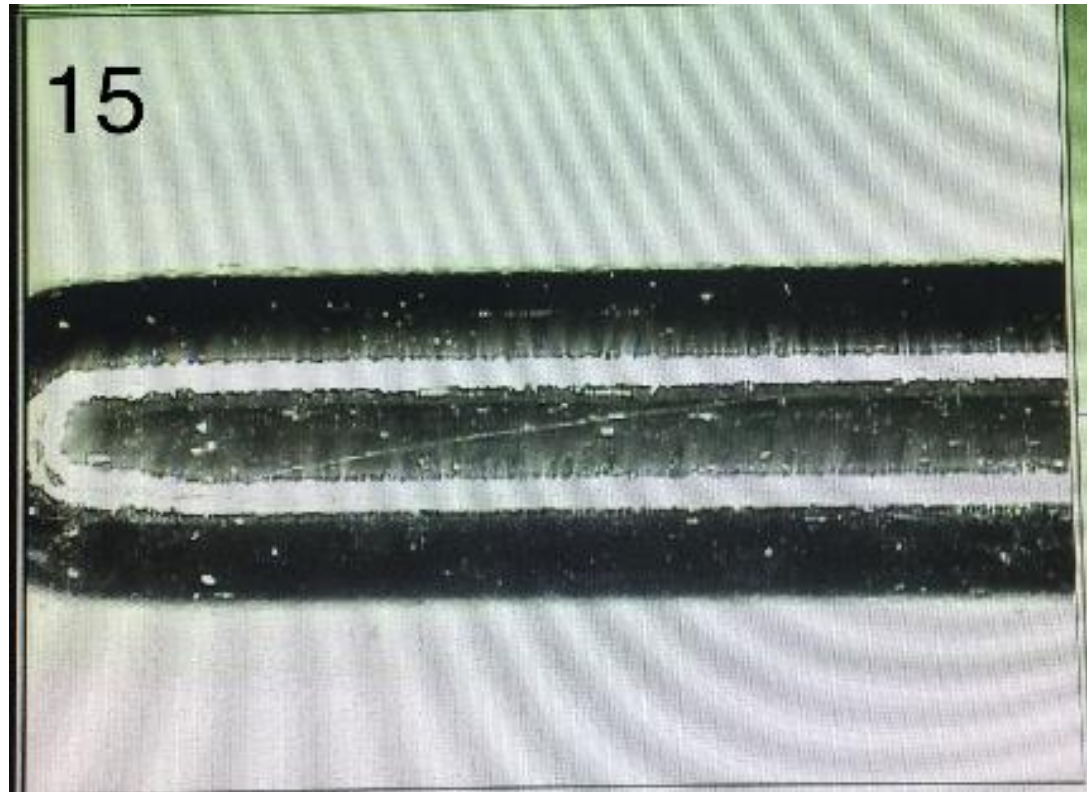
- Visual inspection of failed needle (Sample #15)

Before testing no longitudinal scratches  
Observed but scratches observed as per a  
bove photo.

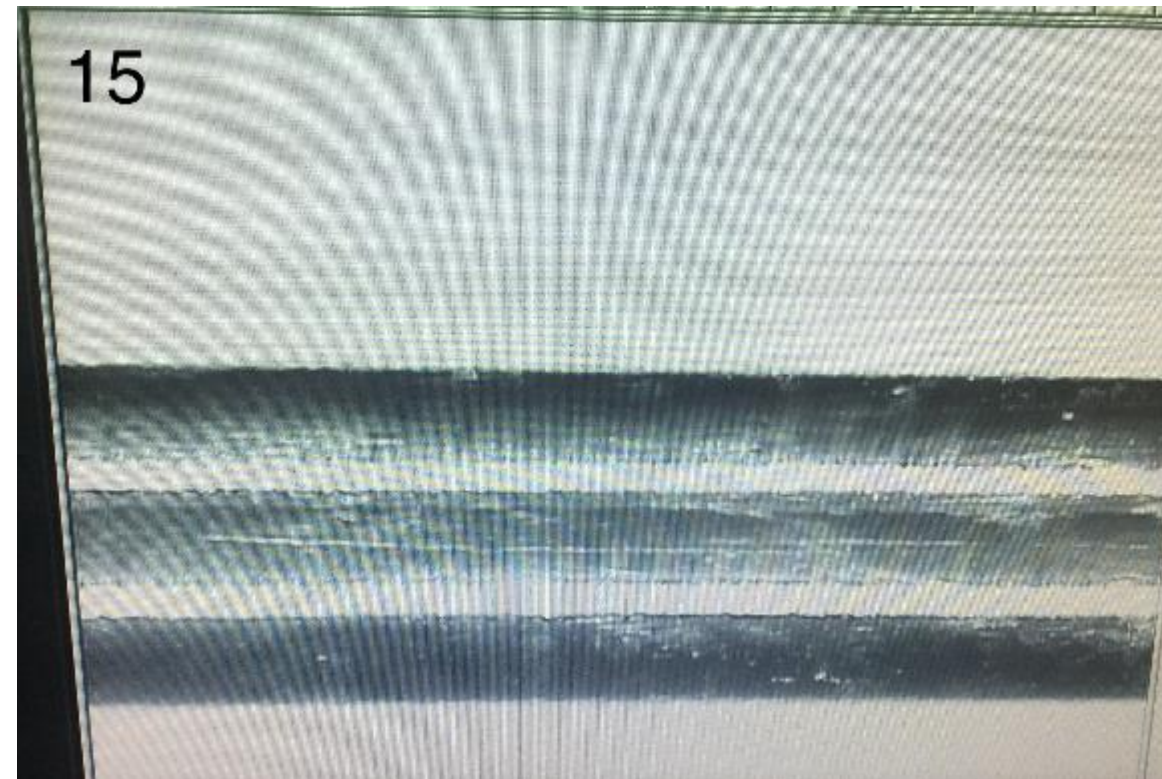
Longitudinal scratches observed
