# Evaluation of 20u 405001338 Needle

17 Jan 2019

- On 11 Jan 2019 evening, Eugene provided a base (guideline), to evaluate on the 10% failures reported at Alliance Injector Sub-assy in WW01-2019.

- About 50% of the needles found with scratches when checked under 40x magnification.
- Majority of the known good (no scratches) fresh needle are found with longitudinal scratches after testing.
- It may be a concern to observed longitudinal scratches on the known good (no scratches) fresh needle after testing. WPPL and Flex may need to look into this concern.
- As of to date 17 Jan 2019, it is still not known whether the needles themselves and/or possibly other associated mechanisms or parts, is/are causing the high reject rate (10% fallout) in Pressure Decay test .

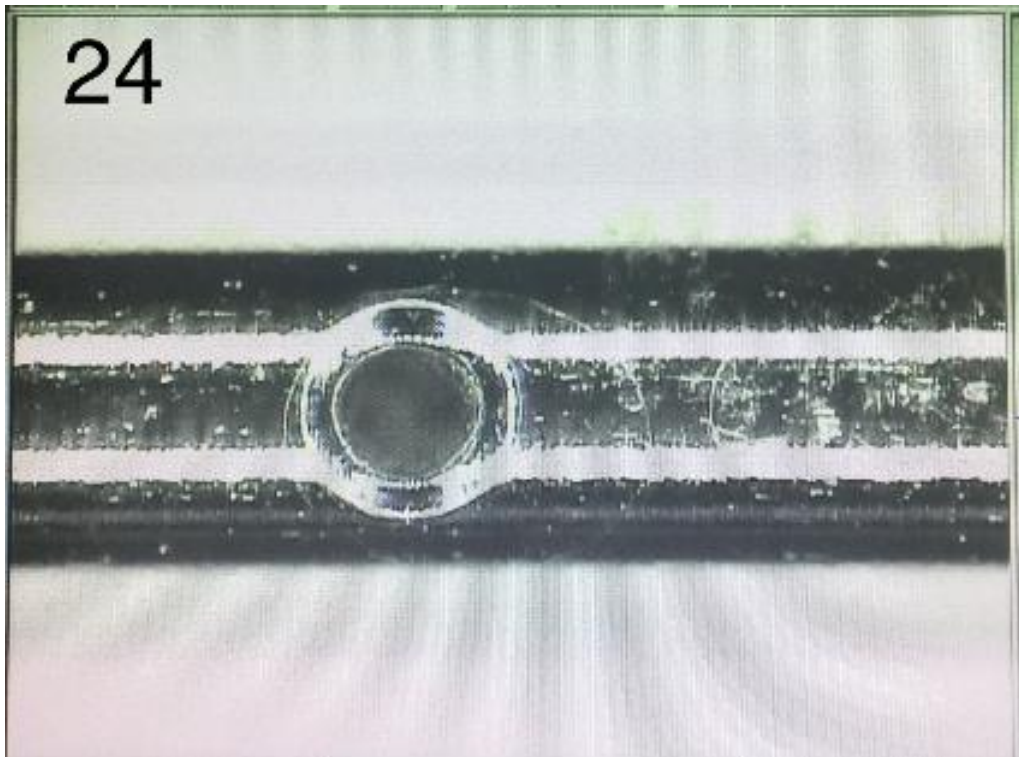
- Visual inspection of failed needle (Sample #24)

Before testing, no longitudinal scratches observed but circular scratches observed near the needle hole as per above photo.

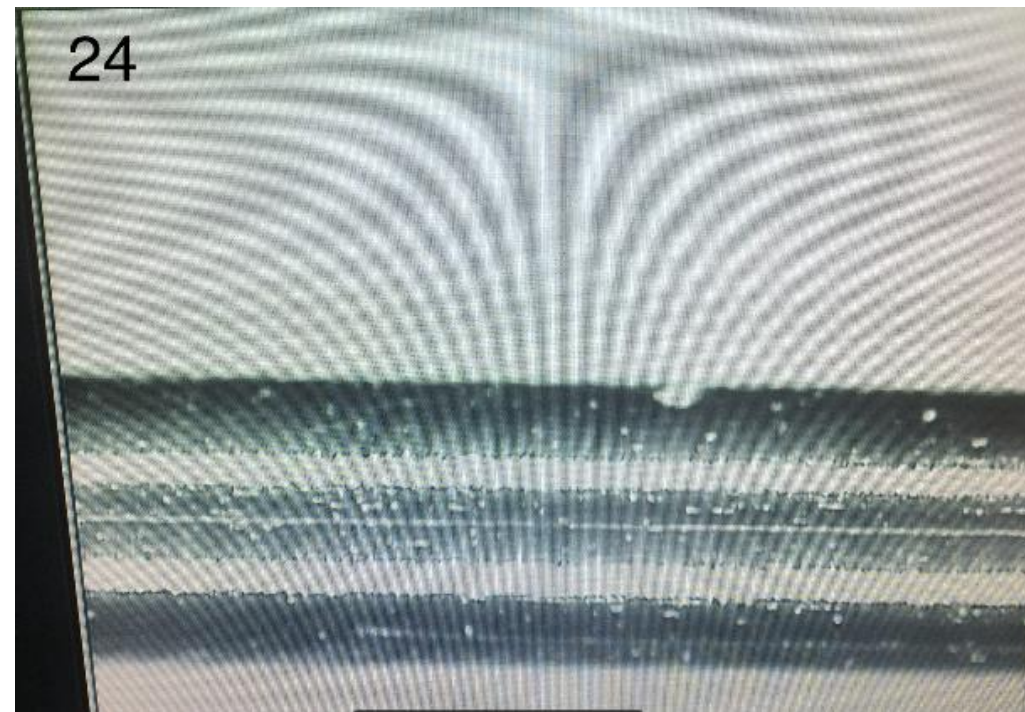
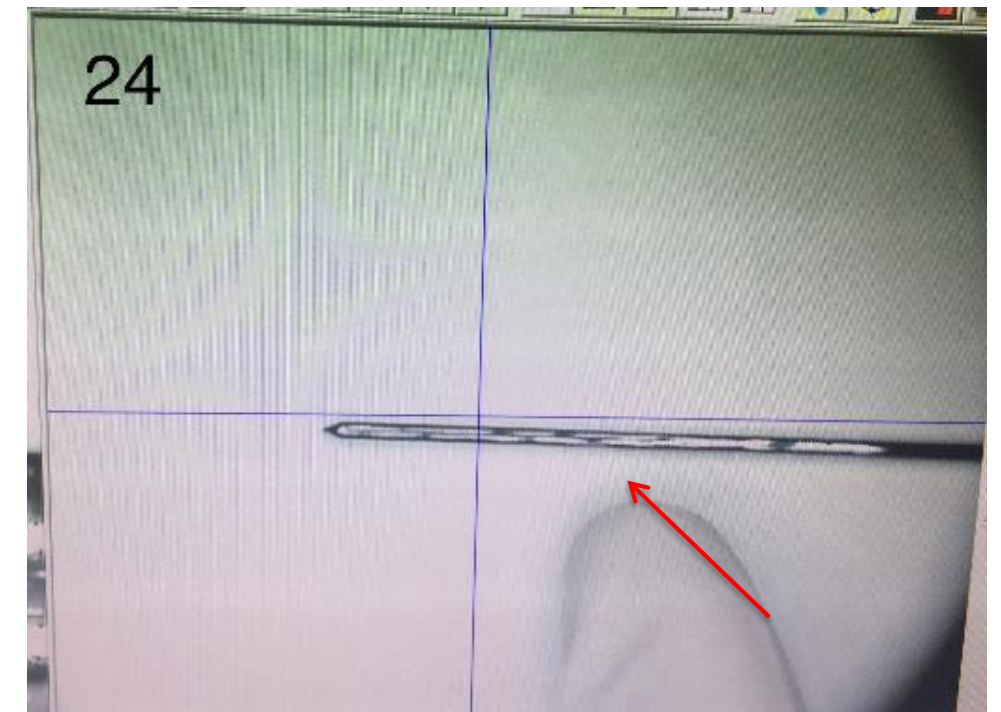
After testing, longitudinal scratches observed along needle body from near the needle tip to the arrow as indicated in the right photo.

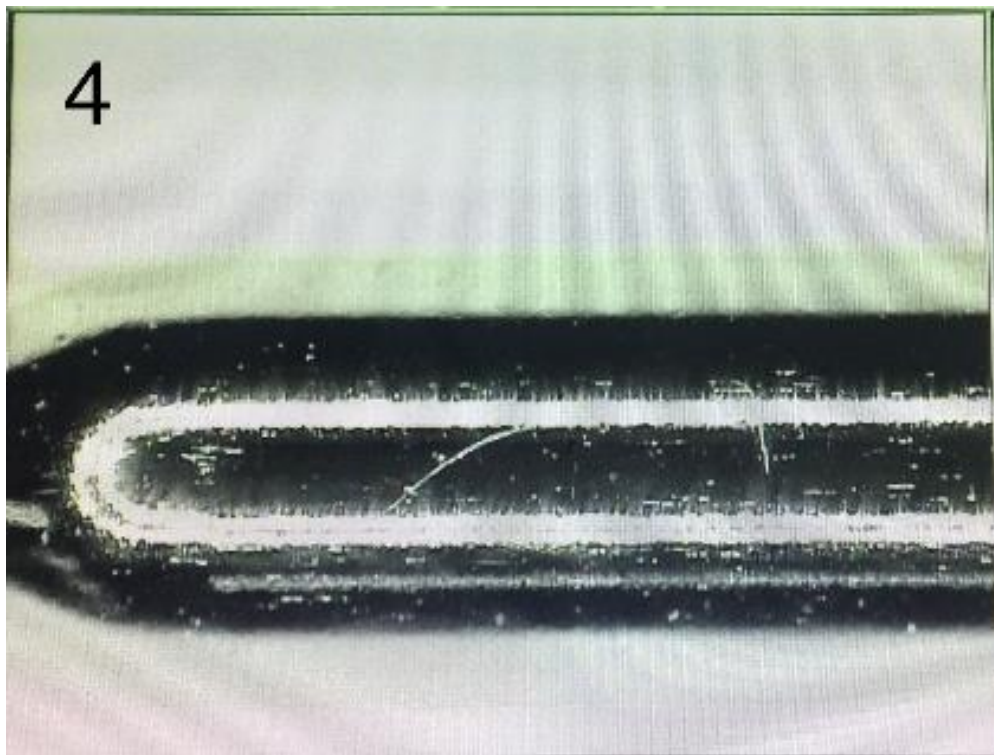
No longitudinal scratches observed but scratches observed as per above photo.

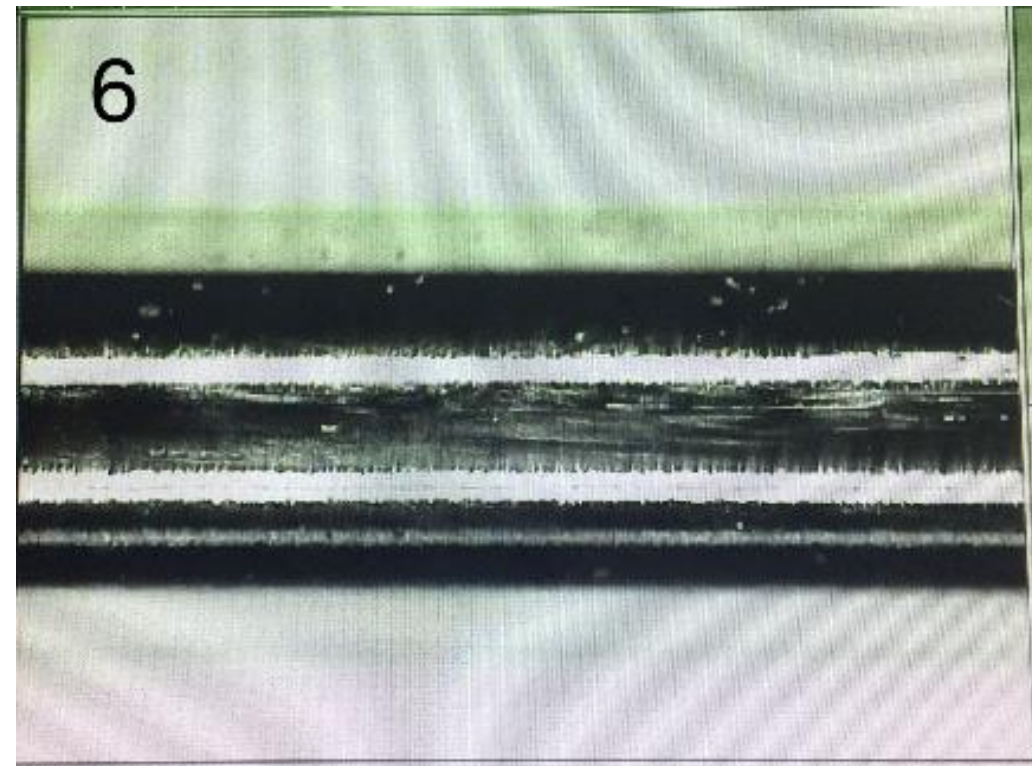
No longitudinal scratches observed but scratches observed as per above photo.

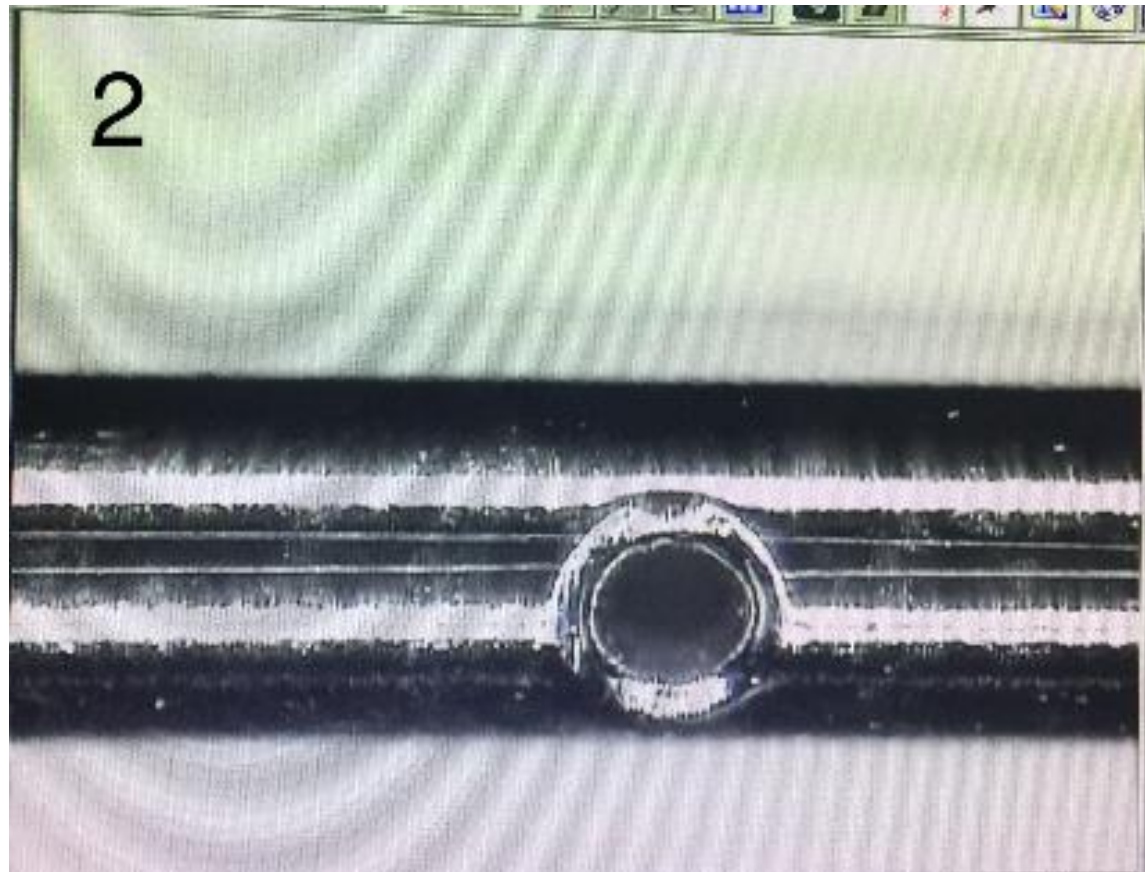
Longitudinal scratches observed

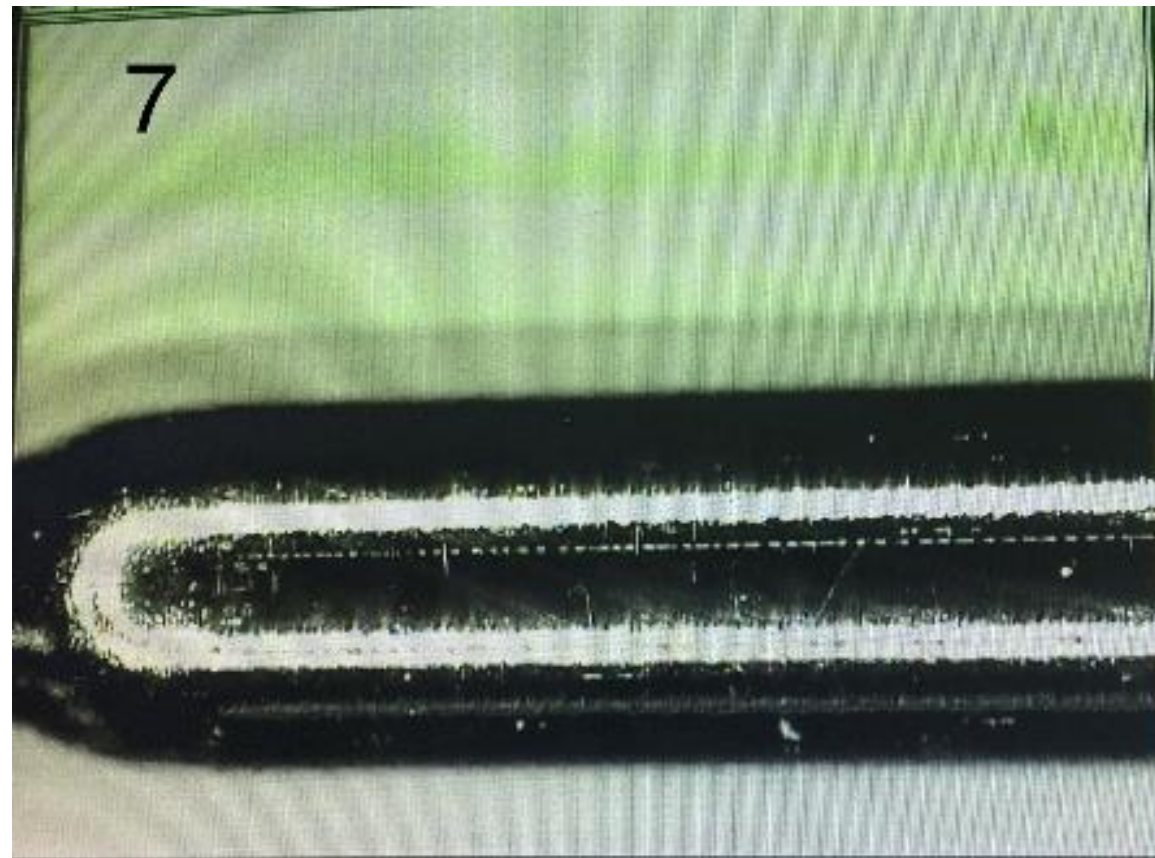
Longitudinal scratches observed

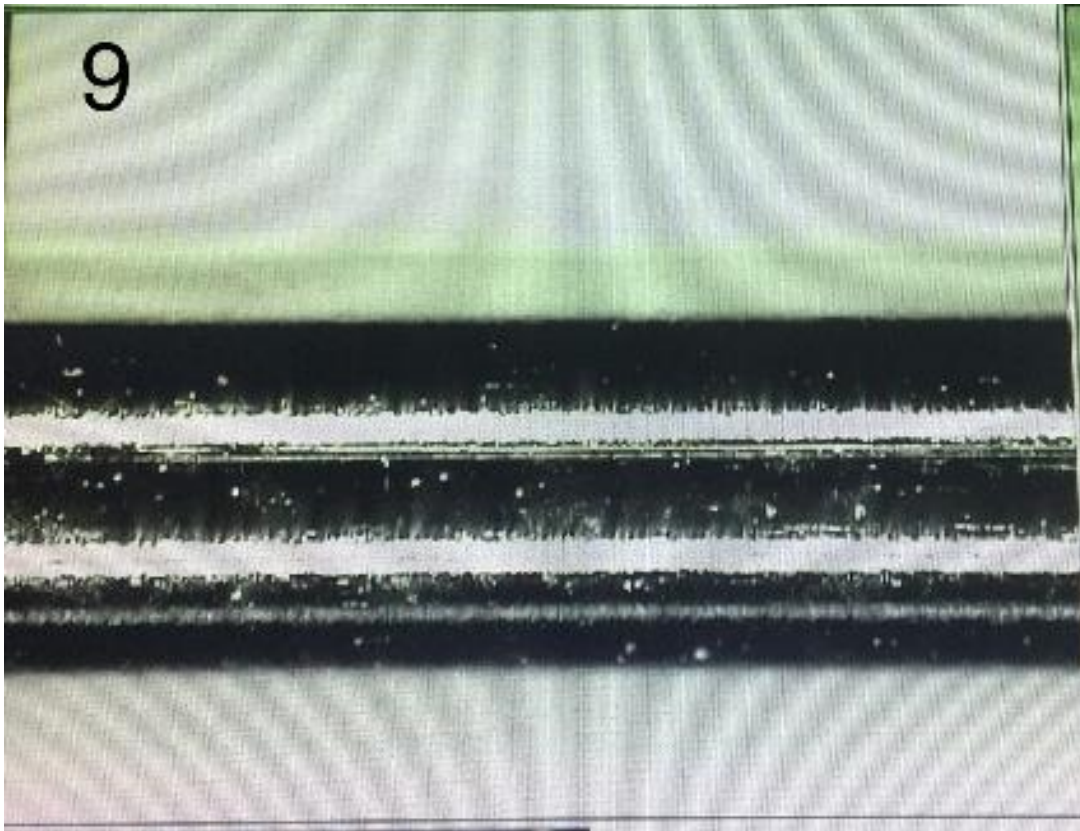
Longitudinal scratches observed

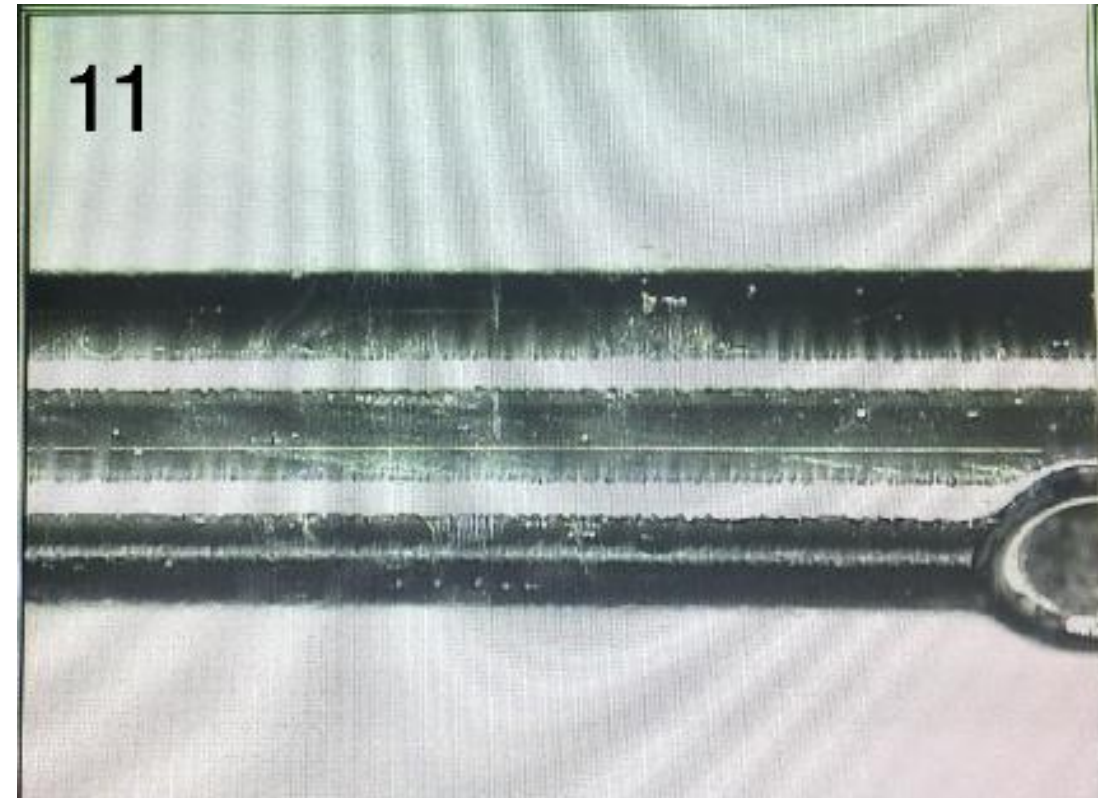
Longitudinal scratches observed

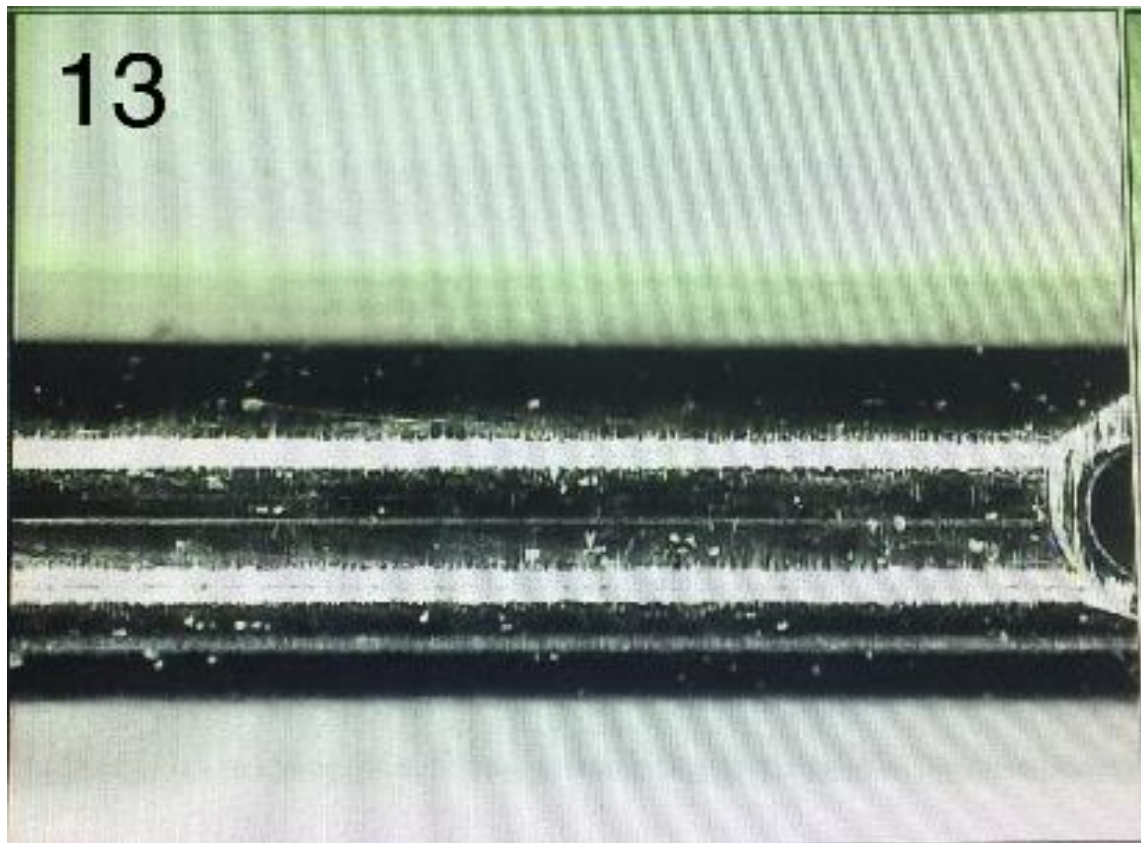
Longitudinal scratches observed

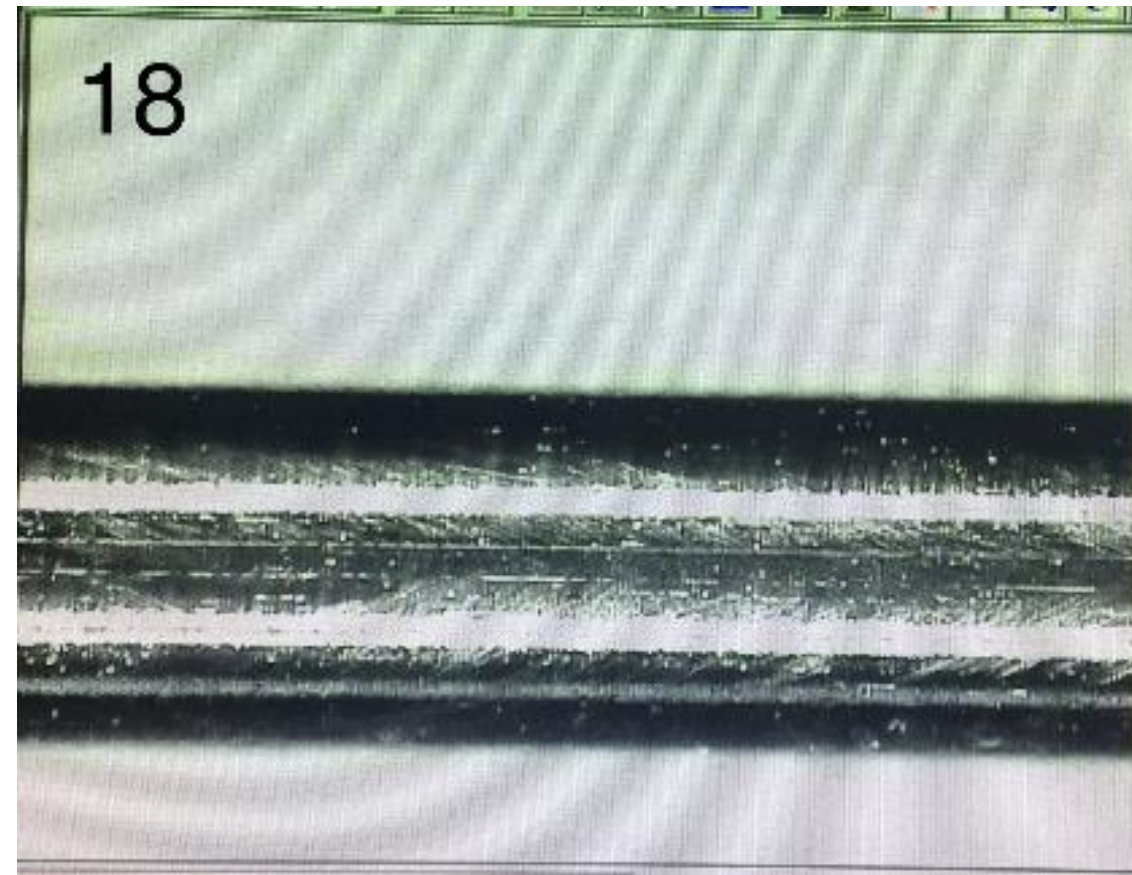
Longitudinal scratches observed

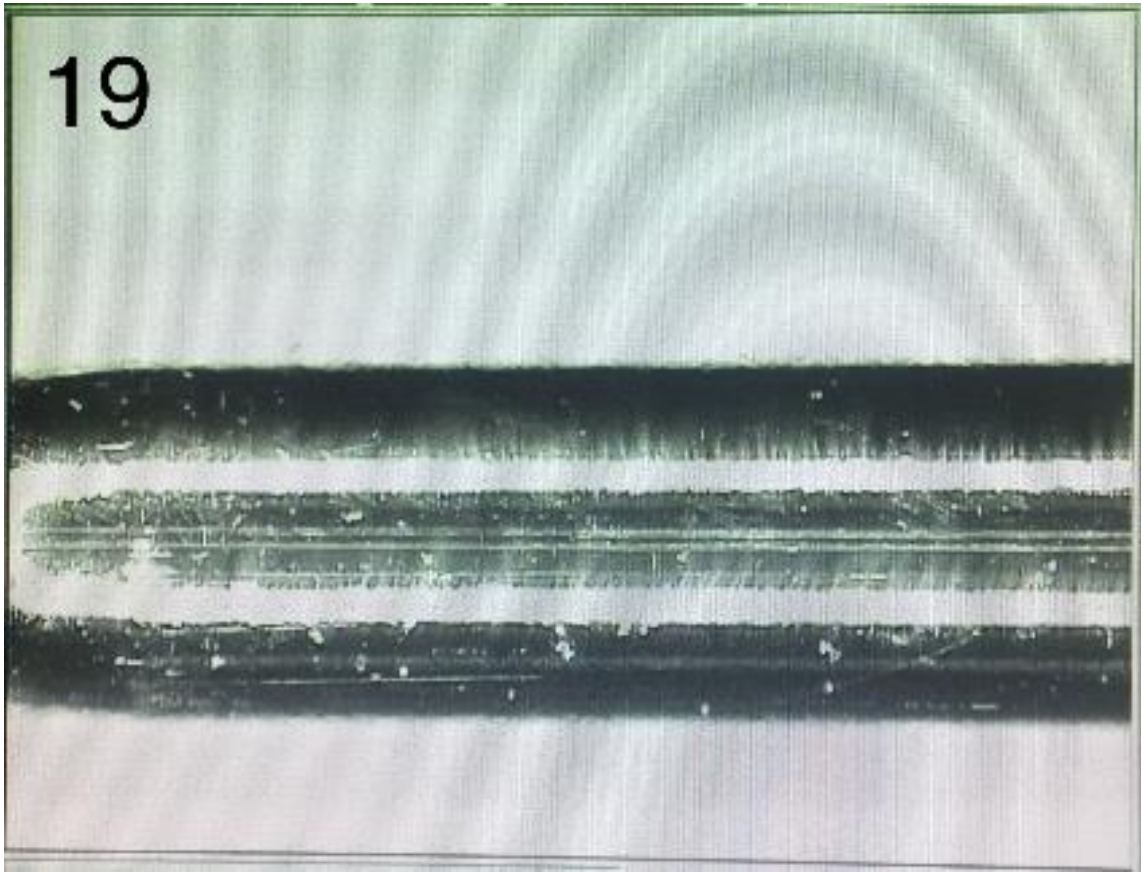
Longitudinal scratches observed

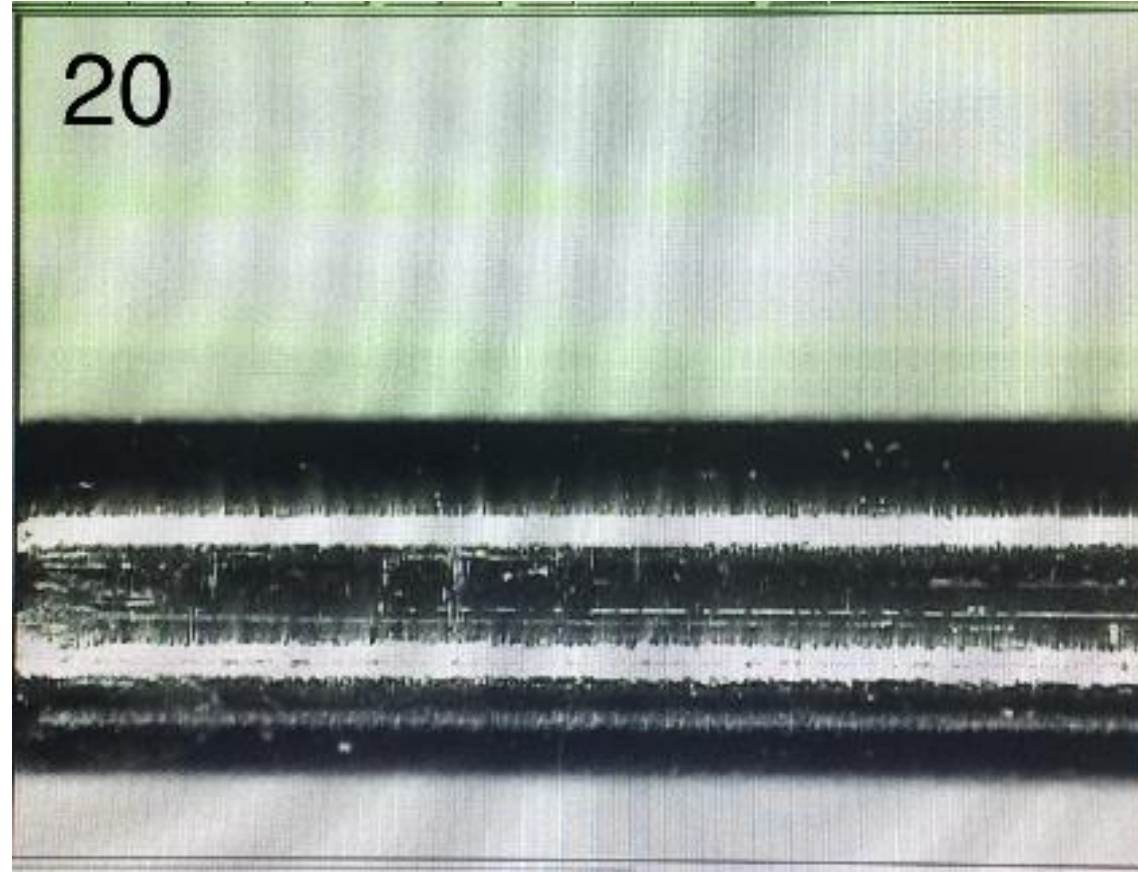
Longitudinal scratches observed

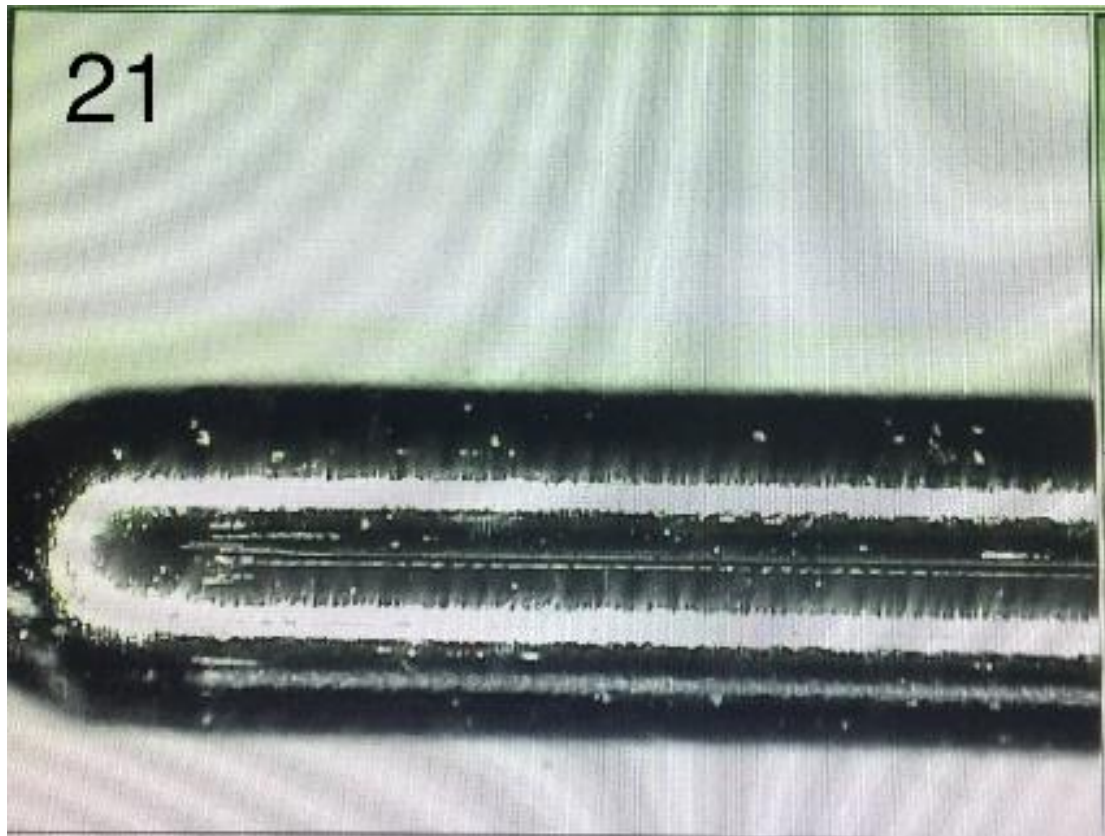
Longitudinal scratches observed

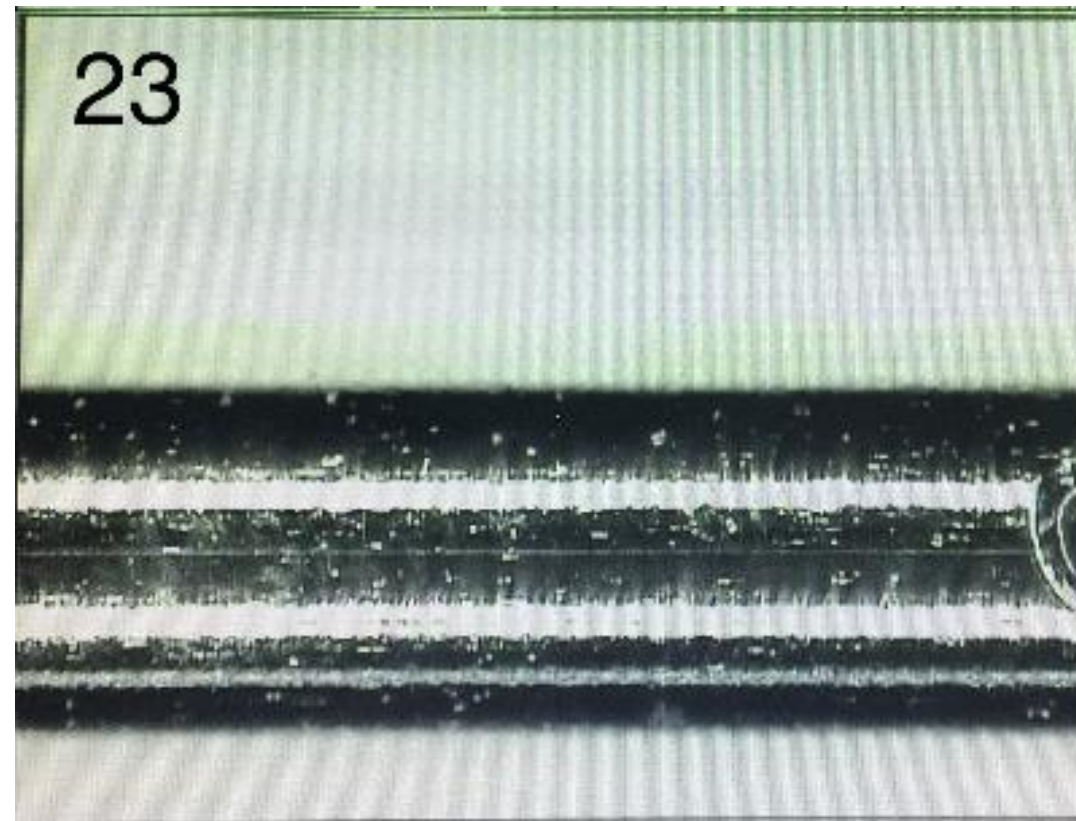
Longitudinal scratches observed

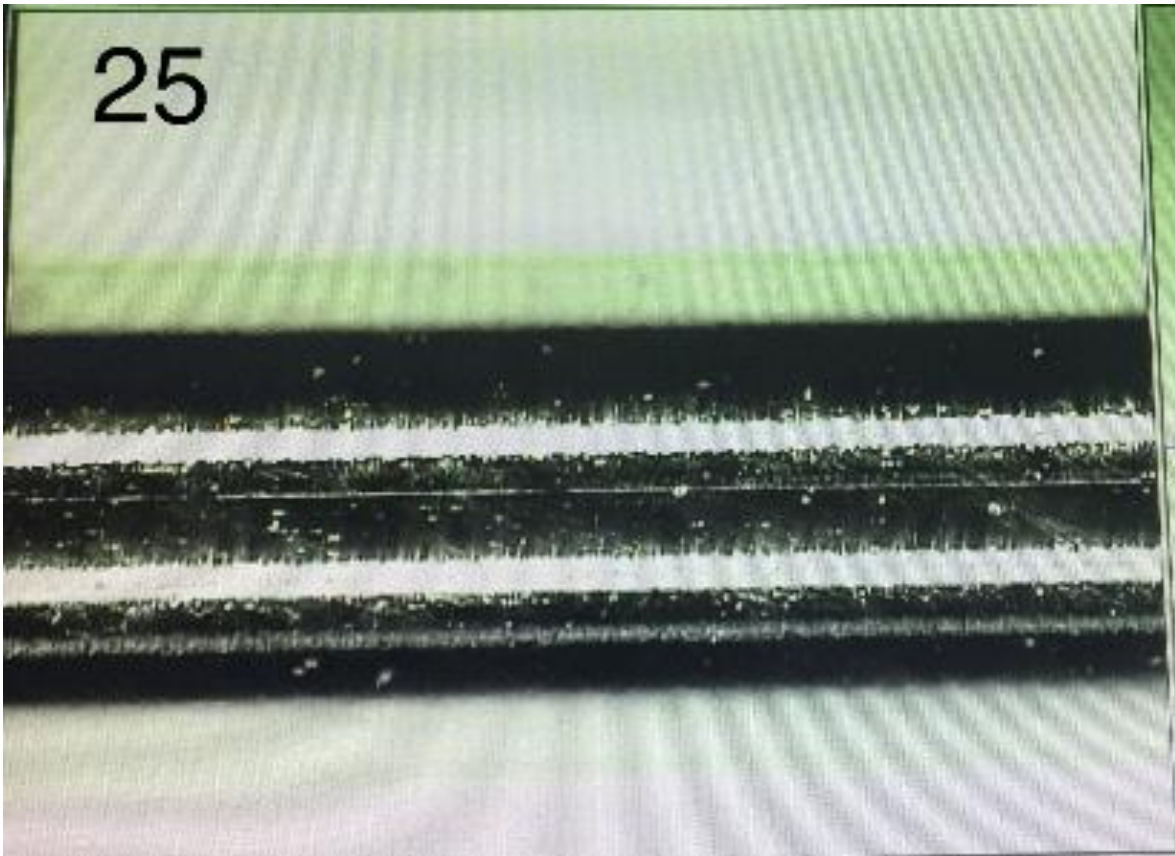
Longitudinal scratches observed

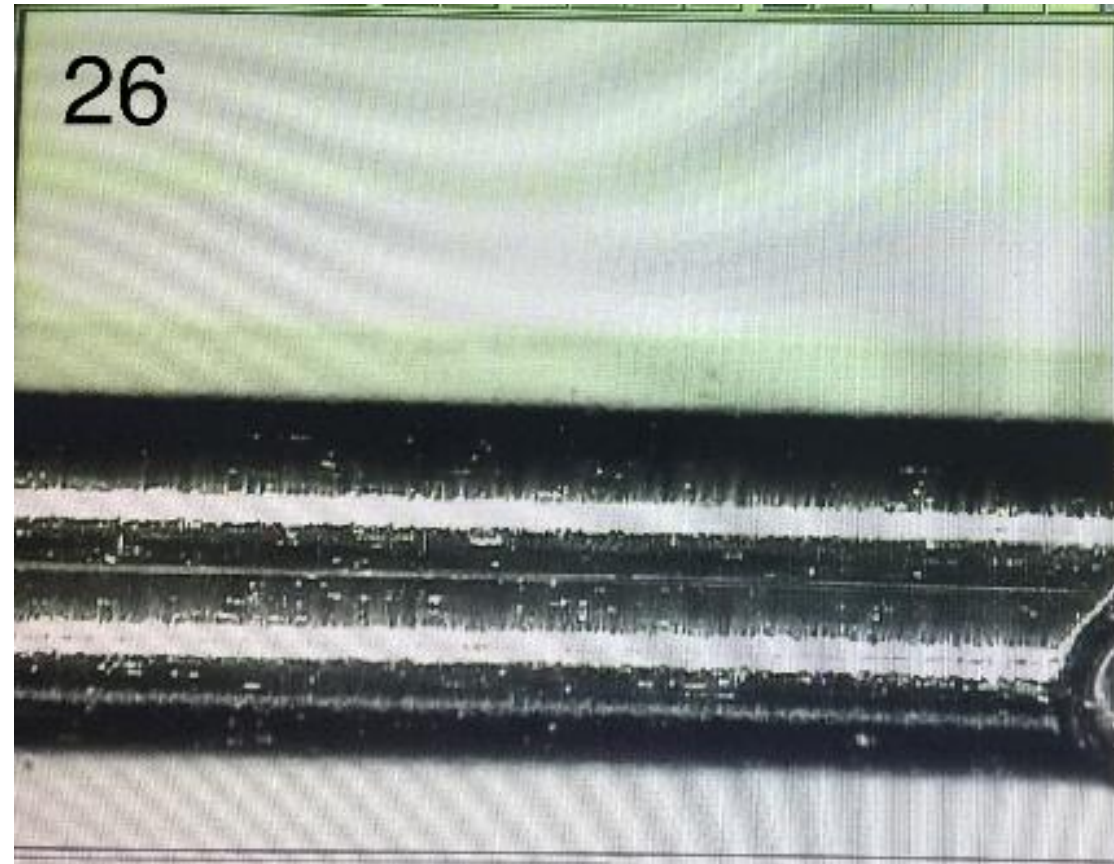
Longitudinal scratches observed

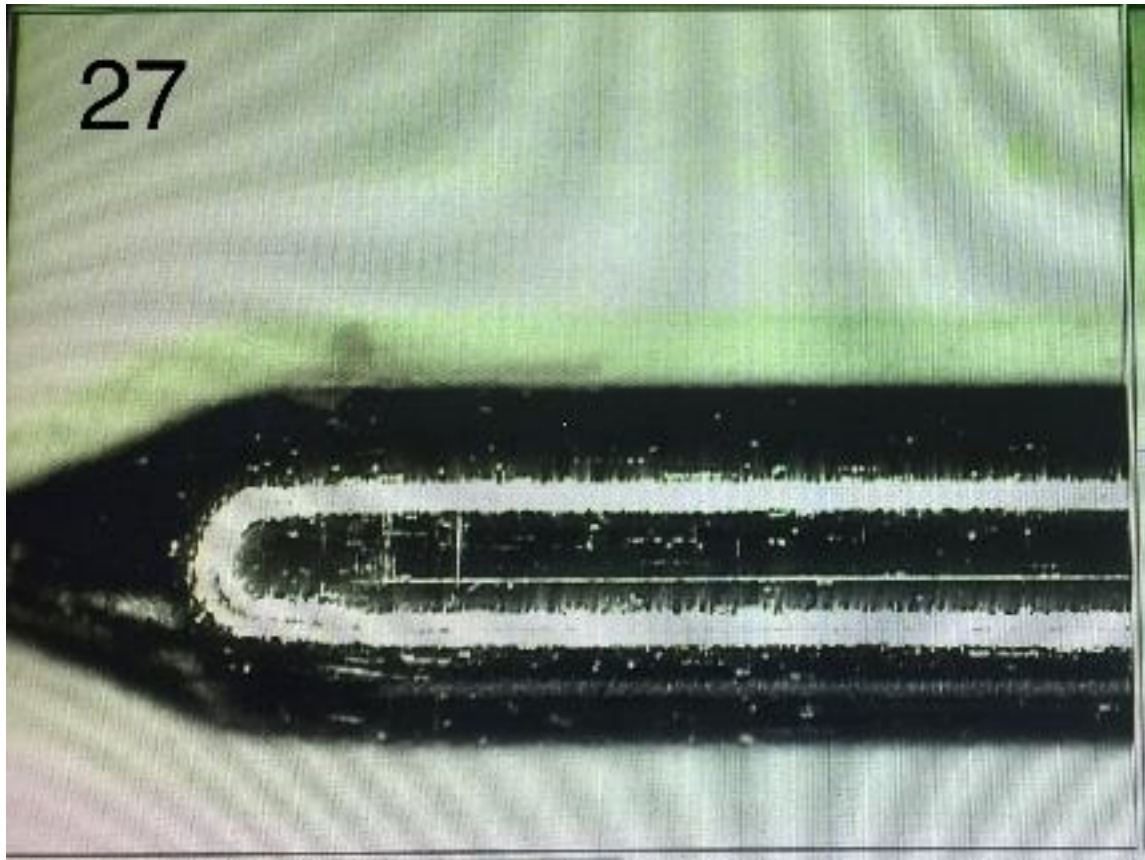
Longitudinal scratches observed

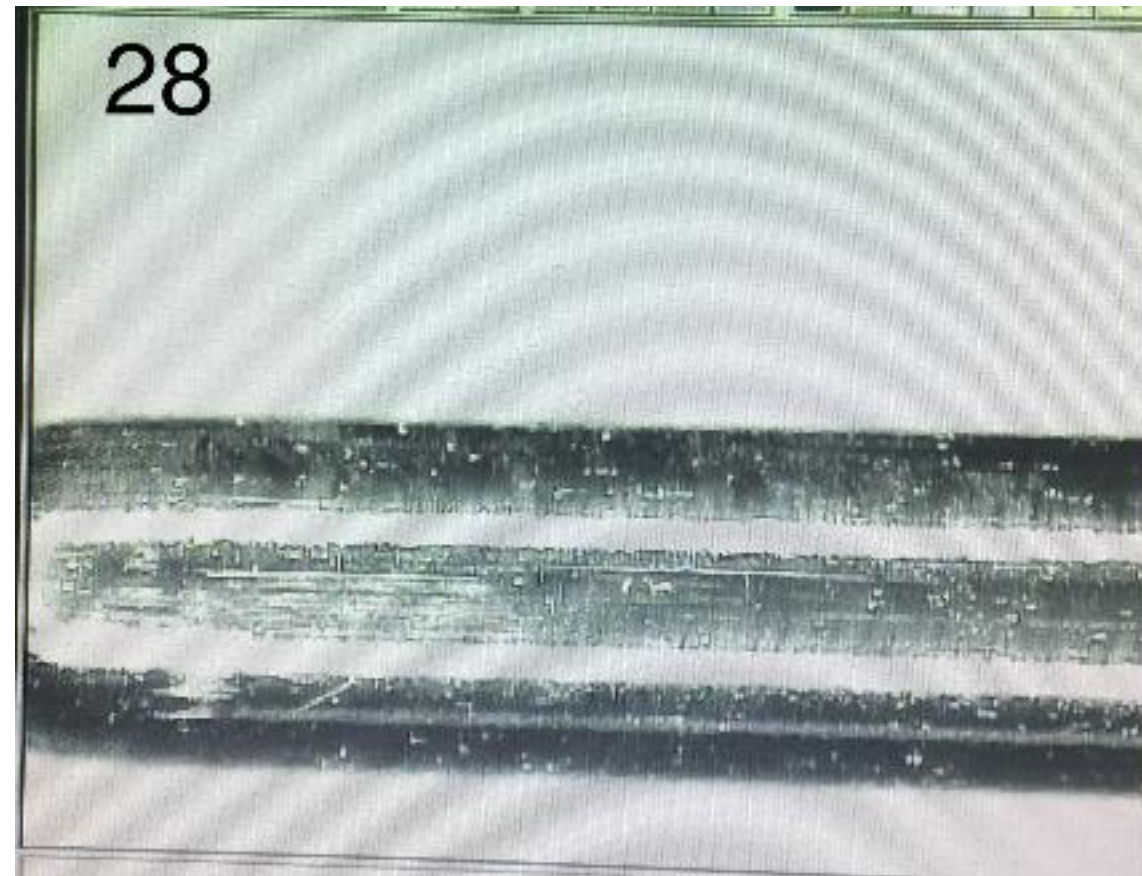
Longitudinal scratches observed

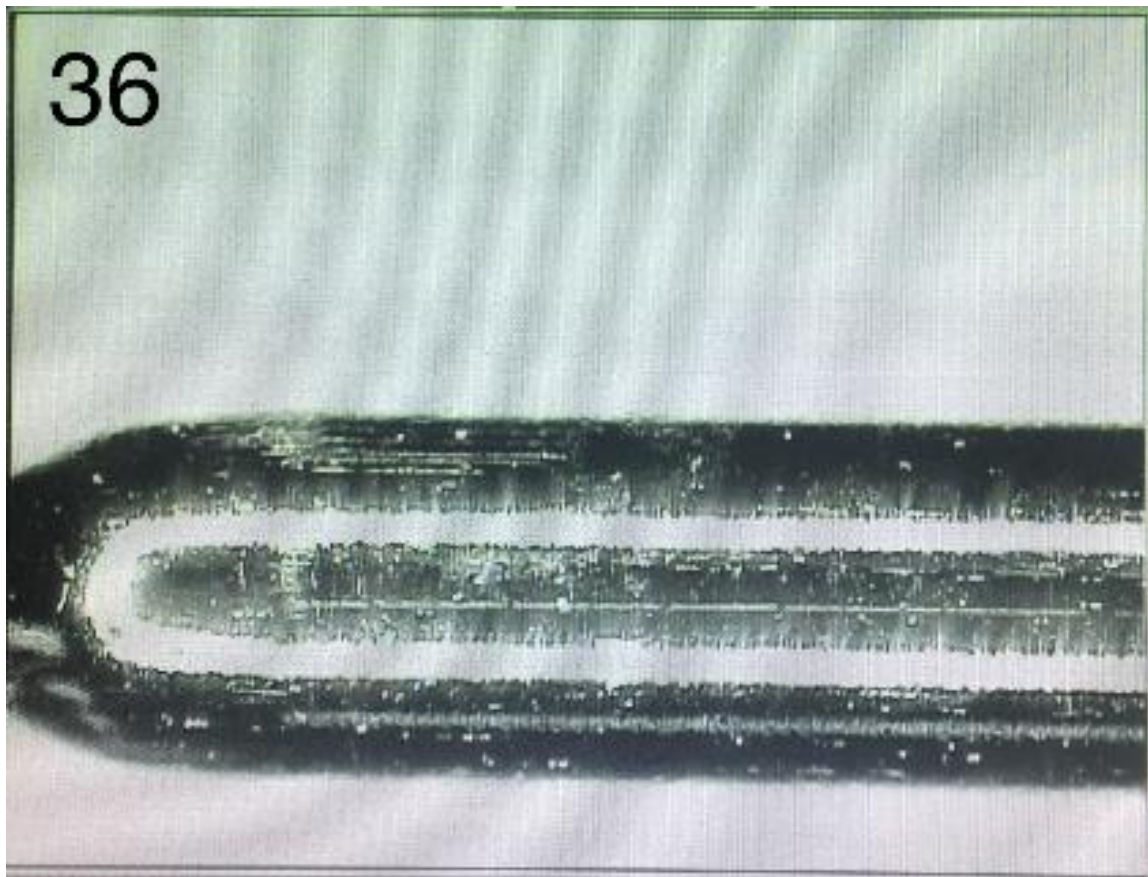
Longitudinal scratches observed

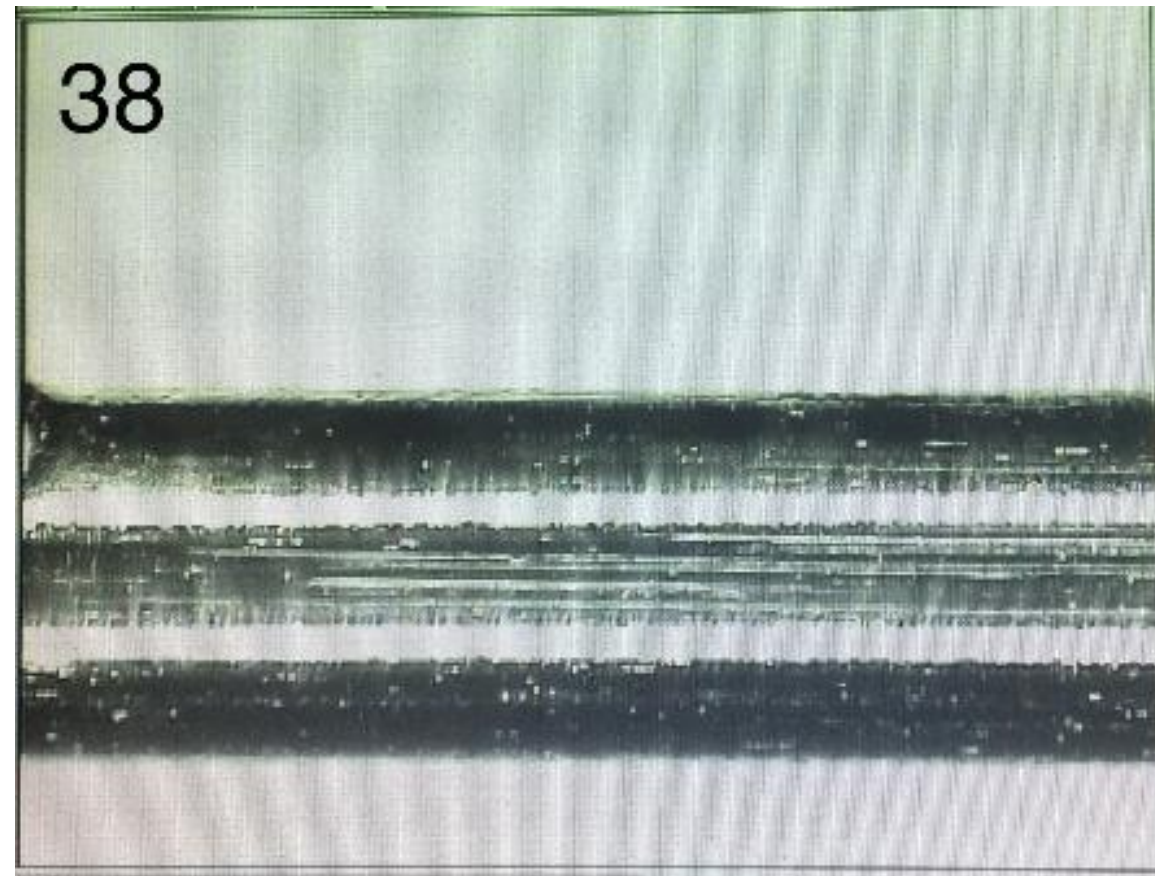
Longitudinal scratches observed
