## Waters Overall Account Update

27 Apr 2020

# Yield Improvement – Interface Tubing

**Project Title :** Yield Improvement – Interface Tubing Replacement (Soft Failure)

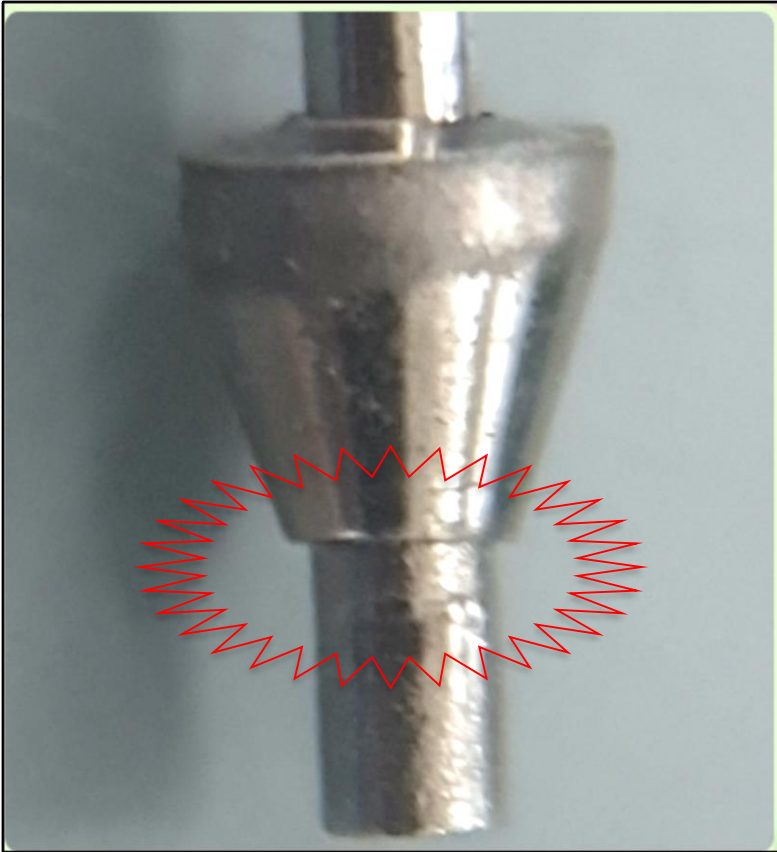
Defect observed before replacement :

1. Scratches on the tubing surface

| | Possible Causes | Verification | Possible cause (Y/ N) | Proposed Actions |
|---|---|---|---|---|
| <b>Machine</b> | Damaged Interface Tubing due to wear and tear. | Verified the interface tubing and shown wear and tear | Y | To perform daily task by Test EA as below before release tester to production |

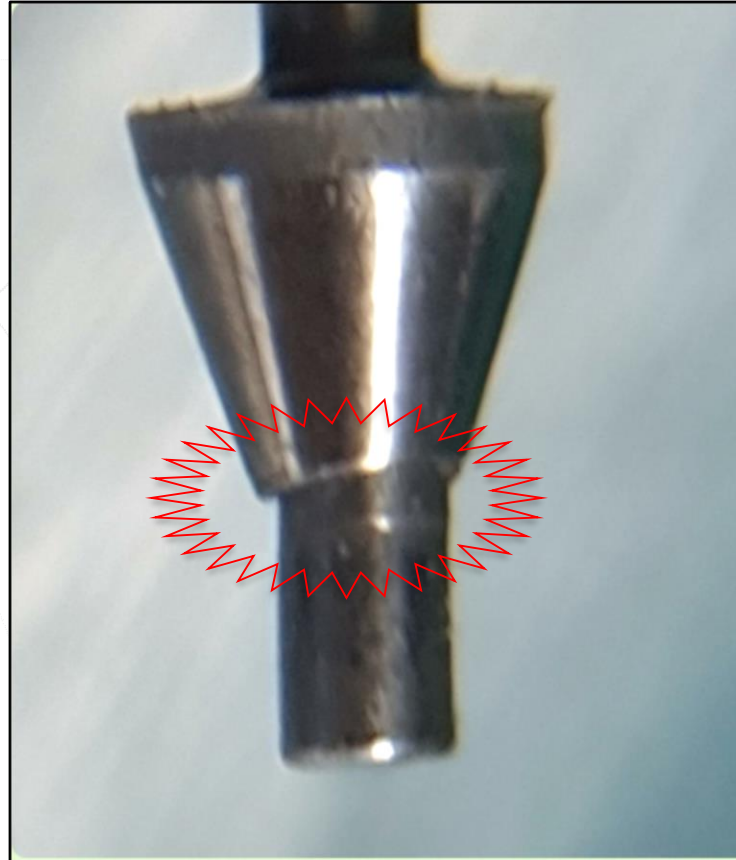
2. Scratches on the tubing surface

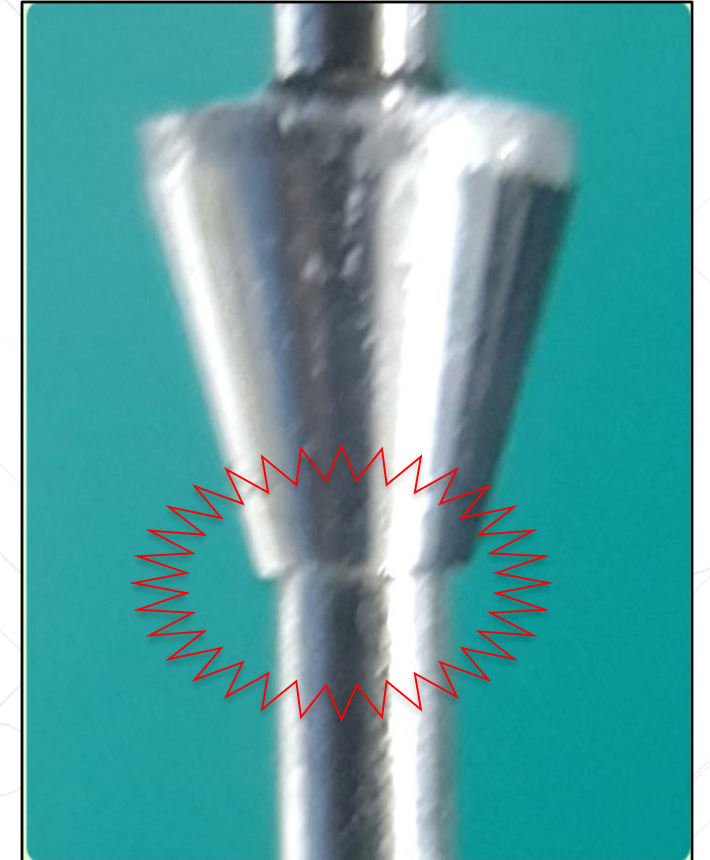
3. Outer wall collapse
