## Waters Overall Account Update

06 May 2020

# Yield Improvement – Communication Failure

**Project Title :** Yield Improvement – Communication Failure

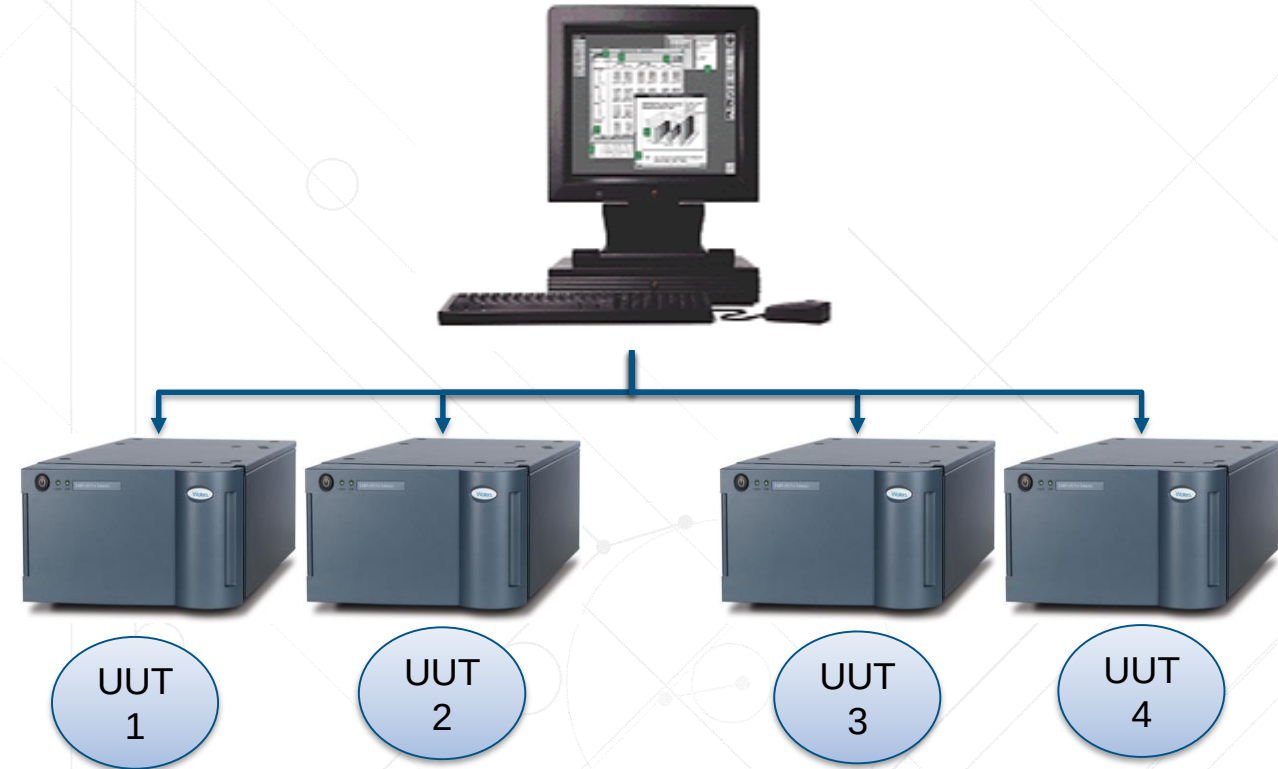
### TE82882 PDA Final Tester

- Test Tech'n \ Operator did not do daily clearing of DHCP, remove rogue IP address and uninitialized S/N not performed
- There's defective CPU board 210000520
- TE82882 have defective Ethernet\RS232 interface headers.
- Empower Node have conflict of settings. additional units.
- Disturb units under test by inserting new UUT while there's UUT running on other port \ position
- Table hit by another table while UUT test in progress

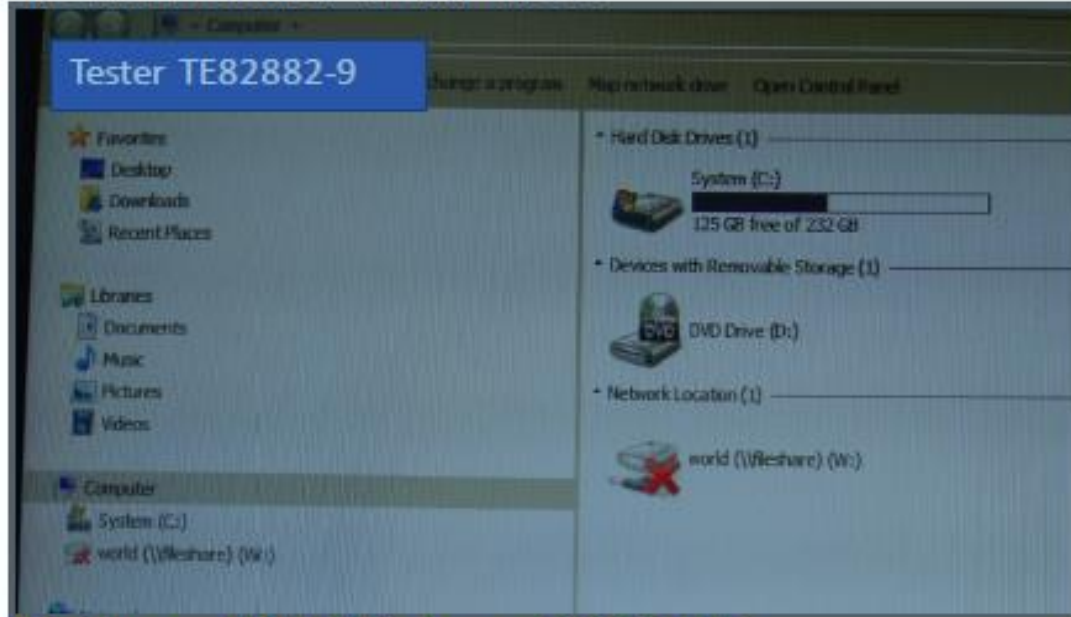
26 Dec – 2019 Completed the removal of old \*.DAT to all TE82882 PDA Final Tester.

Removed old \*.DAT files.

Before : 125 GB free of 232 GB

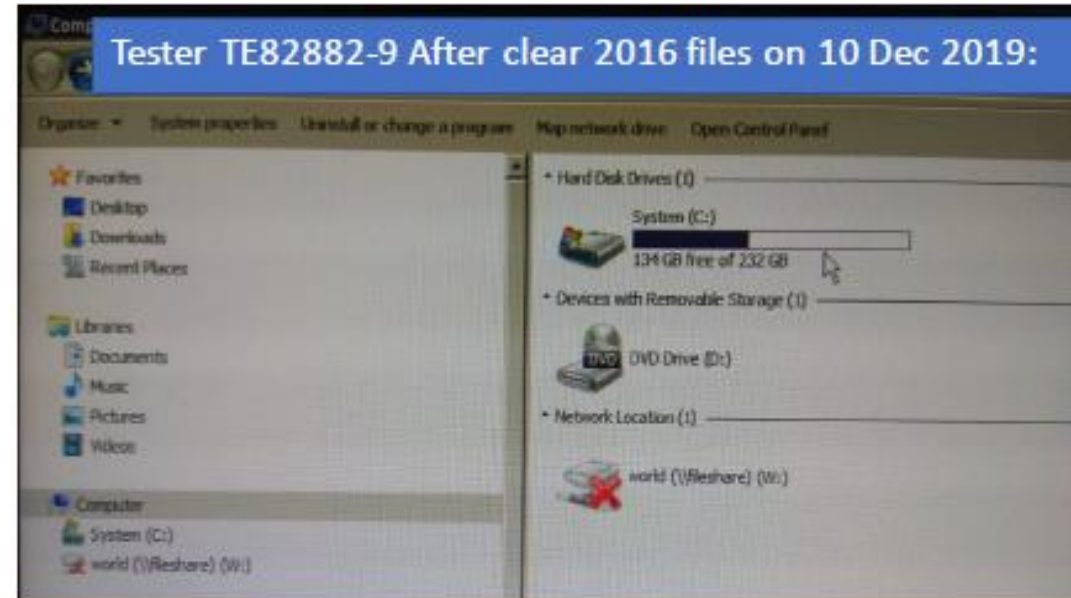
After : 134 GB free of 232 GB

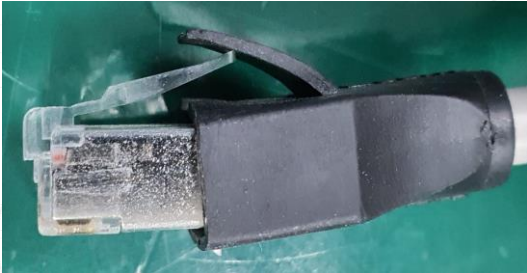
Ethernet Connector Lock  
– Good Condition

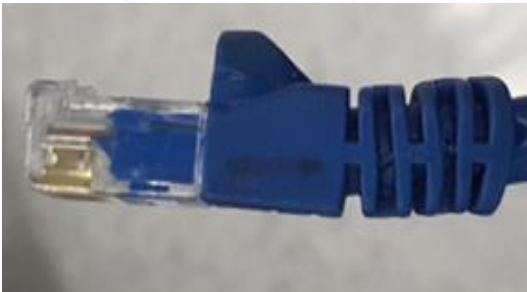
## Damage communication cables / connectors

Ethernet Connector Lock  
– Not good Condition

23 Mar 2020 - DO NOT USE (POS 1,2,3,4, DAMAGED LOCK)  
24 Mar 2020 - DO NOT USE (POS 3,4, Damaged lock)  
25 Mar 2020 - All ethernet cable lock has been repaired.  
End of data

| Action Item | Who | Due Date | Actual Date | % Completed |
|---|---|---|---|---|
| 9. Replace Ethernet Headers per test position | Joel | 05 Mar 20 | 27 Mar 20 | |

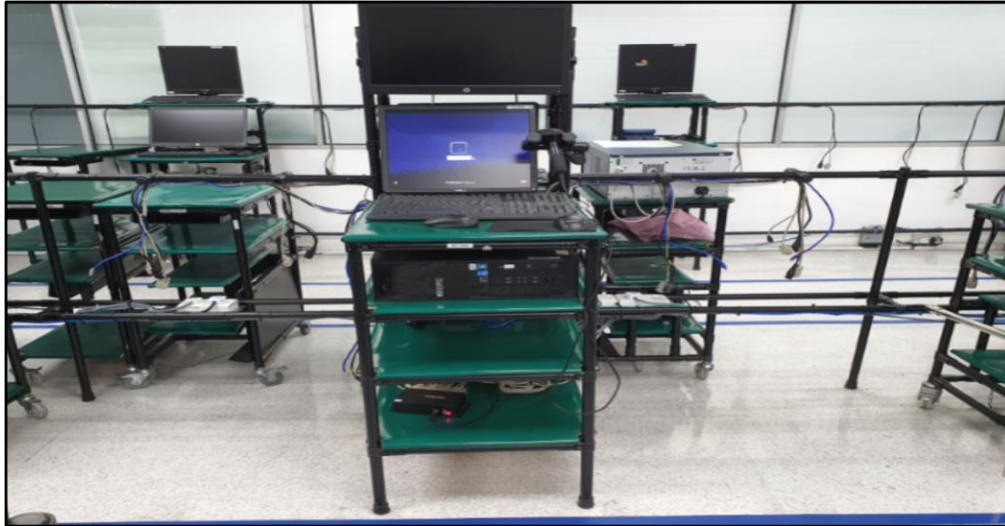
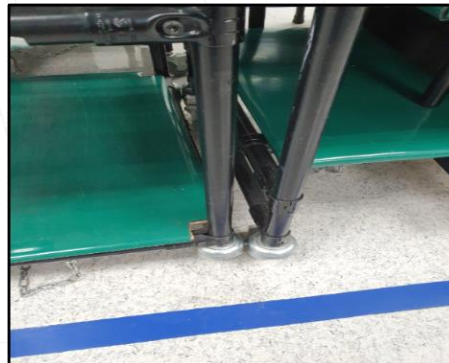
09 Mar 2020 Table hit by another table while UUT test in progress

Tester without spacer in between UUT

Tester with spacer in between UUT accidental bumps on the UUT potentially disturbing communication between UUT and Tester

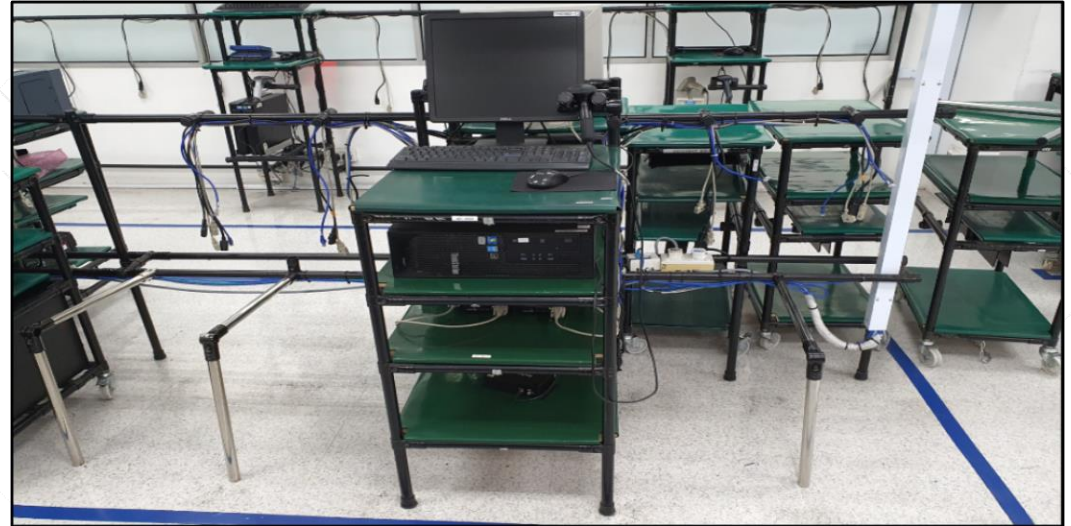
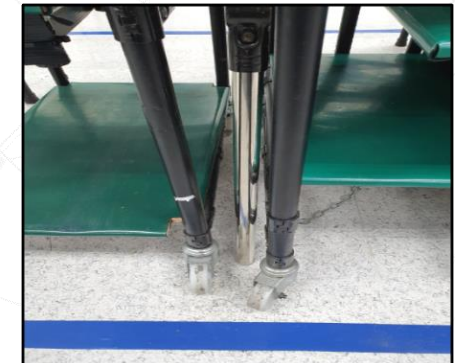
Tester with spacer in between UUT

Tester with spacer in between UUT avoid accidental bumps on the UUT potentially disturbing communication between UUT and Tester

TE82882-13 Introduced a spacer between test position to avoid knocking table – 09 Mar 2020
