## Waters Overall Account Update

27 Apr 2020

# 2020 Overall CI Update

# Yield Improvement – Communication Failure

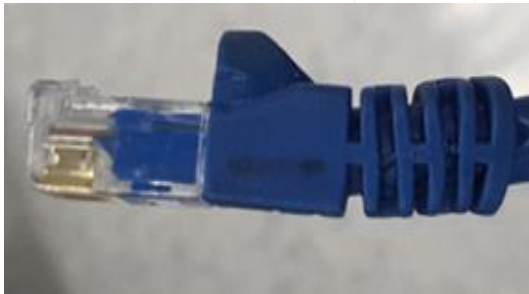
Ethernet Connector Lock  
– Not good Condition

23 Mar 2020 - DO NOT USE (POS 1,2,3,4, DAMAGED LOCK)  
24 Mar 2020 - DO NOT USE (POS 3,4, Damaged lock)  
25 Mar 2020 - All ethernet cable lock has been repaired.  
End of data

- All ethernet ports has been verified in good condition **(27-Mar-2020)**
- Monitoring in progress

| Action Item | Who | Due Date | Actual Date | % Completed |
|---|---|---|---|---|
| 9. Replace Ethernet Headers per test position | Joel | 05 Mar 20 | 27 Mar 20 | |
