# **Waters 2020 FPY Improvement Activities**

13 Aug 2020

# Yield Improvement – Communication Failure

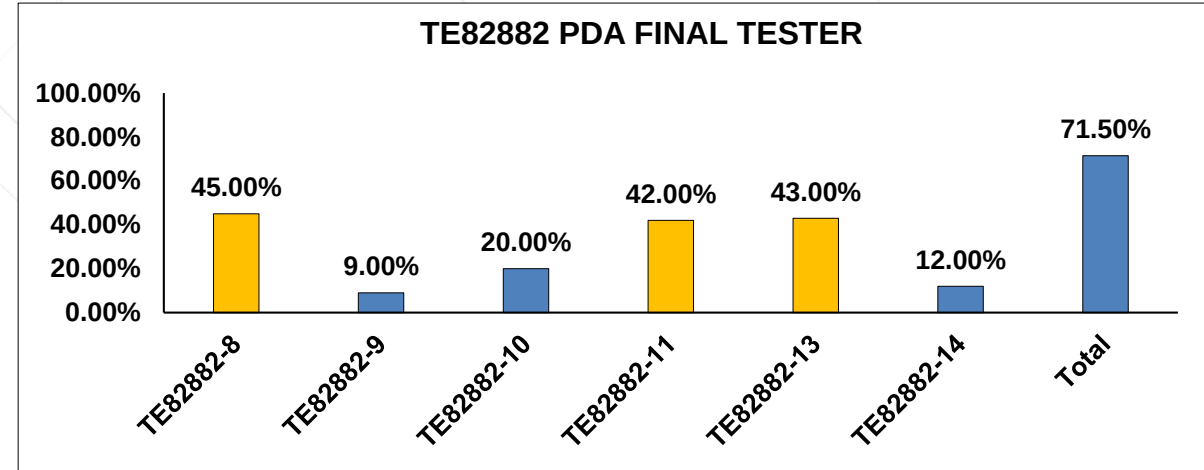
| Manual Data Collection as of 29 Jul 2020 | | | | | | | |
|---|---|---|---|---|---|---|---|
| LOSS COMM | 45 | 9 | 20 | 42 | 43 | 12 | 171 |
| Failure Rate % | 45.00% | 9.00% | 20.00% | 42.00% | 43.00% | 12.00% | 71.50% |

- Loading of PDA Family Detectors completed the 600 units
- Refer to manual data collection table.

TE82882-9, 10, 14 showing better yield  
TE82882-8, 11, 13 showing low yield

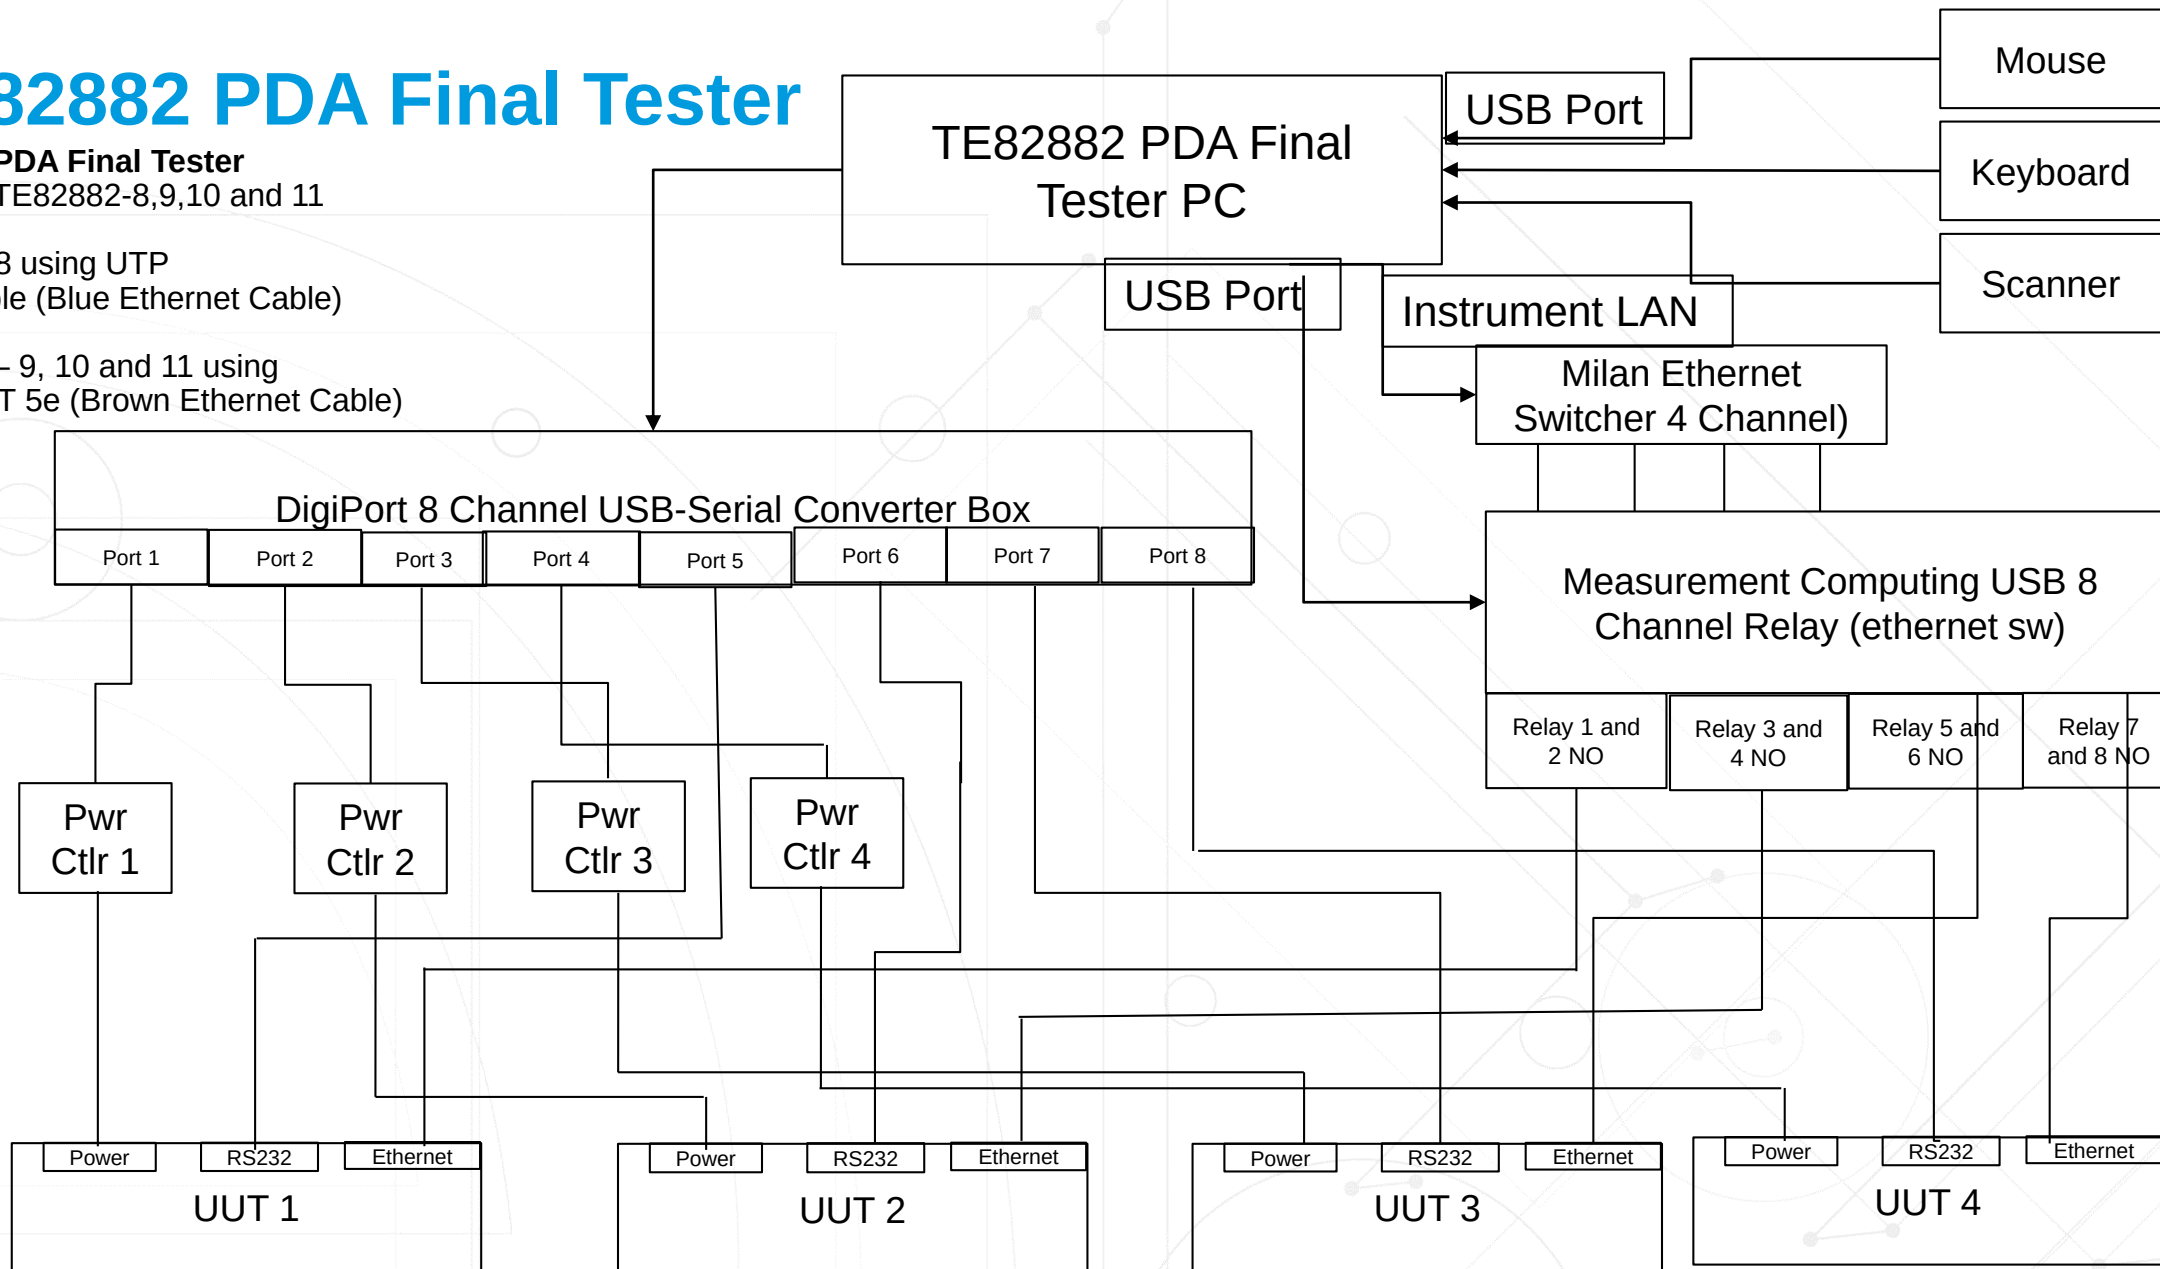
Setup for TE82882-8,9,10 and 11

TE82882-8 using UTP

CAT 6 cable (Blue Ethernet Cable)

TE82882 – 9, 10 and 11 using

LCOM CAT 5e (Brown Ethernet Cable)

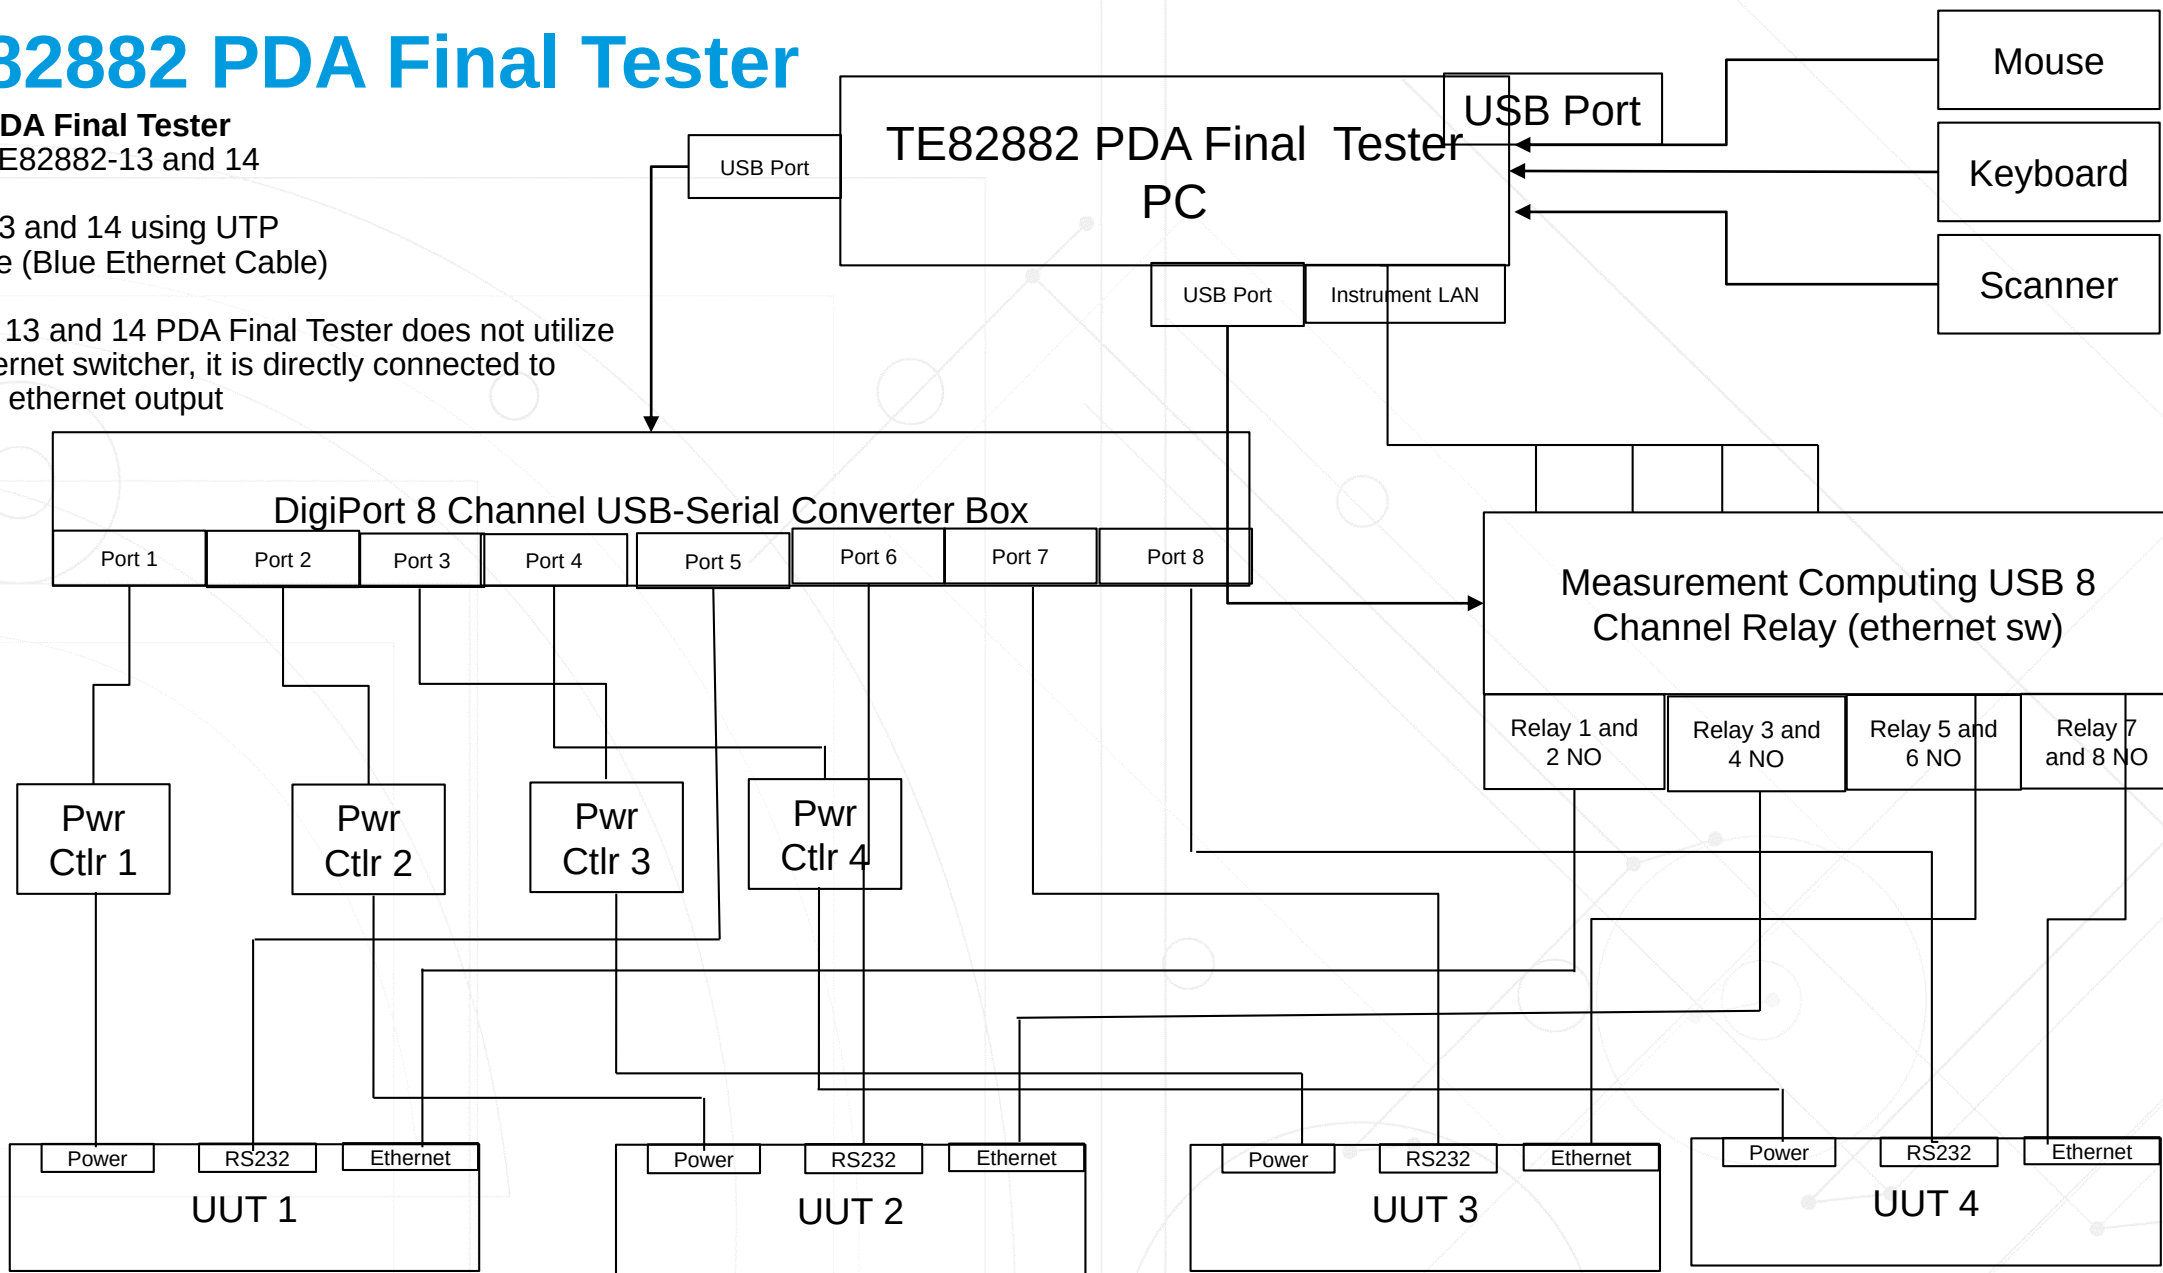
**TE82882 PDA Final Tester**  
Setup for TE82882-13 and 14

TE82882-13 and 14 using UTP  
CAT 6 cable (Blue Ethernet Cable)

TE82882 – 13 and 14 PDA Final Tester does not utilize  
MILAN ethernet switcher, it is directly connected to  
CPU with 4 ethernet output

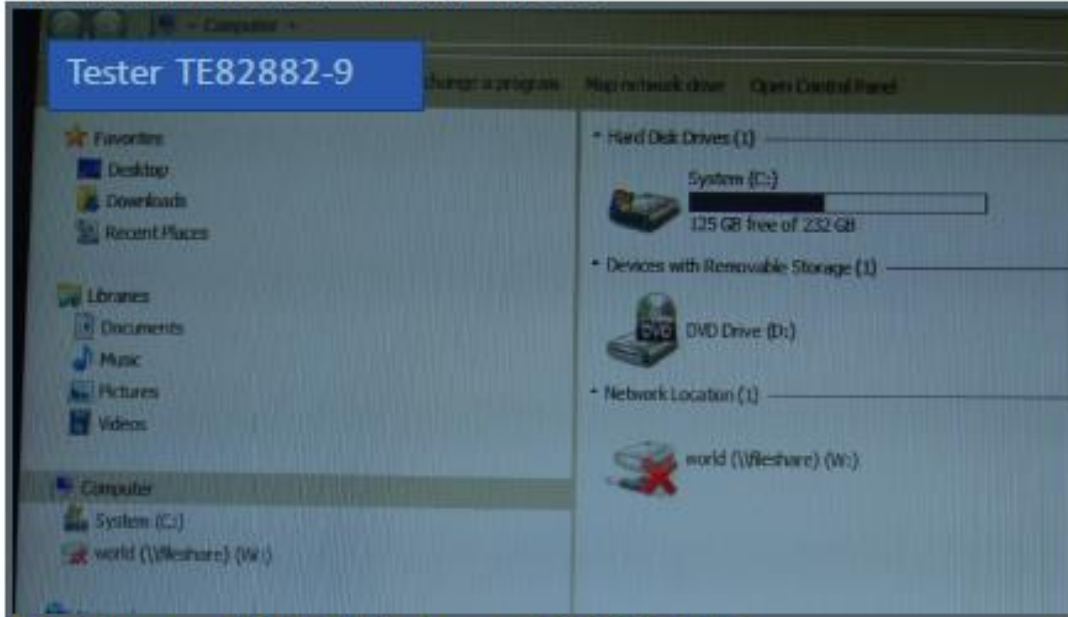
Before : 125 GB free of 232 GB

Removed old \*.DAT files.

**26 Dec – 2019** Completed the removal of old \*.DAT to all TE82882 PDA Final Tester.

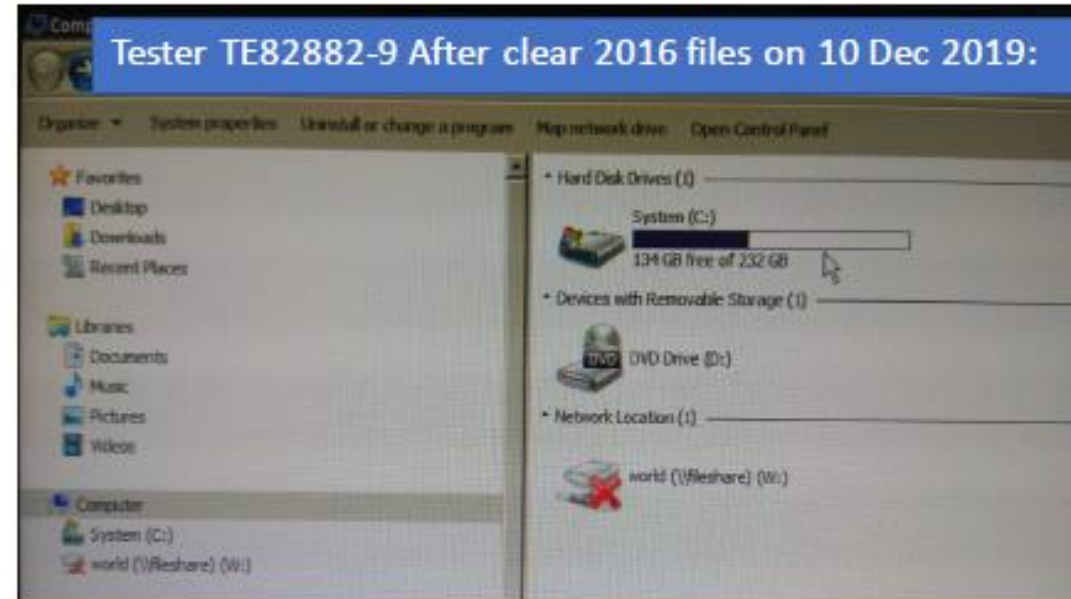
After : 134 GB free of 232 GB

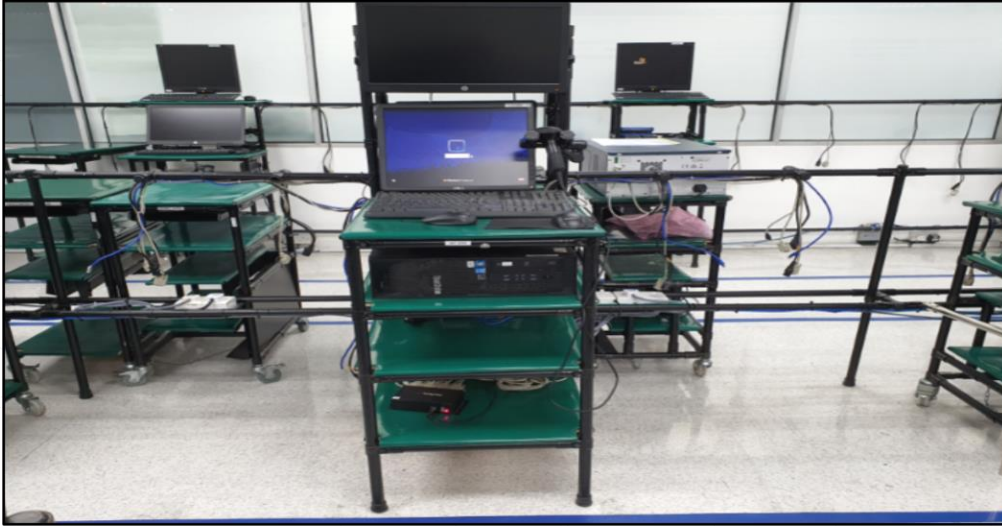
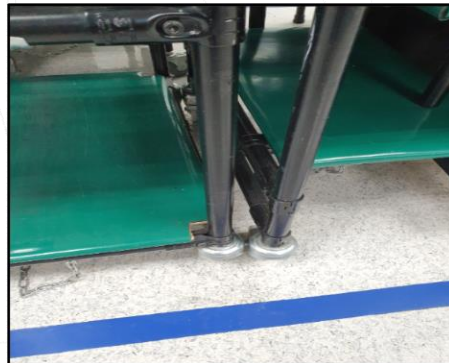
Table hit by another table while UUT test in progress

Tester without spacer in between UUT

Tester with spacer in between UUT accidental bumps on the UUT potentially disturbing communication between UUT and Tester

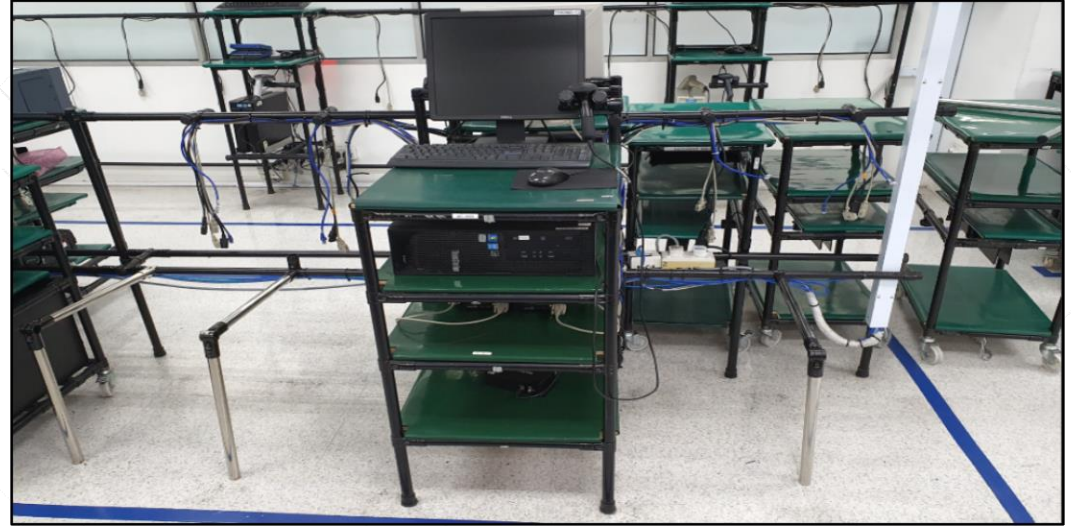
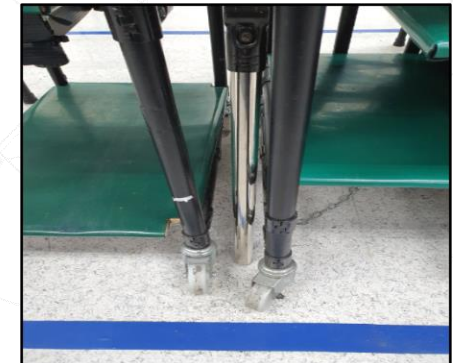
Tester with spacer in between UUT

Tester with spacer in between UUT avoid accidental bumps on the UUT potentially disturbing communication between UUT and Tester

09 Mar 2020 – TE82882-13 Introduced a spacer between test position to avoid knocking table

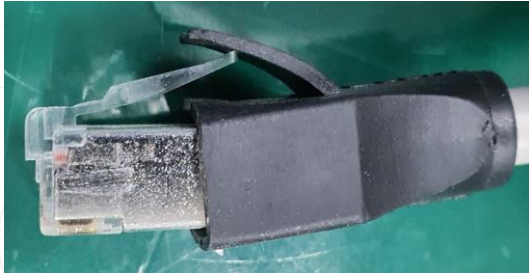
Ethernet Connector Lock  
– Good Condition

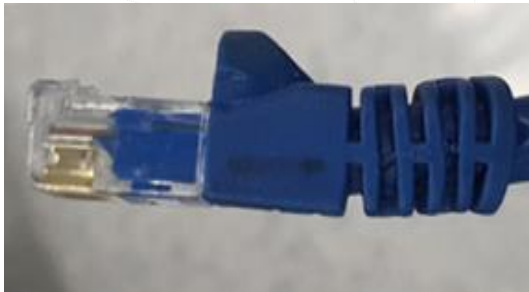
Ethernet Connector Lock  
– Not good Condition

**27 Mar 2020** – Completed All ethernet ports has been verified in good condition. Monitoring in progress through daily checking of Ethernet Cable and Lock not broken or damage. From 26 to 31 Mar 2020, there were no report of broken or damage cable and locks.
