## Monthly Technical Review (Oct 2020 Data)

Flex CFT  
25 Nov 2020

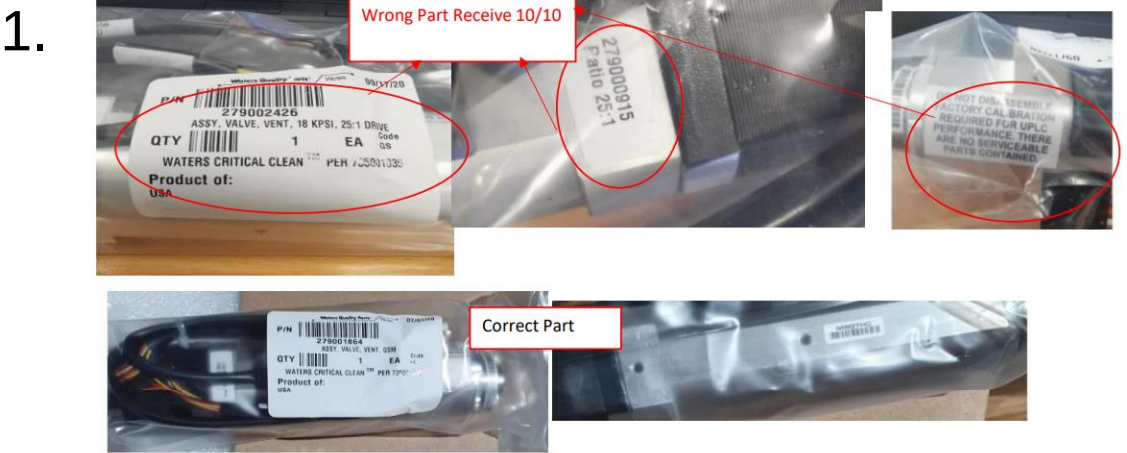
Failure Analysis WAT-RW-SKI06331 issued to WATERS TECHNOLOGIES CORP for p/n WAT-279001864-C ,the defect of wrong part received. Correct part p/n is 279001864 but received 279002426.

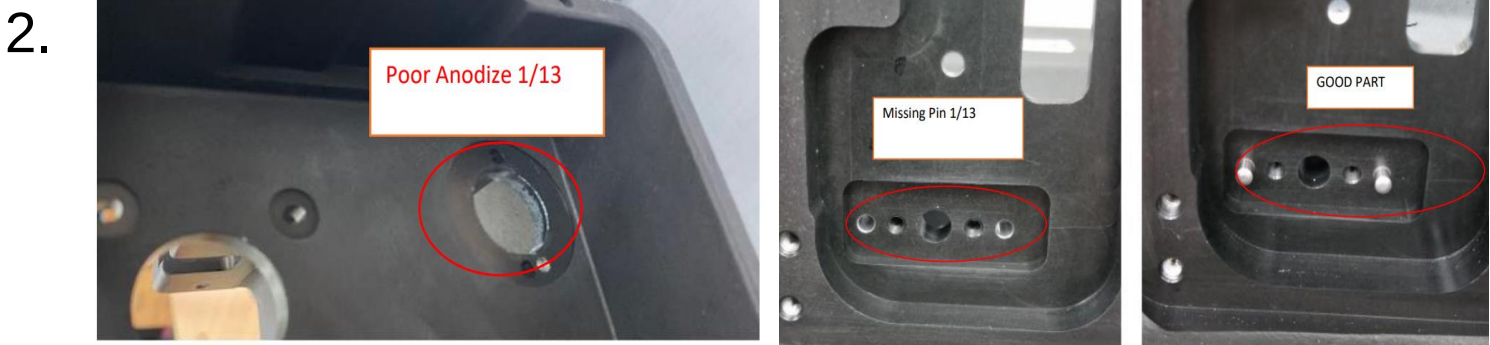
Failure Analysis WAT-RW-SKI06328 issued to JCC for p/n WAT081300-P, the defect of Poor Anodize & missing pin.
