**Selected Alliance Error Codes**

Waters

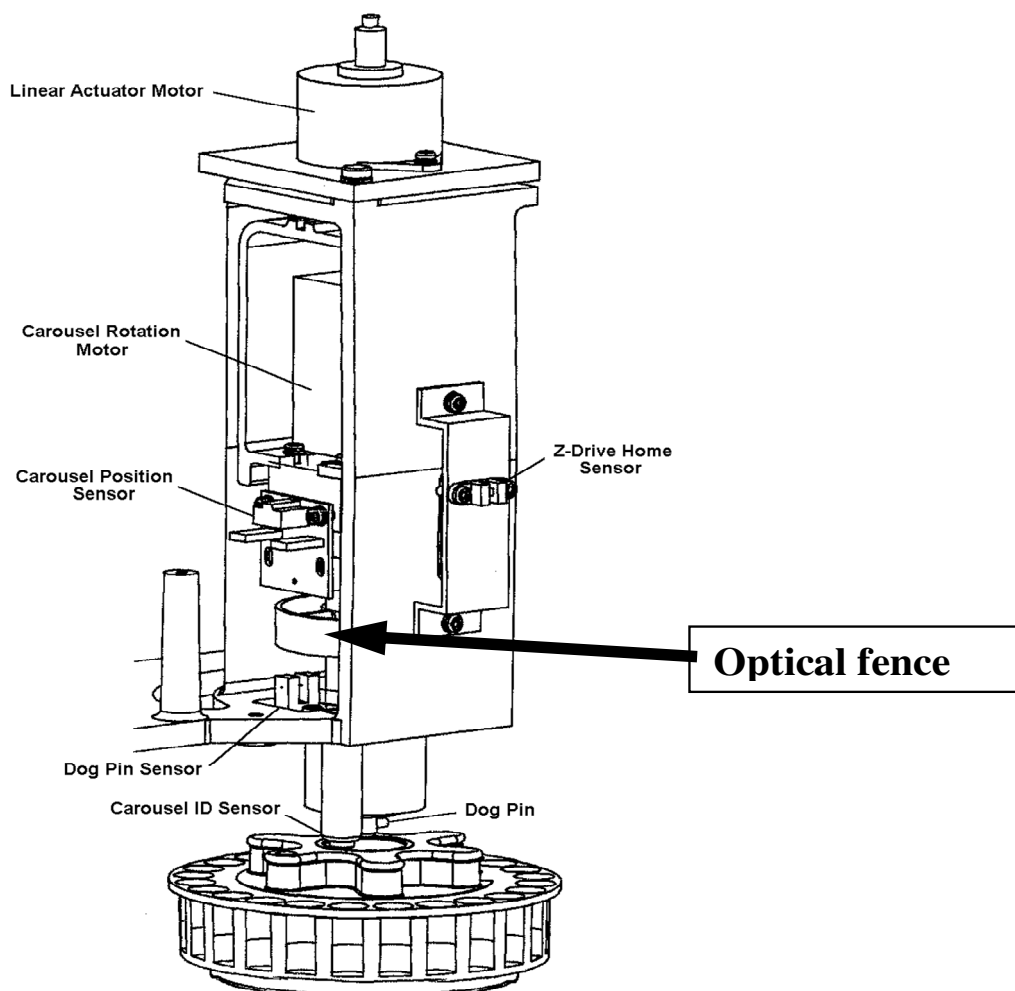
## 2. Carousel Z axis malfunction

**Carousel Drive Operation** Each time a carousel is in the LOAD position, the adjacent carousel is located under the carousel dog pin shaft assembly. Just as the carrier rotates to position and identify carousels,

The individual sample carousels must be rotated to locate specific sample vials. This is accomplished by two stepper motors within the carousel drive mechanism and is a multistep process. First, the sample carousel must be engaged by the carousel RAM shaft assembly. This is accomplished by a linear actuator motor located at the top of the carousel drive mechanism and a dog-pin shaft at the bottom of this mechanism. The linear actuator motor drives the entire carousel motor lift housing and dog pin shaft down and engages the sample carousel. The dog pin shaft is so named because of the right-angled pin at the bottom, which fits into a similarly shaped slot in the center of each sample carousel. When the dog pin engages a sample carousel, an optical fence, attached to the dog-pin shaft, drops into a sensor within the carousel drive mechanism. The corresponding DOG PIN LED - DS38 on the Fluidics Driver PCB lights.

If you get a Z axis malfunction:

1. Inspect the optical fence and insure that it is parallel to the base of the carousel drive. If the fence has gone into the sensor and wobbles so that light is detected when it shouldn't be seen you get the error.
2. The sensor may be too low.
3. The optical fence may be hitting the top of the sensor bracket.
4. Insure that the adjacent cables haven't migrated under the fence.

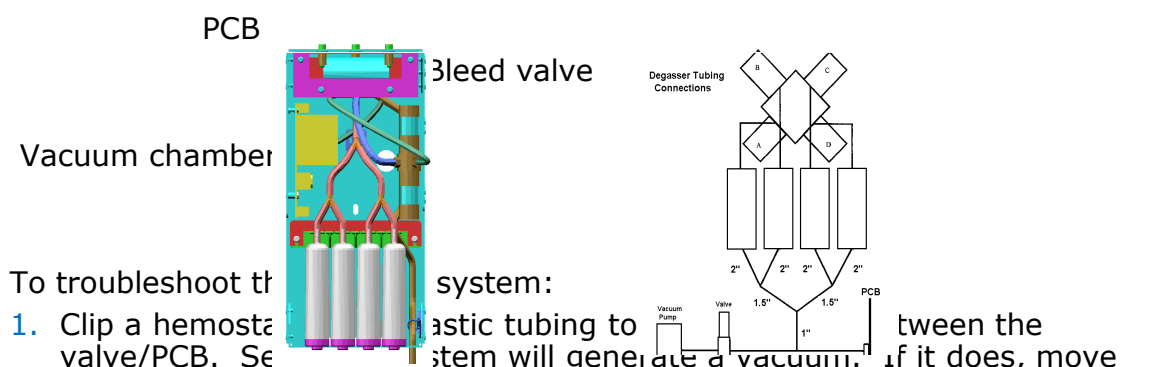
### Vacuum pump

On the older type 2690/5's (pre 11/98) the pressure in the degassing chambers had to get below -9.8 psig and maintain an acceptable leak rate in the "normal" configuration. In the newer 2690/5's (after 3/99) the systems use absolute pressure and these systems must drop below 4 psi.

- To troubleshoot the system:
1. Clip a hemostat to the plastic tubing to isolate the system between the bleed valve/PCB. See the diagram. The system will generate a vacuum. If it does, move the hemostat and isolate a pair of the chambers. If a vacuum results the problem must lie in the tubing associated with and/or the other pair of chambers.

2. If no vacuum is detected on just the pump, valve, and PCB use a syringe to pull a vacuum on just the PCB. If there is no reaction, the PCB is bad.

3. If the PCB is OK check all of the tubing and the vacuum pump and bleed valve. One way to check this combination is to jump out the valve and simply check the pump and PCB combination.
