**From:** [Eric Turner](#)  
**To:** [HuaZhen Luo](#)  
**Subject:** RE: Venture CPSM upgrade TE83064-15 to TE0084050-18  
**Date:** Wednesday, 9 June, 2021 01:23:32  
**Attachments:** [image016.png](#)  
[image017.png](#)  
[image004.png](#)

**Subject:** RE: Venture CPSM upgrade TE83064-15 to TE0084050-18

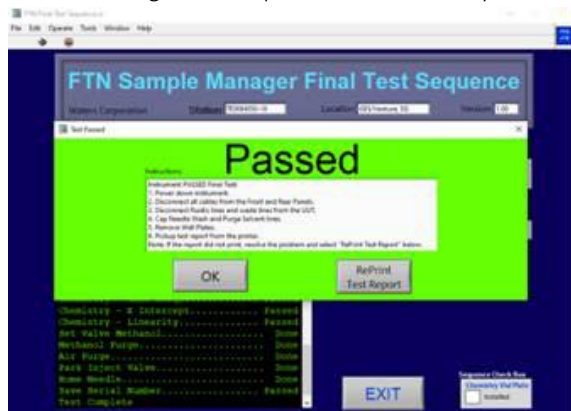
And we managed to complete 1<sup>st</sup> run on this system with Golden Test Box from Christ today.

However I noticed the test program is still running on version 1.00.

Thanks for advice. We fixed this valve controller issue by re-rightening the connections on the test box.

Could you please help to upgrade it to 1.03 per TSP?

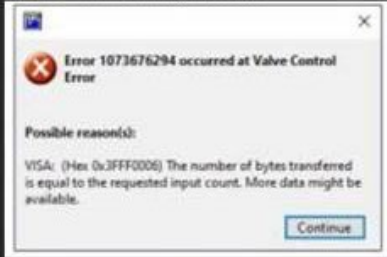
we see this error when we running the final test on valve

different from the error message you seeing now.

but also related to valve control.

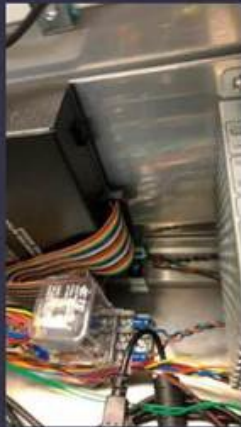
Yes please. I believe the 40pin ribbon cable is disconnected from the VICI controller

Alright, The error we are getting now happens only when i disconnect the 40 pin ribbon cable from the VICI controller (blackbox). The other end of that cable goes to the NI card installed on the side of the testbox. those connections are only screwed in.

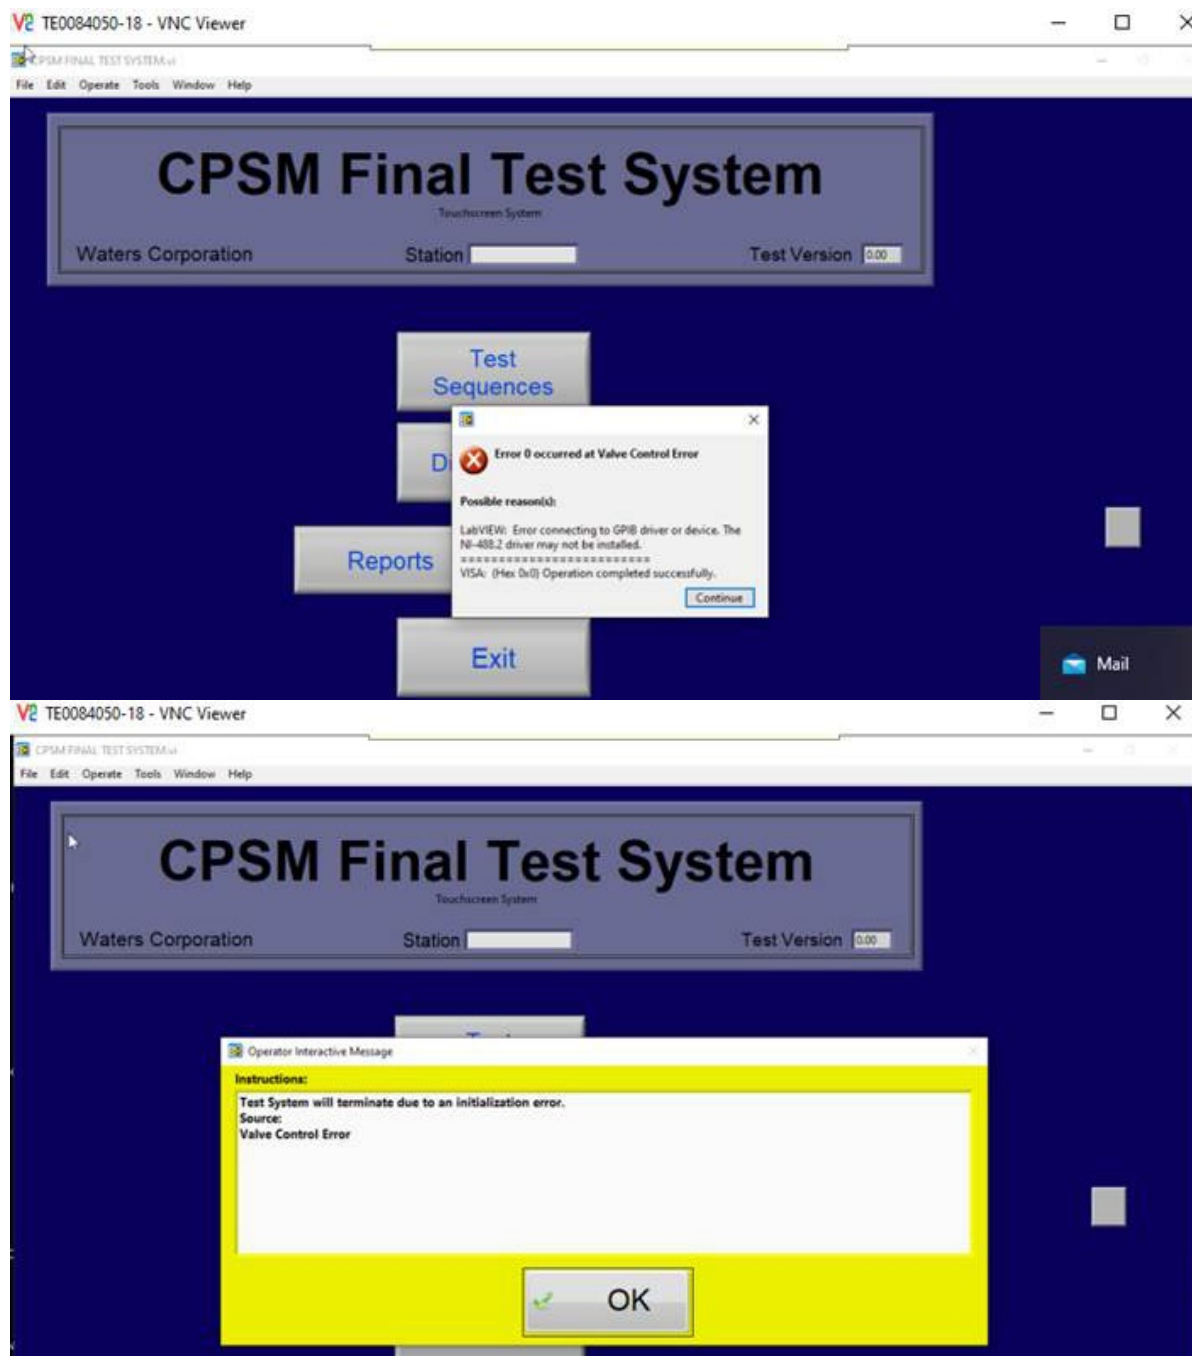
But I encountered the following error messages after I completed all hardware connections and started test program run.

Is PC required to have this test program upgraded? The existing version is one from PC imaged shared by Bill previously.

Please kindly help to remote in and check if test program or configuration update is required. Thank you
