## Monthly Technical Review (Dec 2018 Data)

Flex CFT

23 Jan 2019

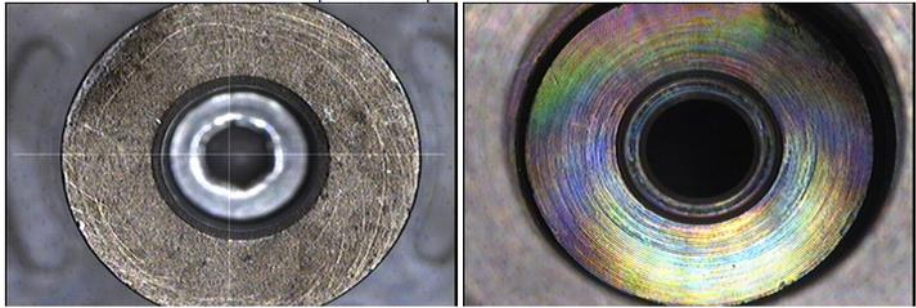
| Description | Responsible | Due Date |
|---|---|---|
| <p><b>2) GPV (WAT270524)</b></p> <ul style="list-style-type: none"><li>15 Sep: after using the corrected lot, 1 failed out of more than 500u tested.</li><li>20 Sep: Parker's FA report- no indication of metallic fragments from the screw thread cutting process in the armature was found. (Refer to below photo cut from Prelim FA). The part will be returned to Flex for control build.</li></ul> <div></div> <ul style="list-style-type: none"><li>21 Nov: pend Parke to return GPV after FA to Flex.</li><li>18 Dec: 3 x RMA, Pend update from Parker</li><li>15 Jan: Request Flex stop checking with Parker until further notice as Parker is relocating the factory</li><li>20 Feb: Flex can start to peruse outstanding issues with Parker</li><li>20 Mar: RMA#14671 (01pc) - produced after corrective action. Flex is query Idex on the findings reported by Idex's FA report.</li><li>20 Mar: pursuing the other outstanding's reports</li><li>17 Apr: WPPL informed the triggering is 15000ppm.</li><li>14 Aug: Jan to Aug PPM – see next slide.</li><li>18 Sep: Implemented GBP Threadless armature. (TMD010532).</li><li>18 Sep: 1<sup>st</sup> SN: H18SM7376A PN 186269505) and H18SM4478A (186269506) for Alliance for WAT270524</li><li>15 Oct: 1<sup>st</sup> SN: 186015080 (H18QSP885A) and 186015018 (H18QSM607A) for QSM and QSM Plus for 279001810</li><li>15 Oct: Parker Oven Change S/N 146380 (WAT270524) and S/N 58188 (279001810)</li><li>15 Oct: Tjreadless armature PPM, please refer to next 2 slides</li><li>20 Nov: .‘additional testing’ GPV in focus.</li><li>18 Dec: 200pcs of Alliance GPV under TMD consumed. 2u failed.</li><li>21 Jan: Flex to closely monitor failure and report out GPV failures weekly.</li></ul> | Parker / Flex | On-going |

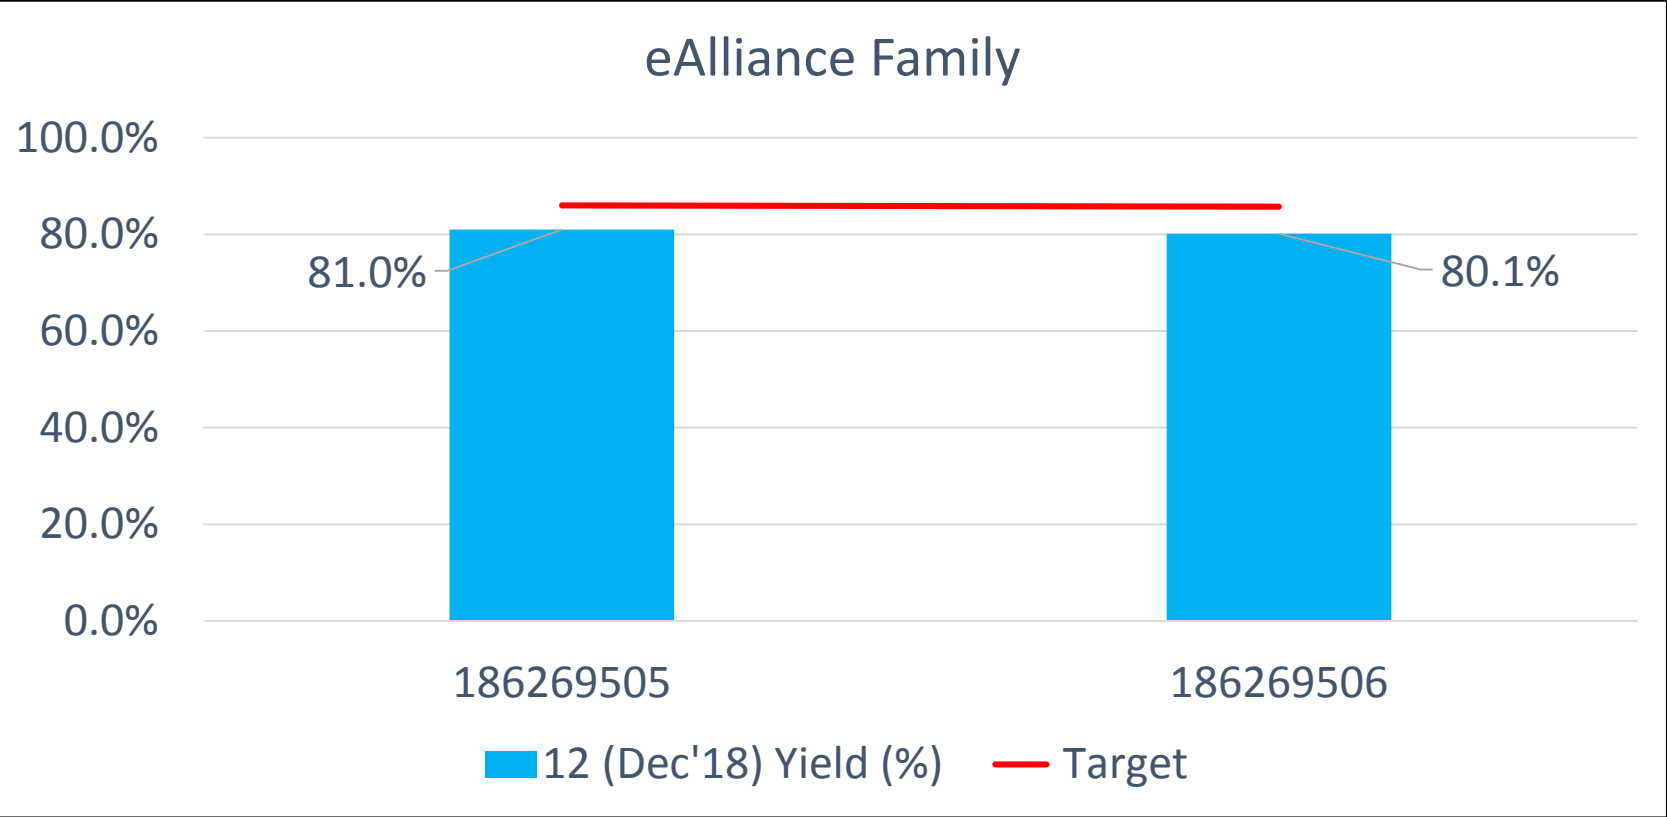
## Alliance Family FPY (Dec 2018 data)

**Both models  
did not meet  
target**

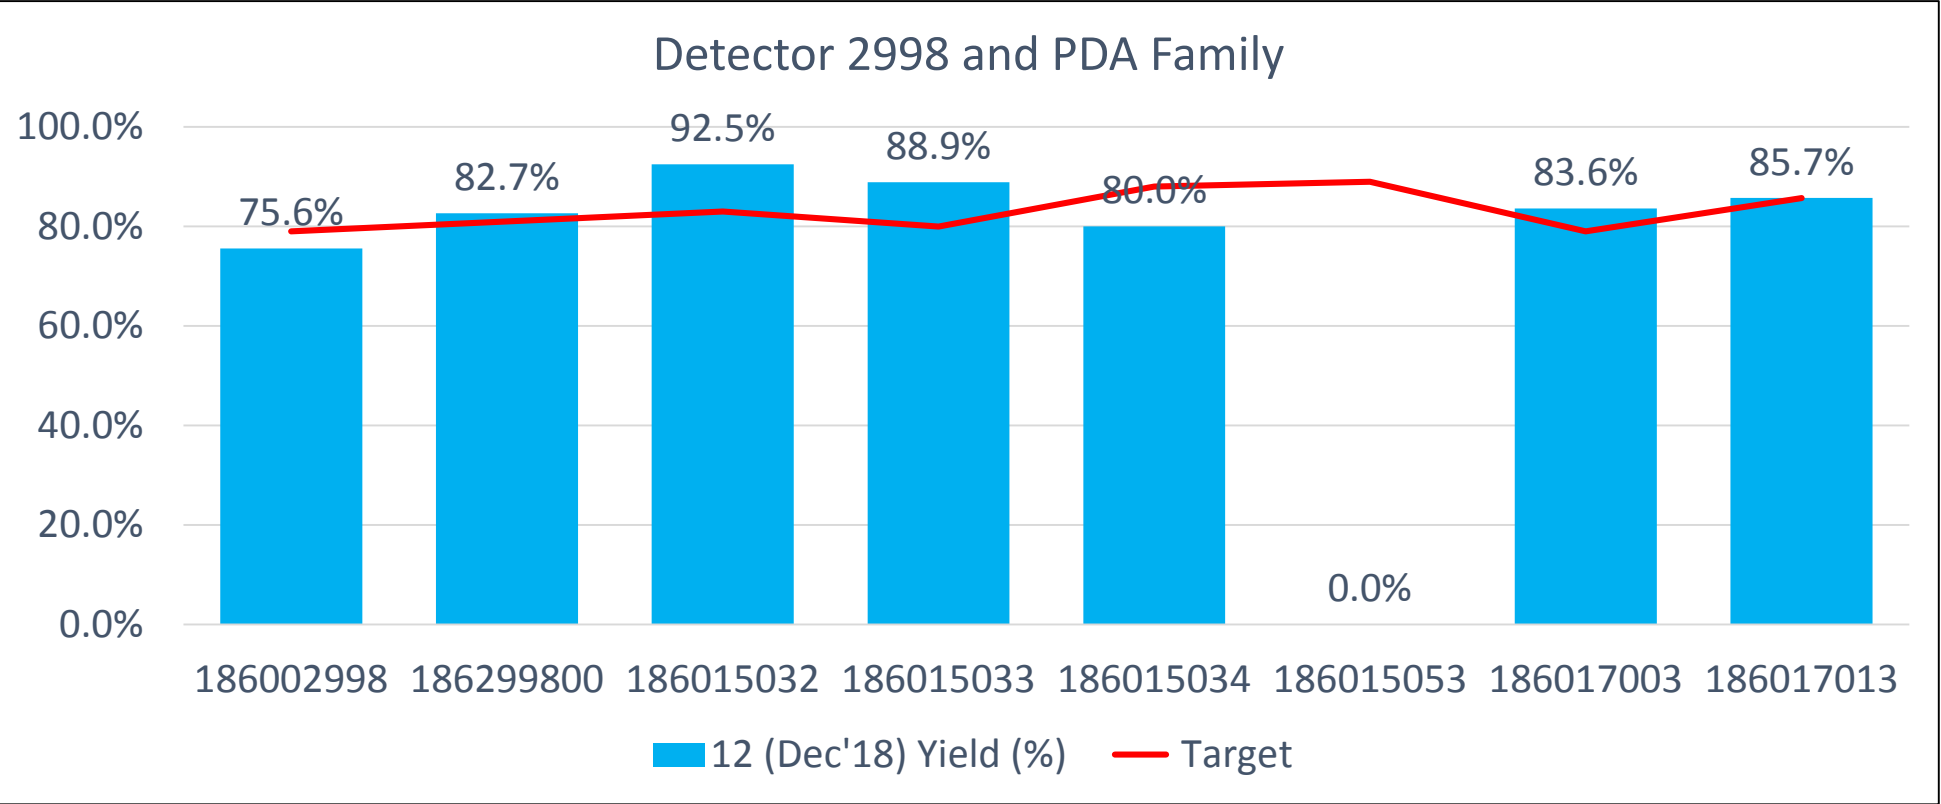
## Detector 2998 and PDA Family FPY (Dec 2018 data)

**186002998 and  
186015034 not  
meet target**

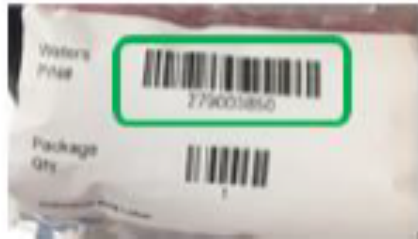
| Q-Alert Notice | | It is the Area/department representatives to retain Q-Alert Notice. | |
|---|---|---|---|
| Description / Sketches/Diagram:<br>Issue: Customer feedback lu wrong part packed in 700011805 - Kit, Alliance e2695 Enhancement<br>Expected: PN 279003850<br>Wrong: WAT221-02<br><br>> Handload Process Instruction for 700011805 (Doc # WAT-RW-SKI04776 ) to update from rev C to D where;<br><div style="display: flex; justify-content: space-around;"><div style="border: 1px solid black; padding: 5px; width: 45%;"><p>For PN: 279003850, not to paste label with Waters logo (as per below):</p></div><div style="border: 1px solid black; padding: 5px; width: 45%;"><p>Instead, Flex Flow to scan the barcode on the supplier label (as per below):</p></div></div><br>> Before the ASP 700011805 (Doc # WAT-RW-SKI04776) released and implemented, Production to take note of below:<br>Material Handler – to ensure to kit part from the correct part location<br>Spare Packing – to check PN 279003850 is correct before pasting label with Waters logo | | | |

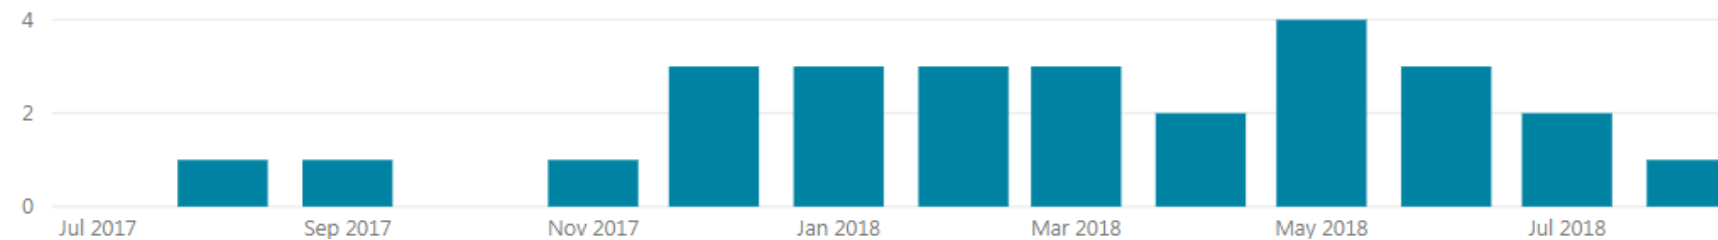
0-90 Day FSR count by DOM

- Product Improvement Management team now involved in Monthly Technical Reviews
- HB Lamp PSU (Hamamatsu) – 700002785 / 279001105

- PSU used across multiple lines, no field trend noted at this time, PIM follow up at next MTR

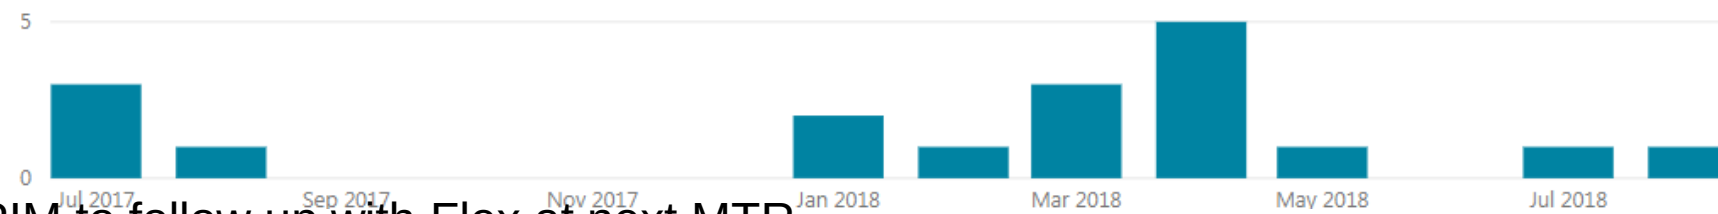
0-90 Day FSR count by DOM

- Carousel Carrier – WAT270928 / WAT271290

- Need to understand cause of recent failures, parts requested for return and analysis

- PIM to follow up with Flex at next MTR

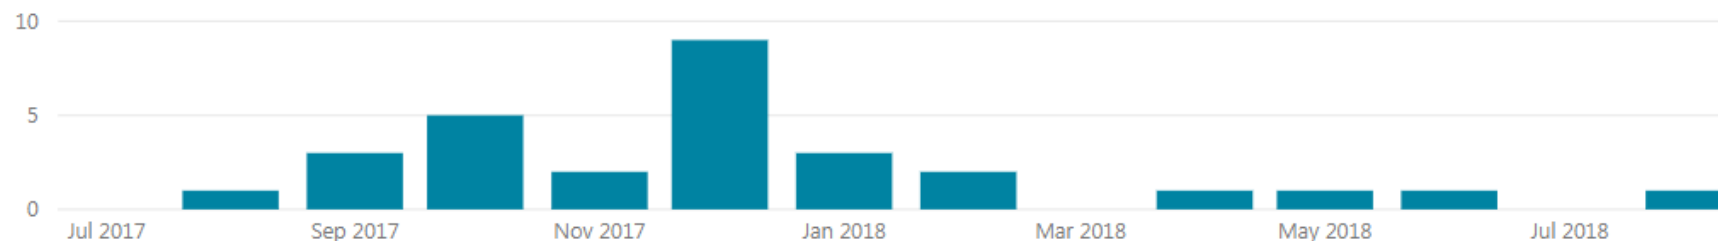
0-90 Day FSR count by DOM

- Alliance Actuators – 700001031 / 289000527

- Failure analysis in process in Milford, plunger homing faults & motor loss sync errors reported

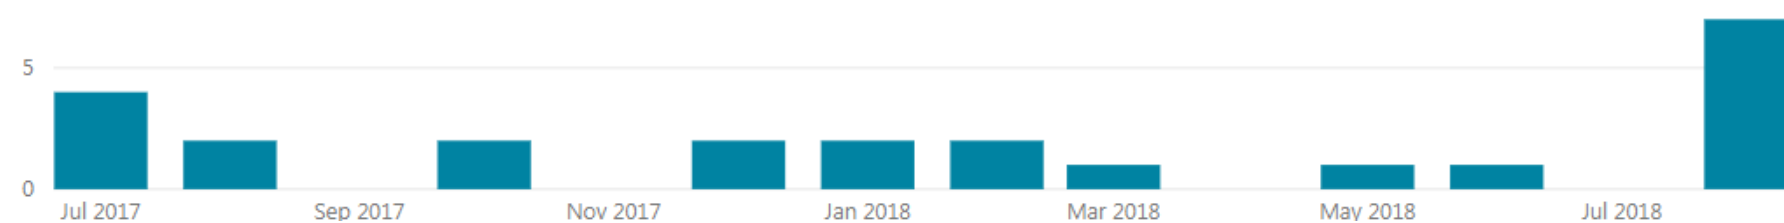
0-90 Day FSR count by DOM

- eAlliance CPU
  - Request Flex look into CPU usage during manufacture
  - Examine Flex Senai for any trends
