## WATERS Weekly FPY review (WW26 – 2018)

04 Jul 2018

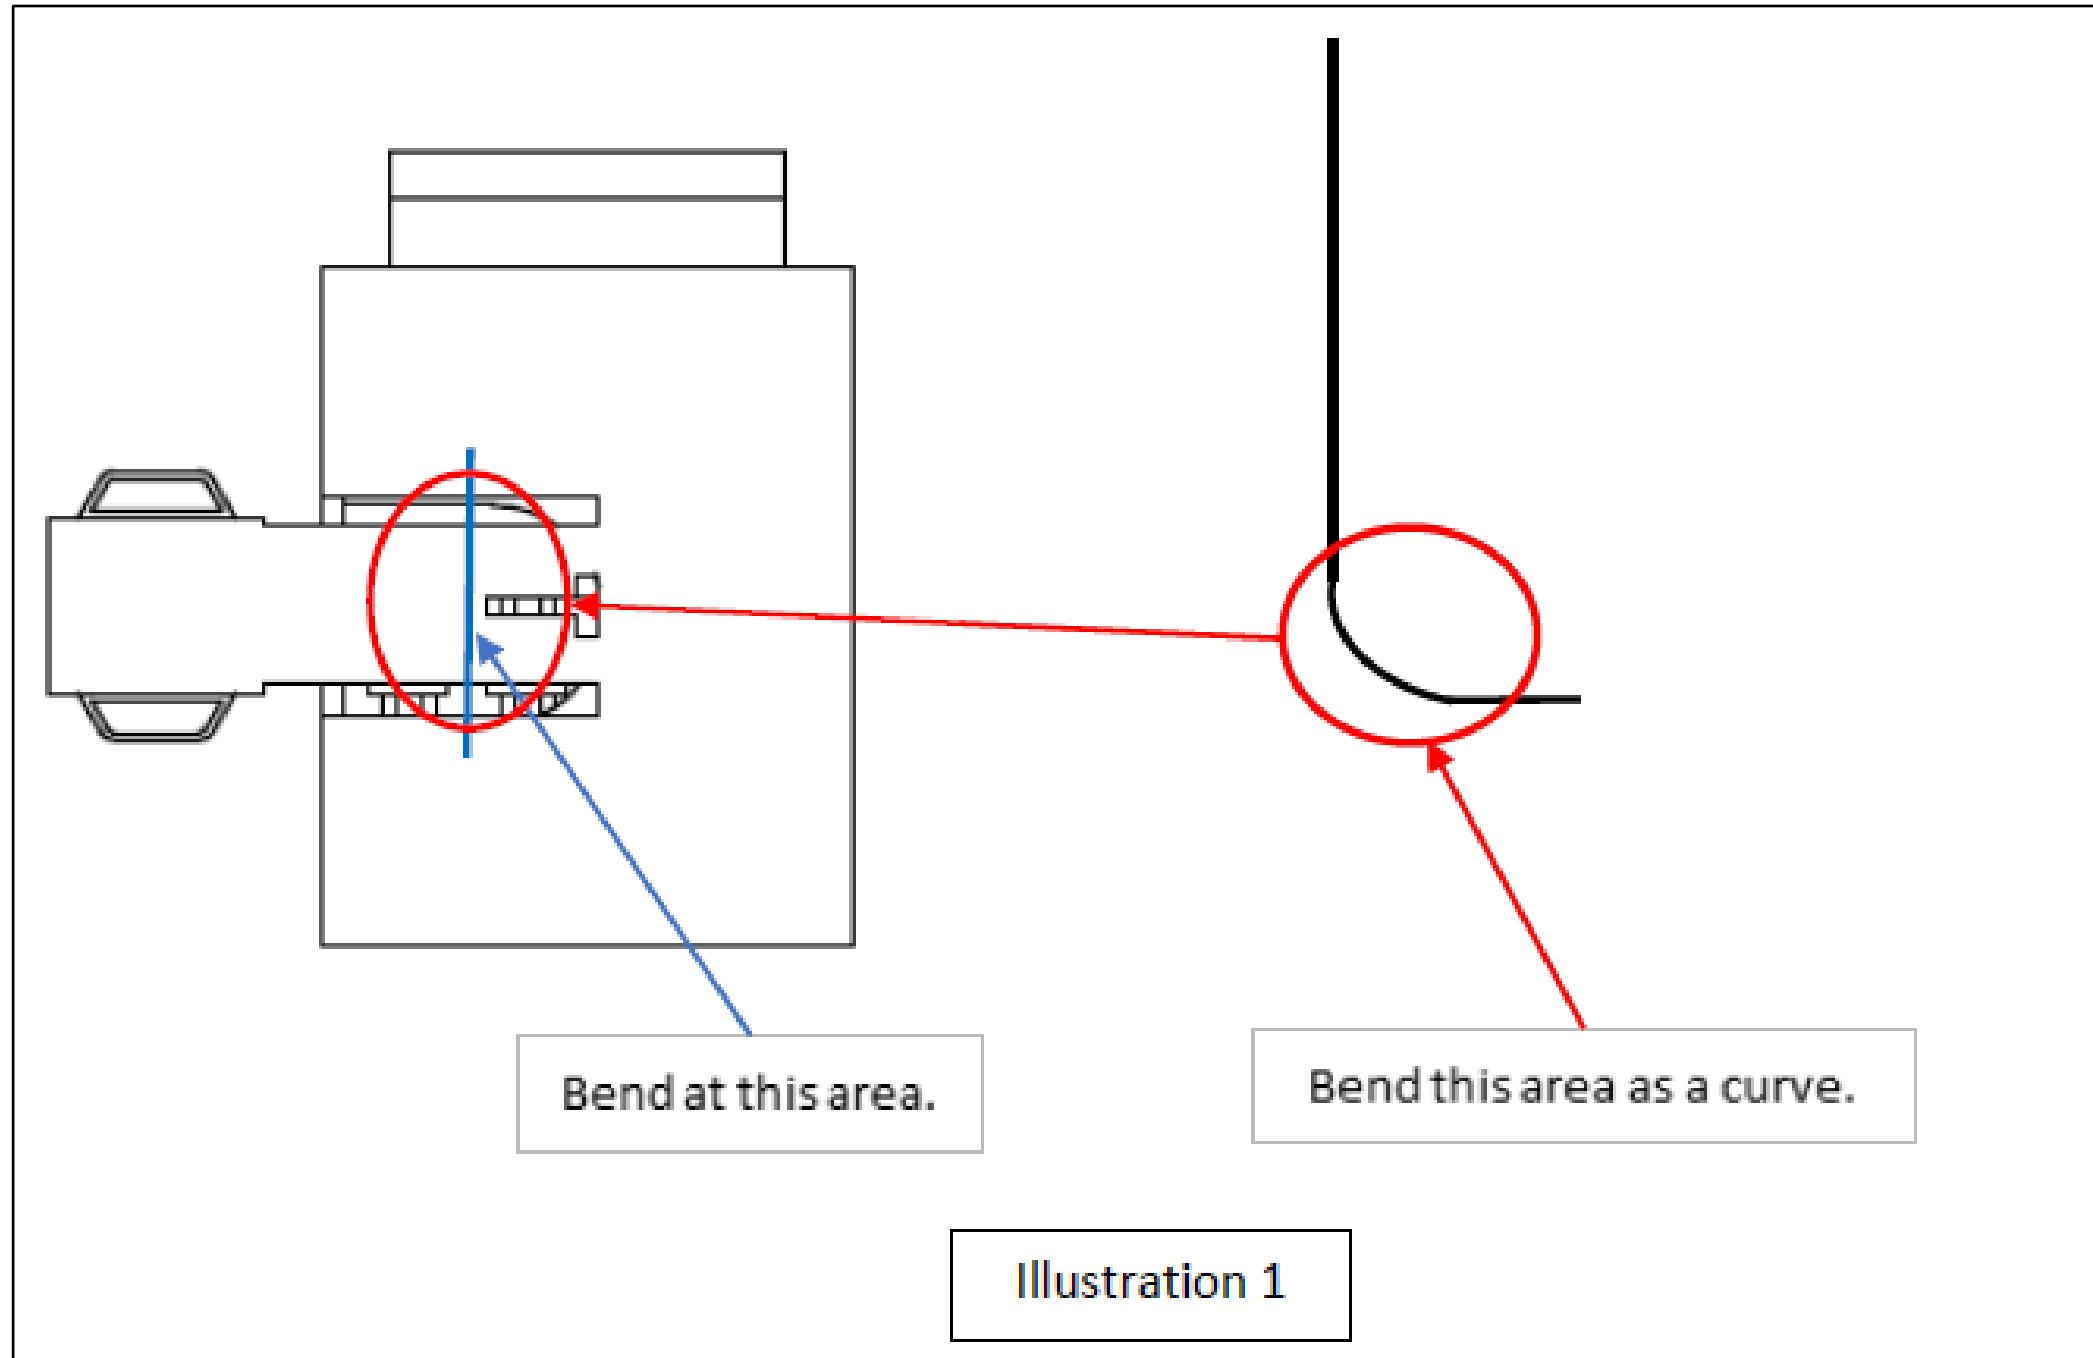
Customer request to study and improve on the bending method to increase strengthen of RJ Connector according to below illustration 1.

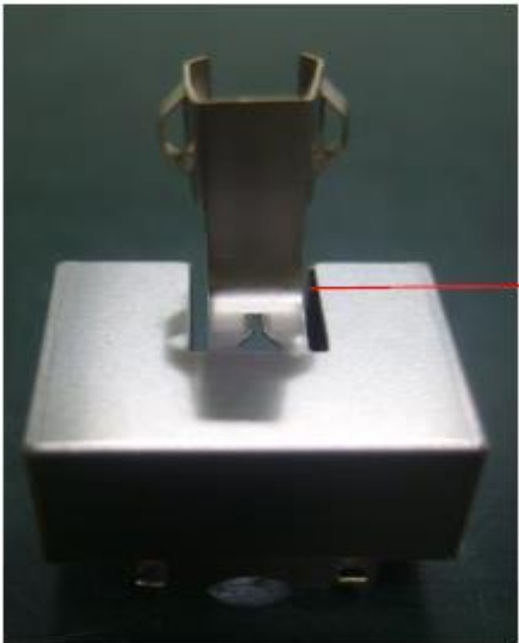
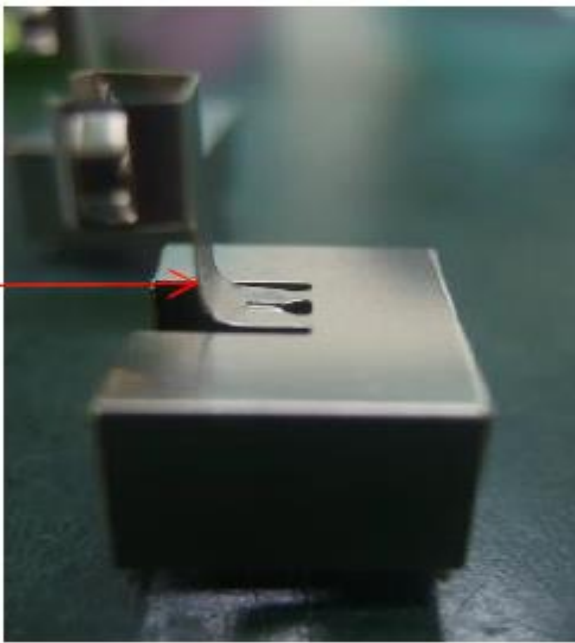
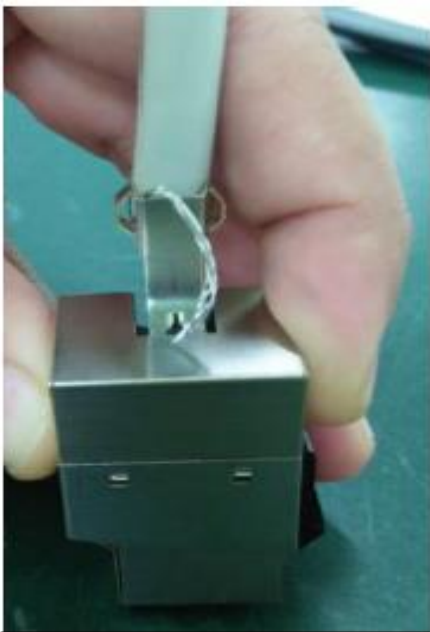
1. Simulation for bending condition as illustration 1 as below :

After assy in  
connector

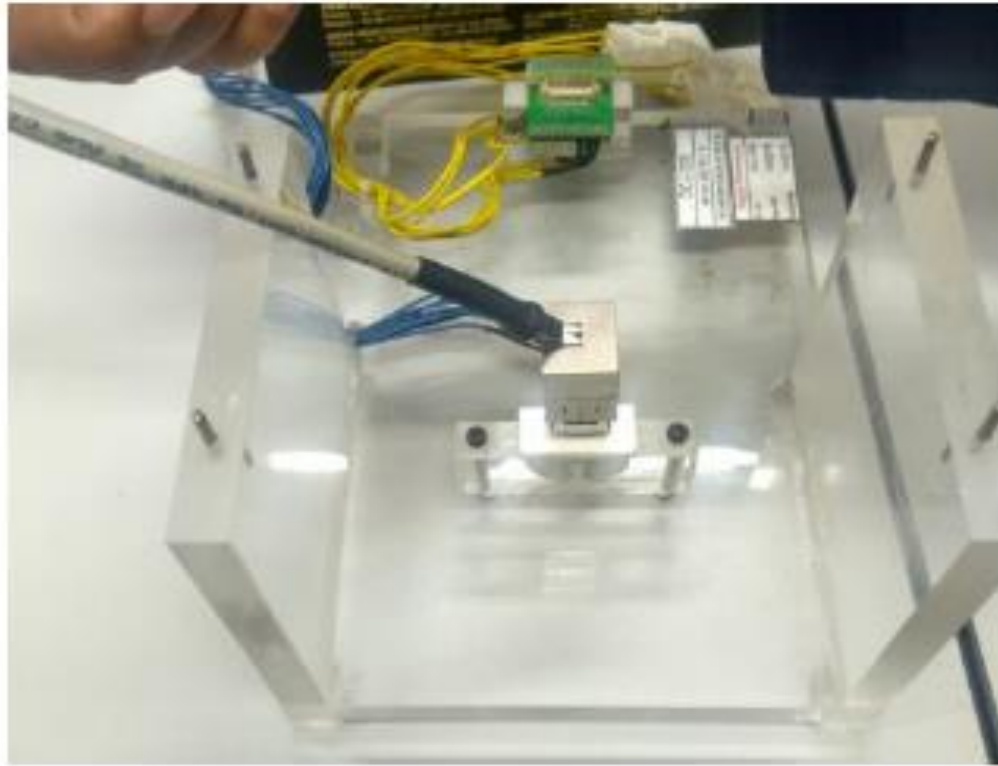
Current bend method

- ✓ Current bending method : Connector broken after 22 times bending
- ✓ Propose bending Method : Connector broken after 64 times bending

- There is no failure in Feb 2018 and Mar 2018 (Total > 600 instrument build)
- As the occurrence (Ethernet cable failing) is low and random, Flex does not recommend to go ahead with this change (Option A).
- Flex recommends to further monitor the yield and keeping this proposal as an option for future discussion.
