## WATERS Weekly FPY review (WW29 – 2018)

25 Jul 2018

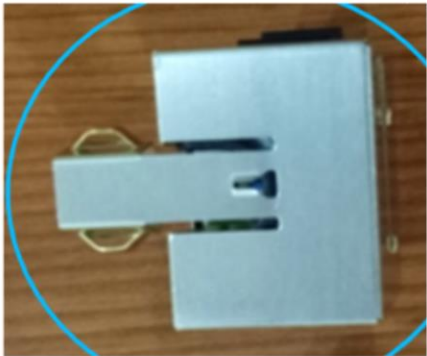
Raw part before bent

| Description | Owner | To complete by | Status |
|---|---|---|---|
| <div>2) Ethernet Cable (PN 441001280) – reopen this issue</div> <div><div><div>• Background: WW52 – one cable found damaged and failed Final Test.</div><div>• Proposal for improvement from CMTI – refer to next slides.</div><div>• 01 May: To jointly review if to go ahead with this proposal.</div><div>• 23 May: CMTi to provide samples.</div><div>• 04 Jul: 2 x samples received. To put up a PCN to WPPL for review.</div></div></div> | Flex | TBA | Open |

- WW52'18: one instrument (PN 186299800) failed Communication error. Investigation: after replace PN 441001280 (Ethernet Cable), the Instrument has passed.
- Further Investigation: it was found that the Grounding was broken (damaged)

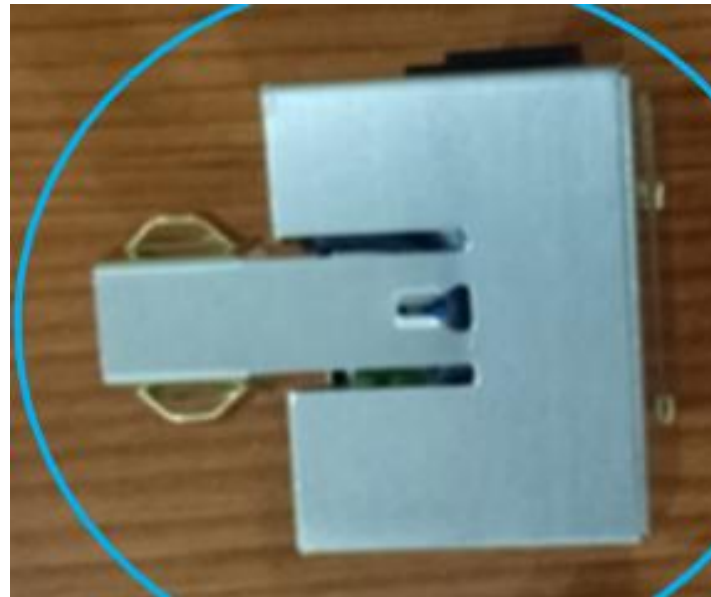
Raw part before bent

- CMTi reported that there is no failure reported at their outgoing since May 2017 (Qty tested: 9200 pcs)
- CMTi proposed to change the bending point.
- See Appendix A for more detail

- Option A – if we were to proceed with this change, CMTi will have to raise a PCN (Process Change Notice). A small qty for trail is proposed before implementation in mass production.
- Option B – no change is needed. Based on the performance the failure rate is relatively low.

- There is no failure in Feb 2018 and Mar 2018 (Total > 600 instrument build)
- As the occurrence (Ethernet cable failing) is low and random, Flex does not recommend to go ahead with this change (Option A).
- Flex recommends to further monitor the yield and keeping this proposal as an option for future discussion.

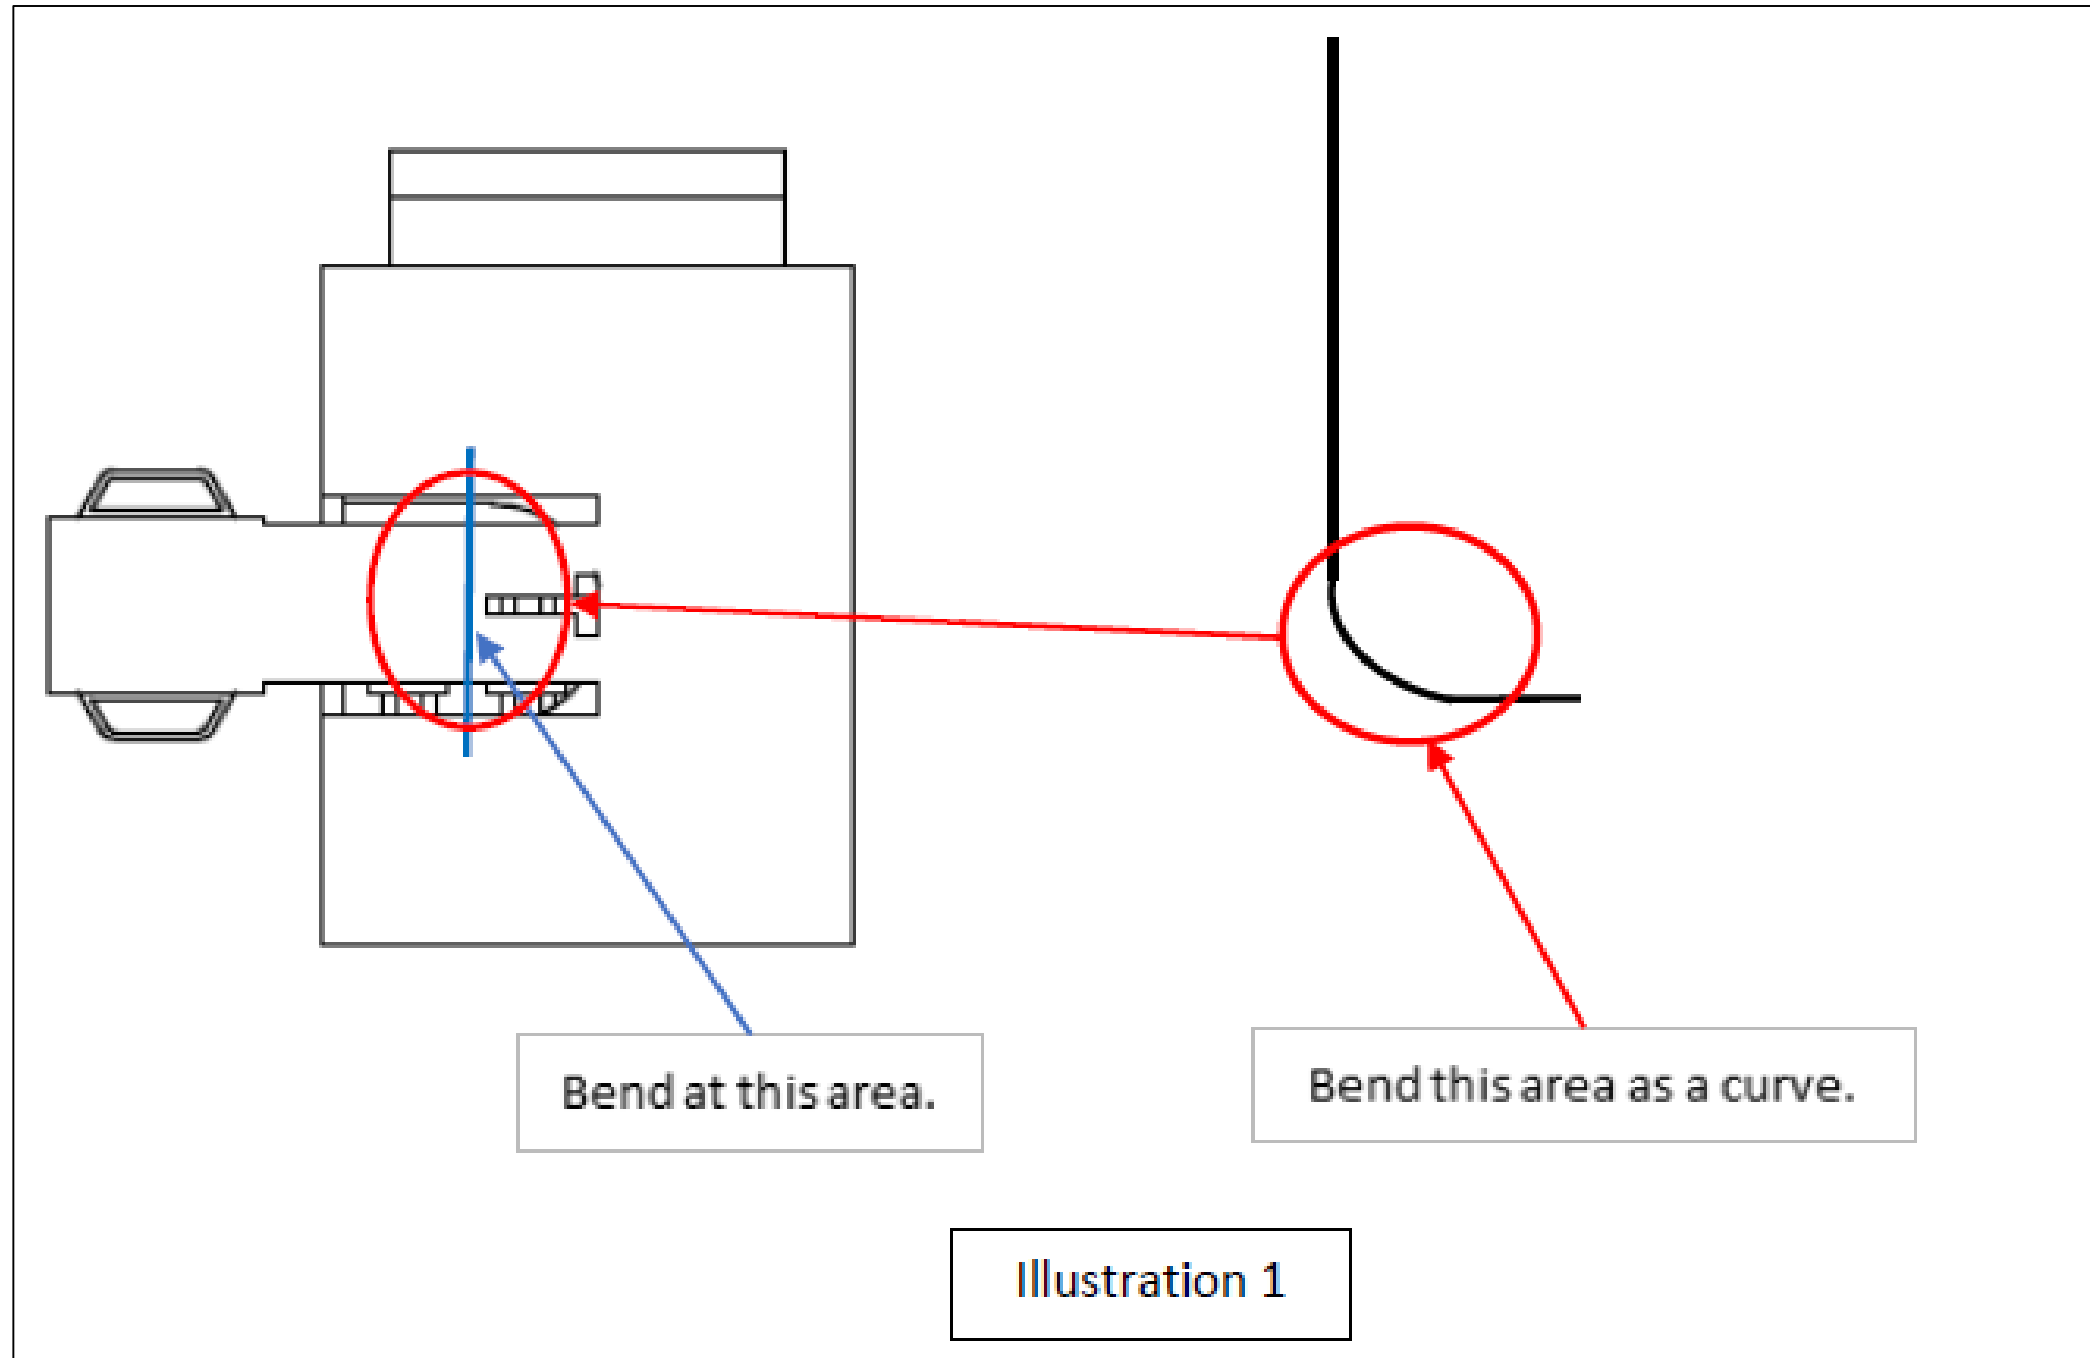
Customer request to study and improve on the bending method to increase strengthen of RJ Connector according to below illustration 1.

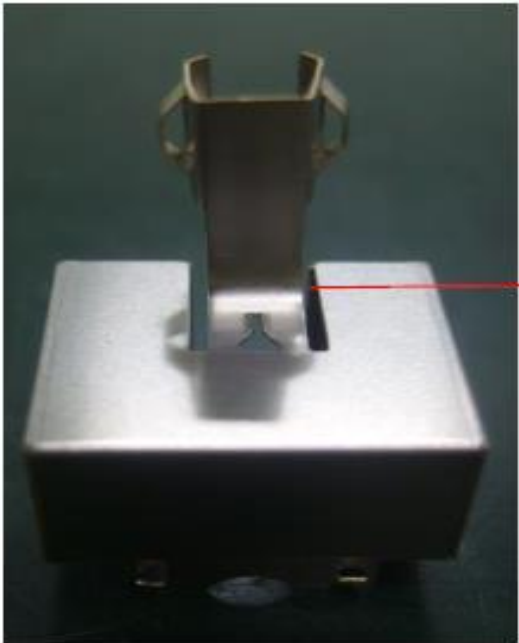
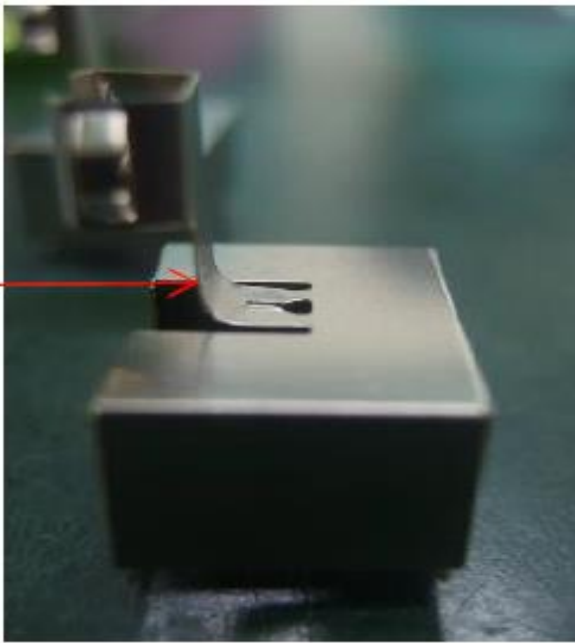
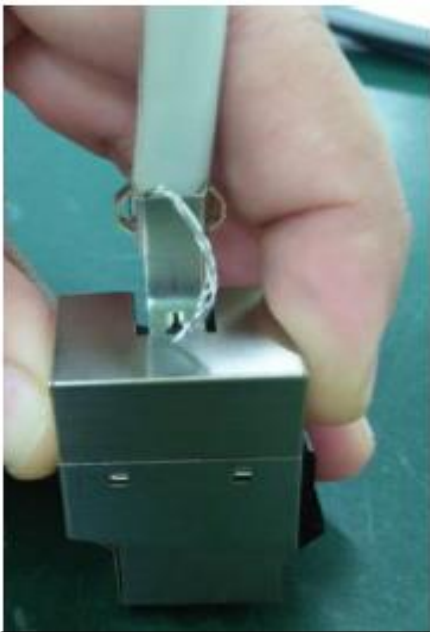
After assy in  
connector

1. Simulation for bending condition as illustration 1 as below :

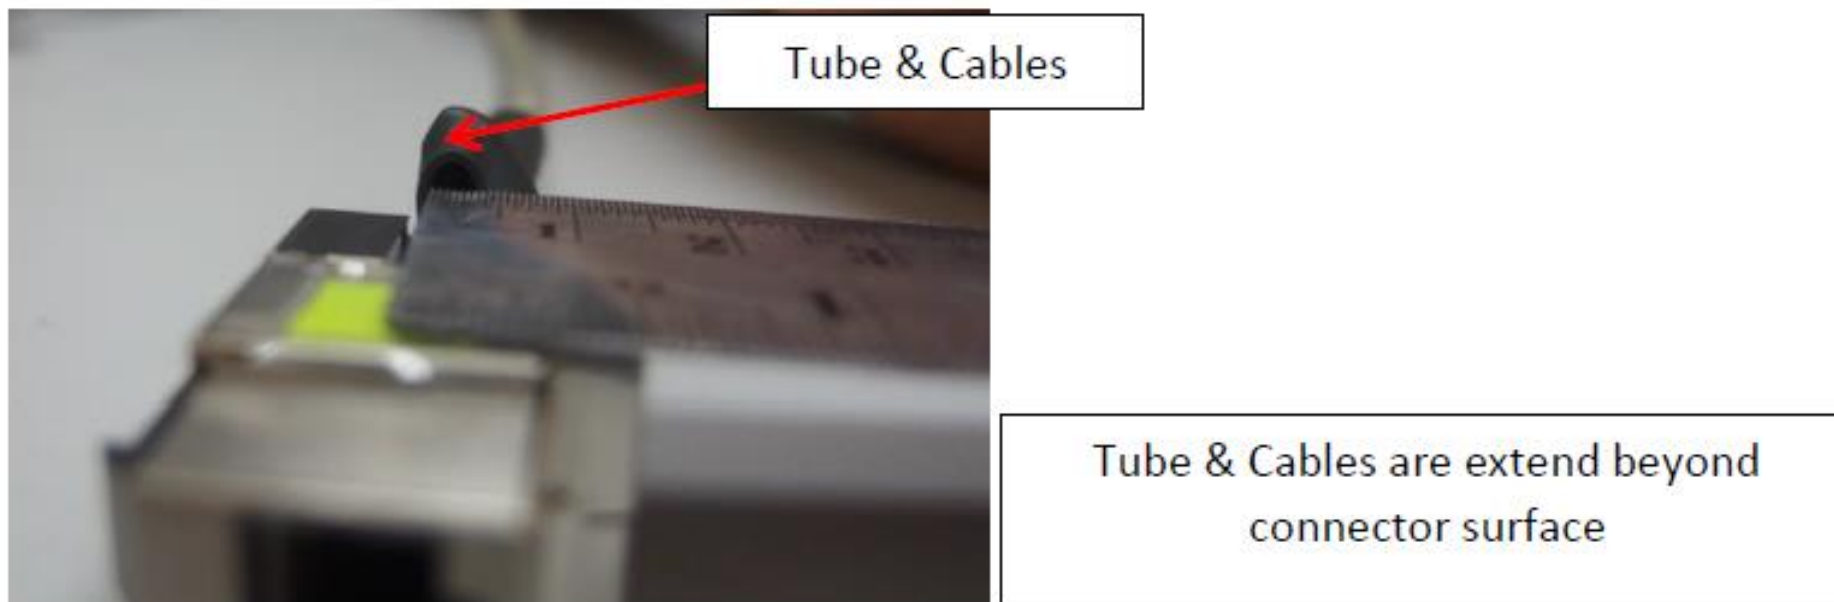
### Propose bending method

- ✓ Current bending method : Connector broken after 22 times bending
- ✓ Propose bending Method : Connector broken after 64 times bending

3. There's additional cutting process for shield wire before solder to metal shield

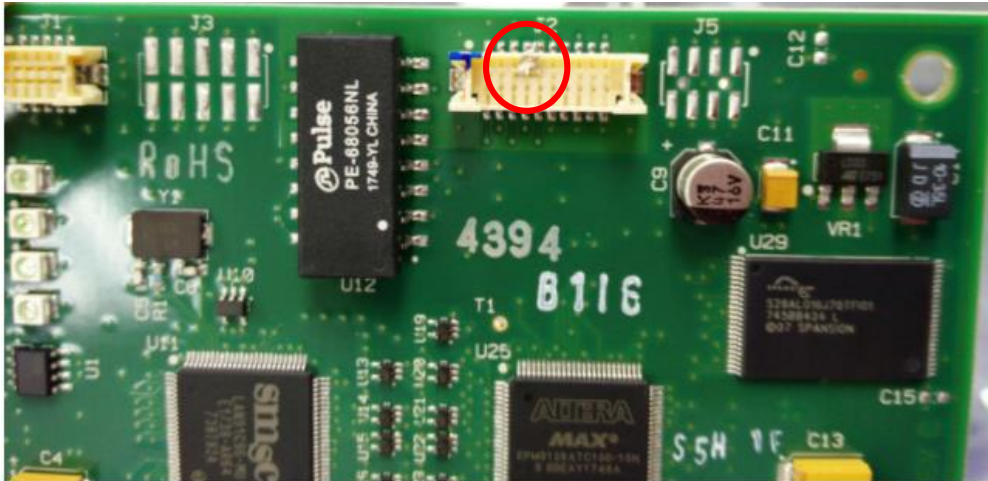
| Problem Statement | Investigation/<br>Possible Root Cause | Corrective Action/<br>Improvement |
|---|---|---|
| <p>Reported Date: 11 Apr 2018</p> <p>Instrument Part Number: 186248900<br/>Instrument SN: D1887E318A<br/>Affected Qty: 1u</p> <p>Problem: Solder residue found at socket pin (J2)</p> <p>Date of Manufactured: Apr 2018</p> <p>Reported site: Flex Kallang</p> | <p><b>Investigation:</b><br/>On 11 Apr: Technician visual checked all Connections – no visual issue.</p> <p><b>Containment Actions:</b><br/>On 11 Apr, Technician replaced one PCB, CPU (PN: 210000520), from SN 160318582C to SN 160318221C.<br/>Retest Instrument – passed.<br/>Defective part transferred to Non Conformance Area<br/>Performed by: Technician (842185)</p> <p>The Defective part is to be RTV to Supplier.<br/>PCB, CPU Supplier: CEI LIMITED</p> <p><b>Root Cause</b><br/>It is confirmed that the Defective part has caused the Instrument to fail Final Test as per stated in the Problem Statement.</p> | <p><b>Corrective Action:</b><br/>Flex Kallang: NA</p> <p>Supplier:<br/>RMA 25918 received on 4 May 18.<br/>30 May 18 board collected by supplier. FA sent 04 July, board repaired and pending to send back to Flex.</p> |
