## **WATERS Weekly FPY review (WW34 – 2018)**

29 Aug 2018

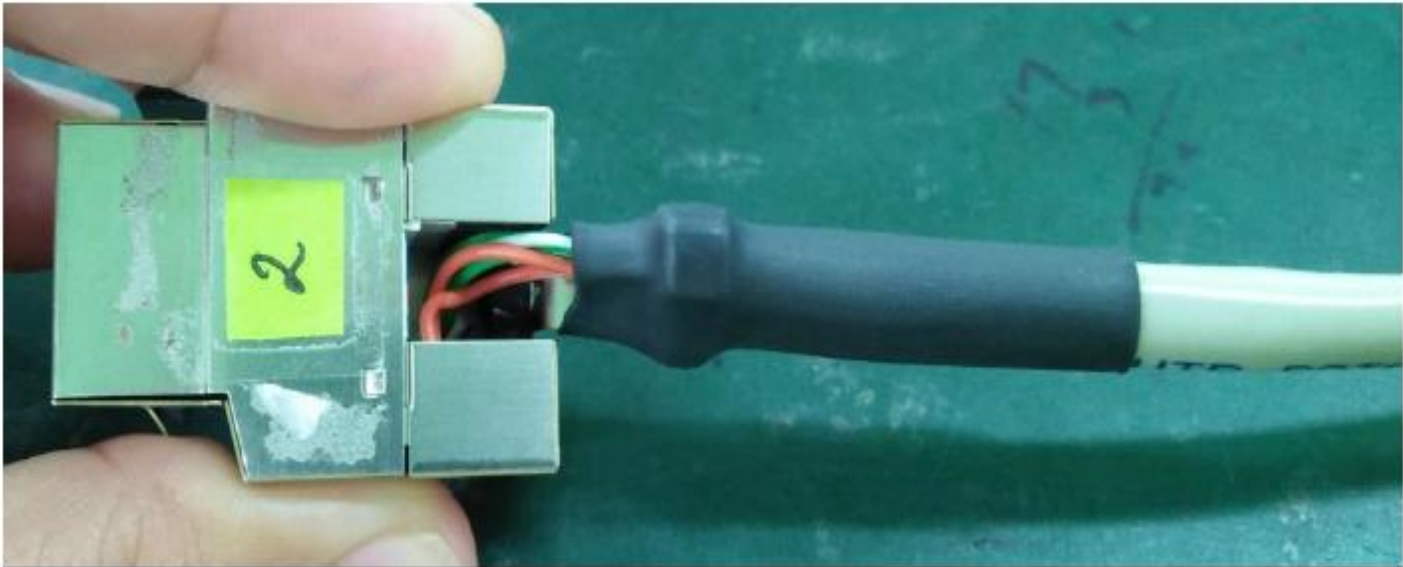
Overall condition of simulation part

- ✓ Current bending method : Connector broken after 22 times bending
- ✓ Propose bending Method : Connector broken after 64 times bending
