## WATERS Weekly FPY review (WW47 – 2018)

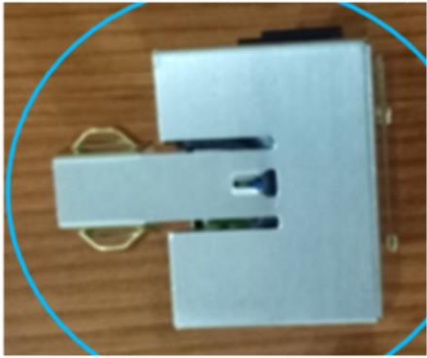
Raw part before bent

| Description | Owner | To complete by | Status |
|---|---|---|---|
| <p>2) Ethernet Cable (PN 441001280) – reopen this issue</p> <ul style="list-style-type: none"><li>• Background: WW52 – one cable found damaged and failed Final Test.</li><li>• Proposal for improvement from CMTi – refer to next slides.</li><li>• 01 May: To jointly review if to go ahead with this proposal.</li><li>• 23 May: CMTi to provide samples.</li><li>• 04 Jul: 2 x samples received. To put up a PCN to WPPL for review.</li><li>• 28 Aug: PCN submitted for WPPL review.</li><li>• 08 Oct: PCN approved by WPPL.</li><li>• 23 Oct: Flex working with CMTi on implementation</li><li>• 27 Nov: CMTi expected to implement end Dec 2018.</li></ul> | Flex / WPPL | TBA | Open |

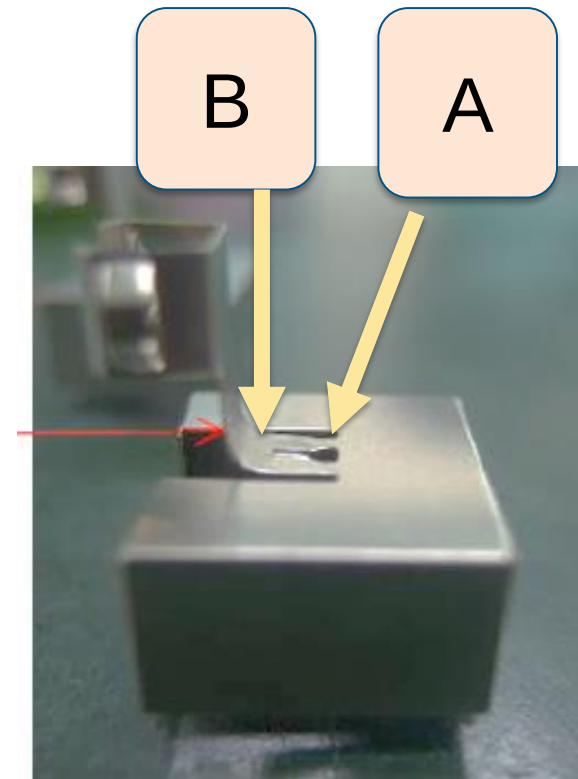
A – current bending point  
B – proposed bending point

Customer request to study and improve on the bending method to increase strengthen of RJ Connector according to below illustration 1.

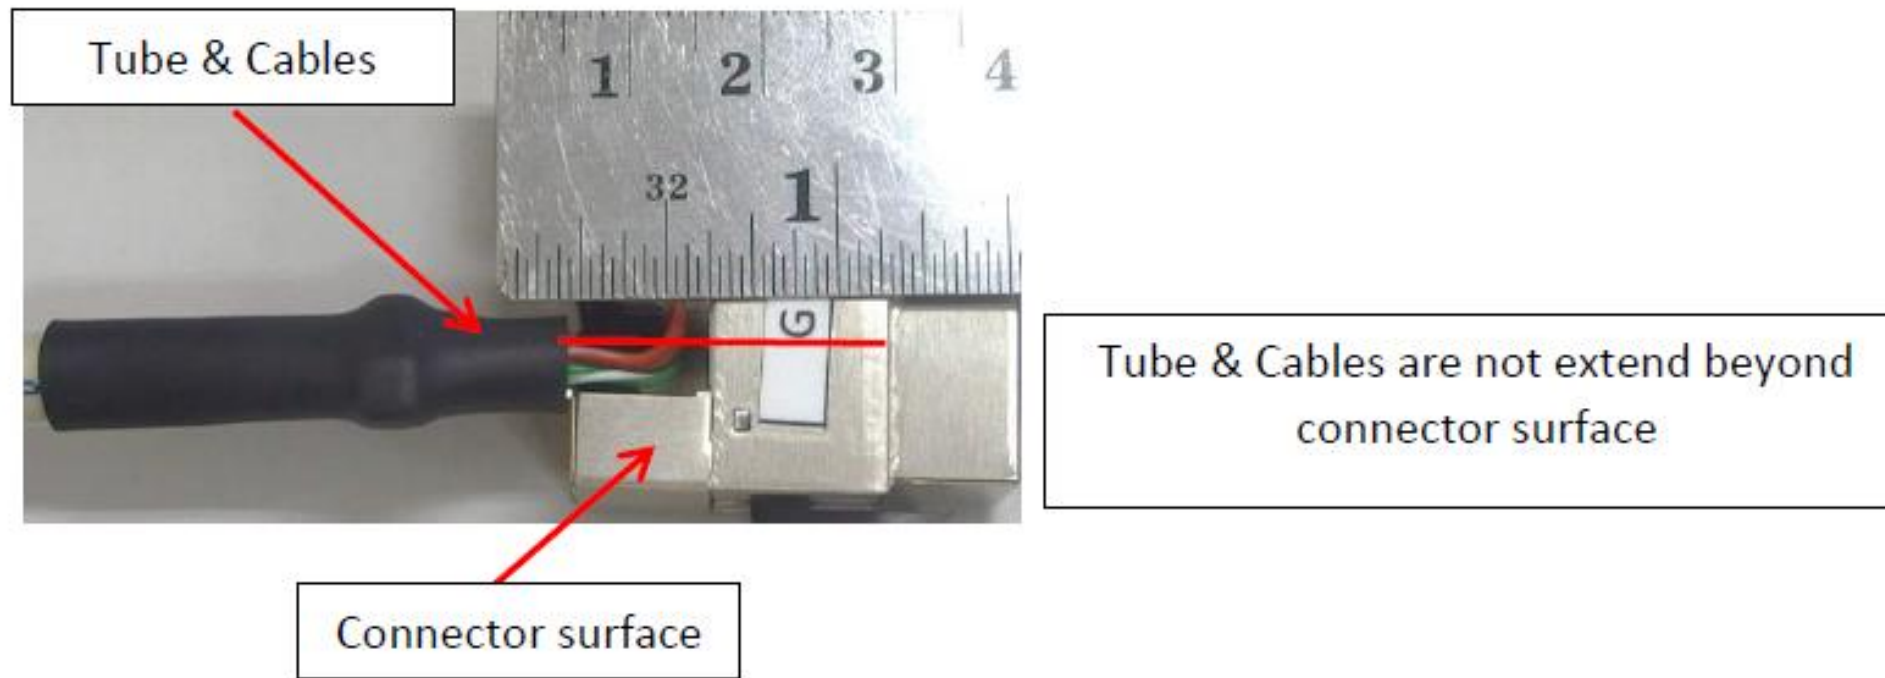
### Current bending method

1. Propose bending method strength result is better than current bending method
2. Cable position of propose bending method is out of connector surface (refer to below picture for comparison)

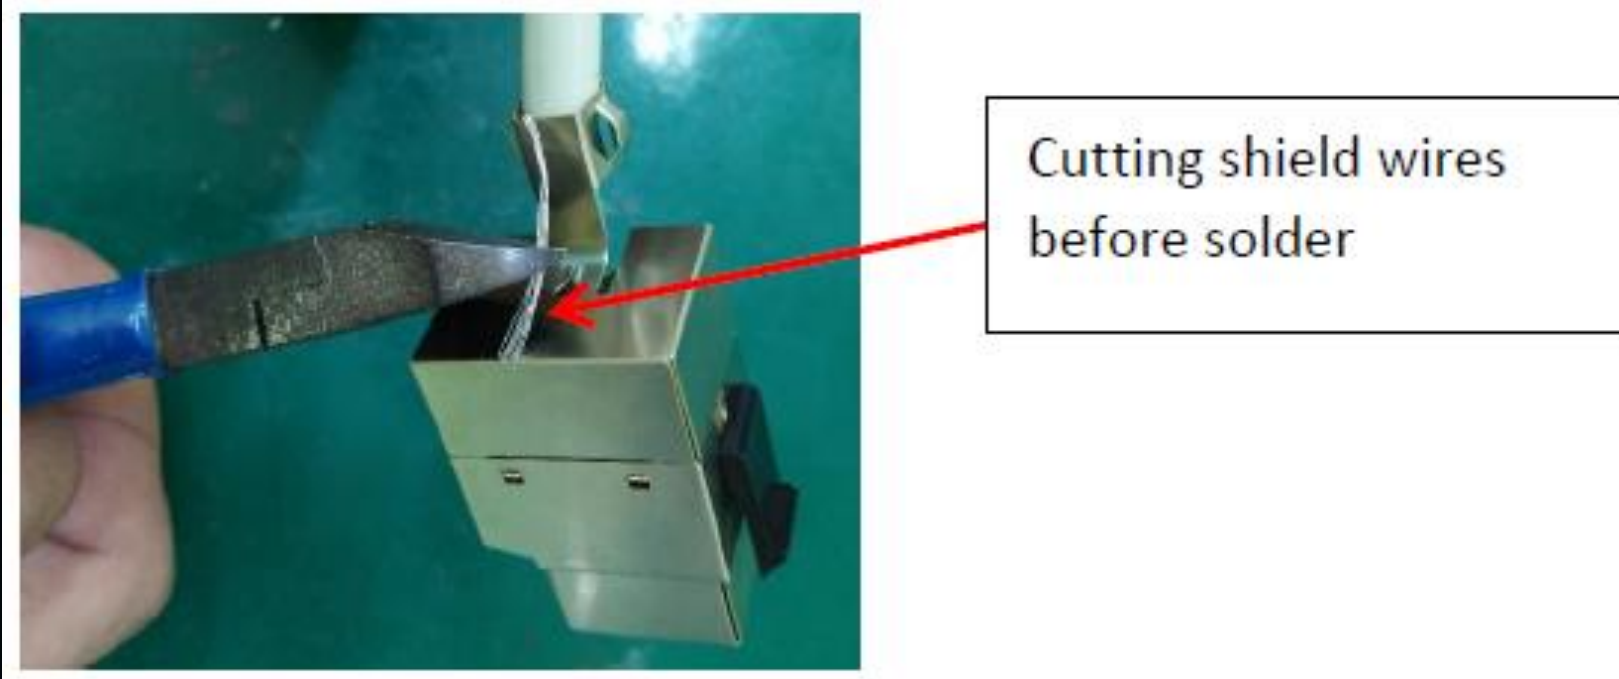
There's additional cutting process for shield wire before solder to metal shield

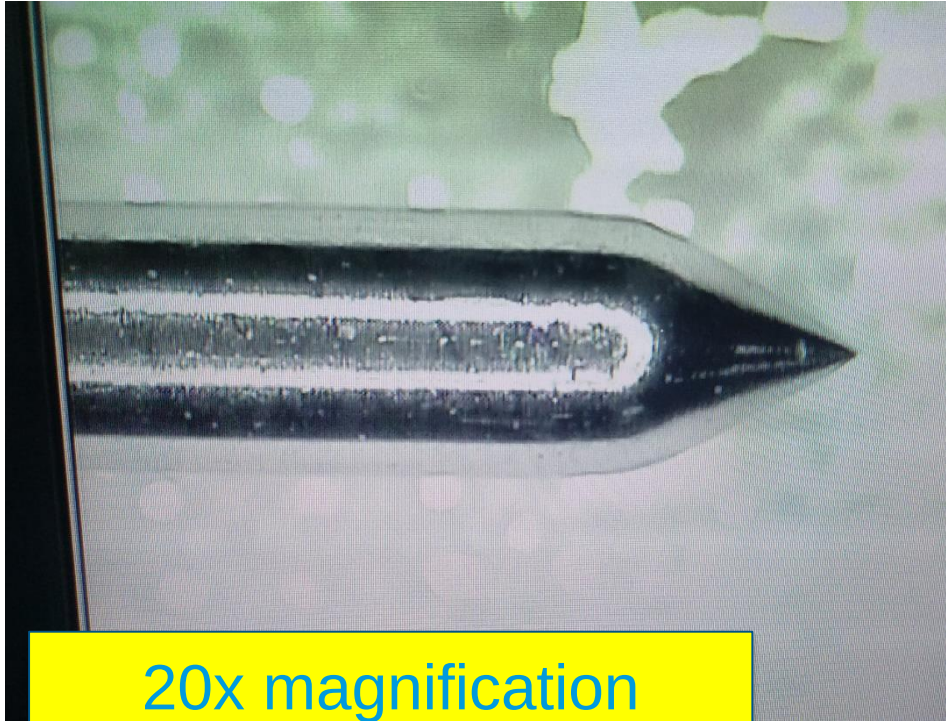
- For the 3 x passed needles samples, to use 20x magnification for inspection (to check for pit and scratches)

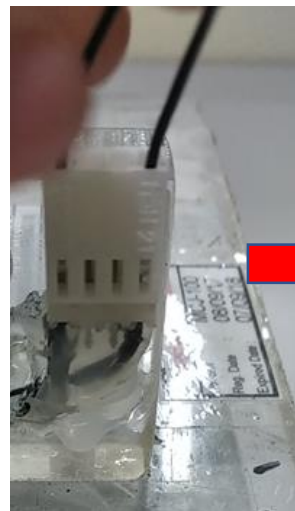
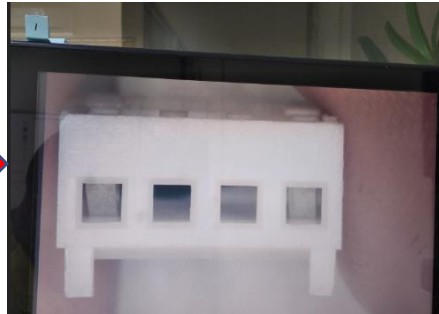
1<sup>st</sup> simulation result

**Simulation result for 5X plug into Mating jig. Result : NO Deformation terminal cause by mating jig (100% continuity test conducted by factory)**

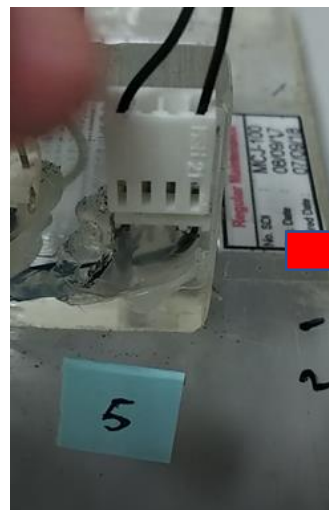
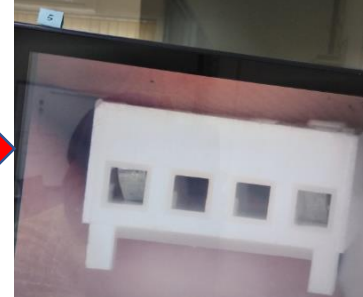
5<sup>th</sup> simulation result

WW31 to 34 – no failure. To move to Monitoring.

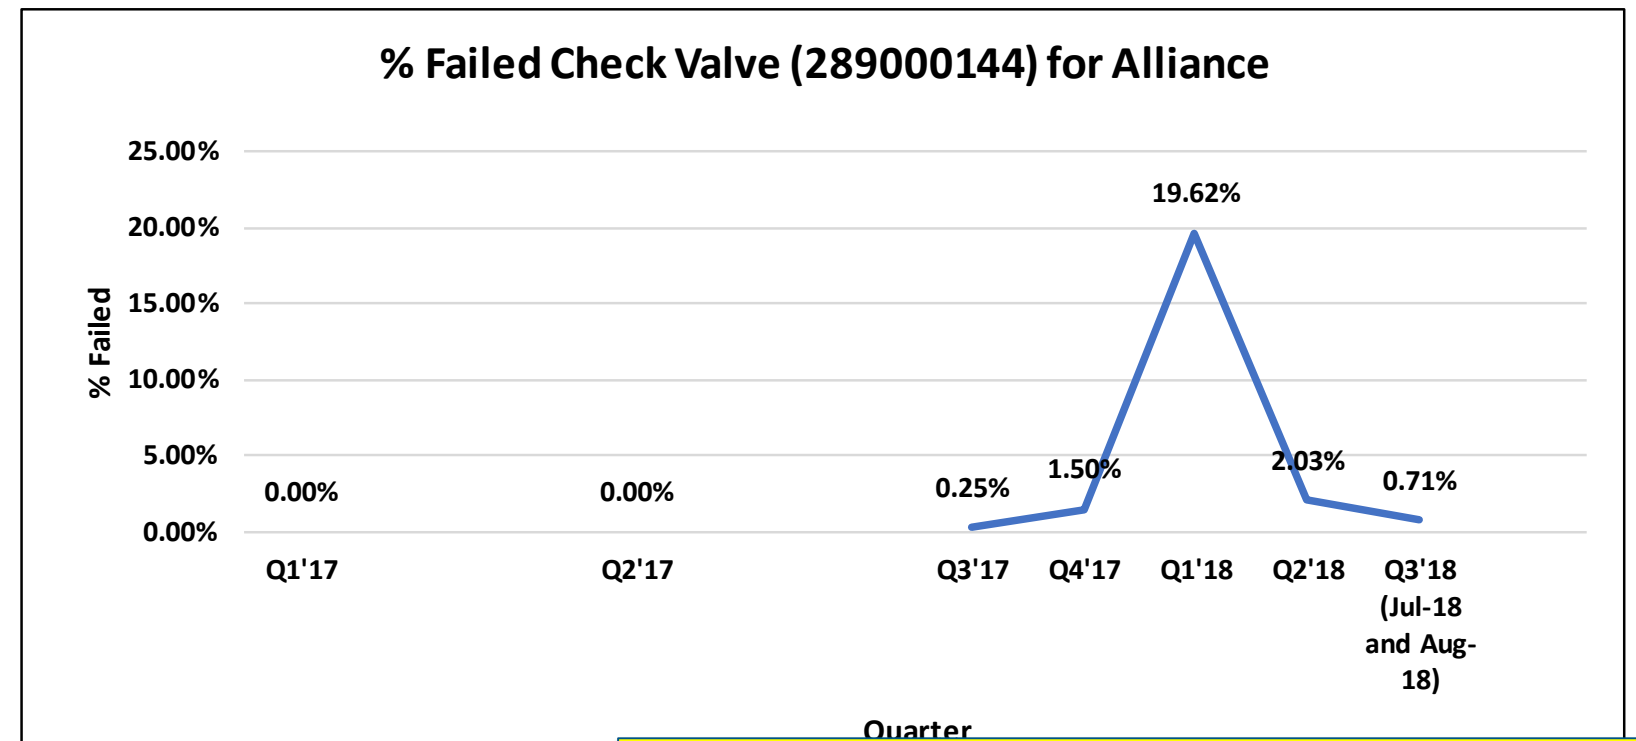
WW30 to Ww33 – no failure.  
Move issue to Monitoring
