**Selected Alliance Error Codes**

Waters

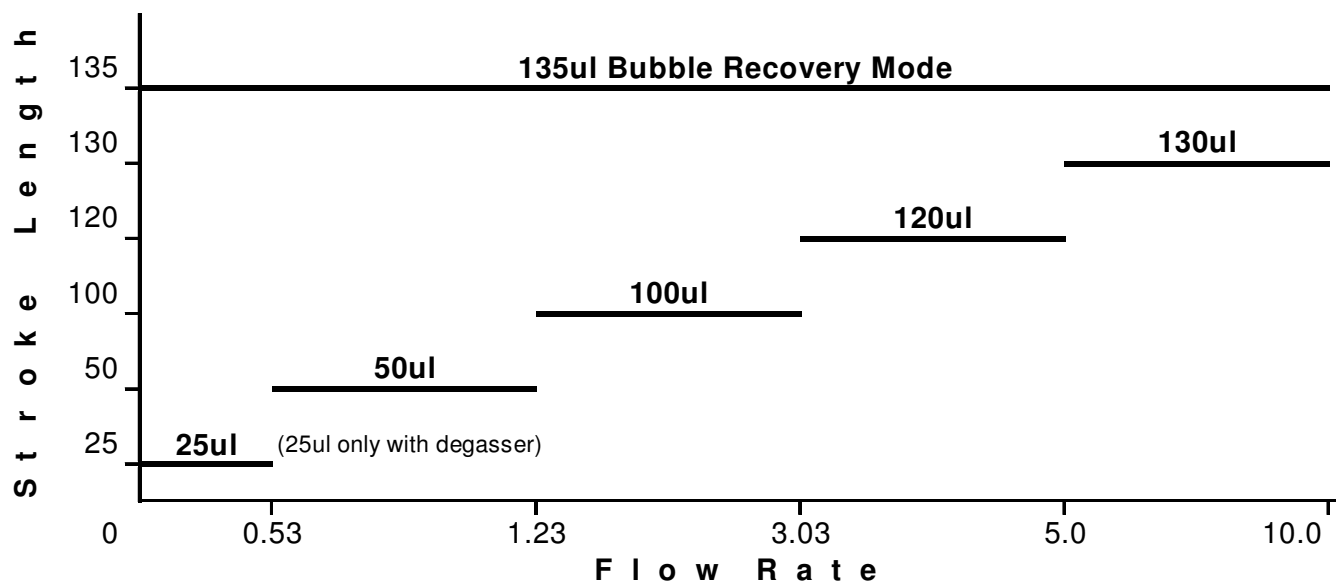
A solvent line with C/D ratios at 1.8 or above should be targeted to determine failure. It can be any fluidic path component failure for those specific solvent lines with elevated C/D ratios. Including improperly primed solvent lines, restricted solvent sink filters, solvent tube failure, loose fittings to/from degasser chambers, inefficient degasser chambers, and GPV leakage.

If all the solvent lines have elevated C/D ratios then the problem is most likely do to some component in common with all the solvent lines. Targeting the tubing connections at the output of the GPV, GPV outlet tubing connections, primary inlet check valve, check valve housing tightness, Primary Head Plunger Seal, Primary Head Face Seals, head and head nut tightness could also be suspect to cause this failure.

Rather than allowing the system to drive the plungers in the "auto" mode, bubbles may be more effectively cleared by forcing the system to operate with a stroke length of 100  $\mu$ L.
