## Waters Overall Account Update

27 Apr 2020

# Yield Improvement – Interface Tubing

**Project Title :** Yield Improvement – Interface Tubing Replacement (Soft Failure)

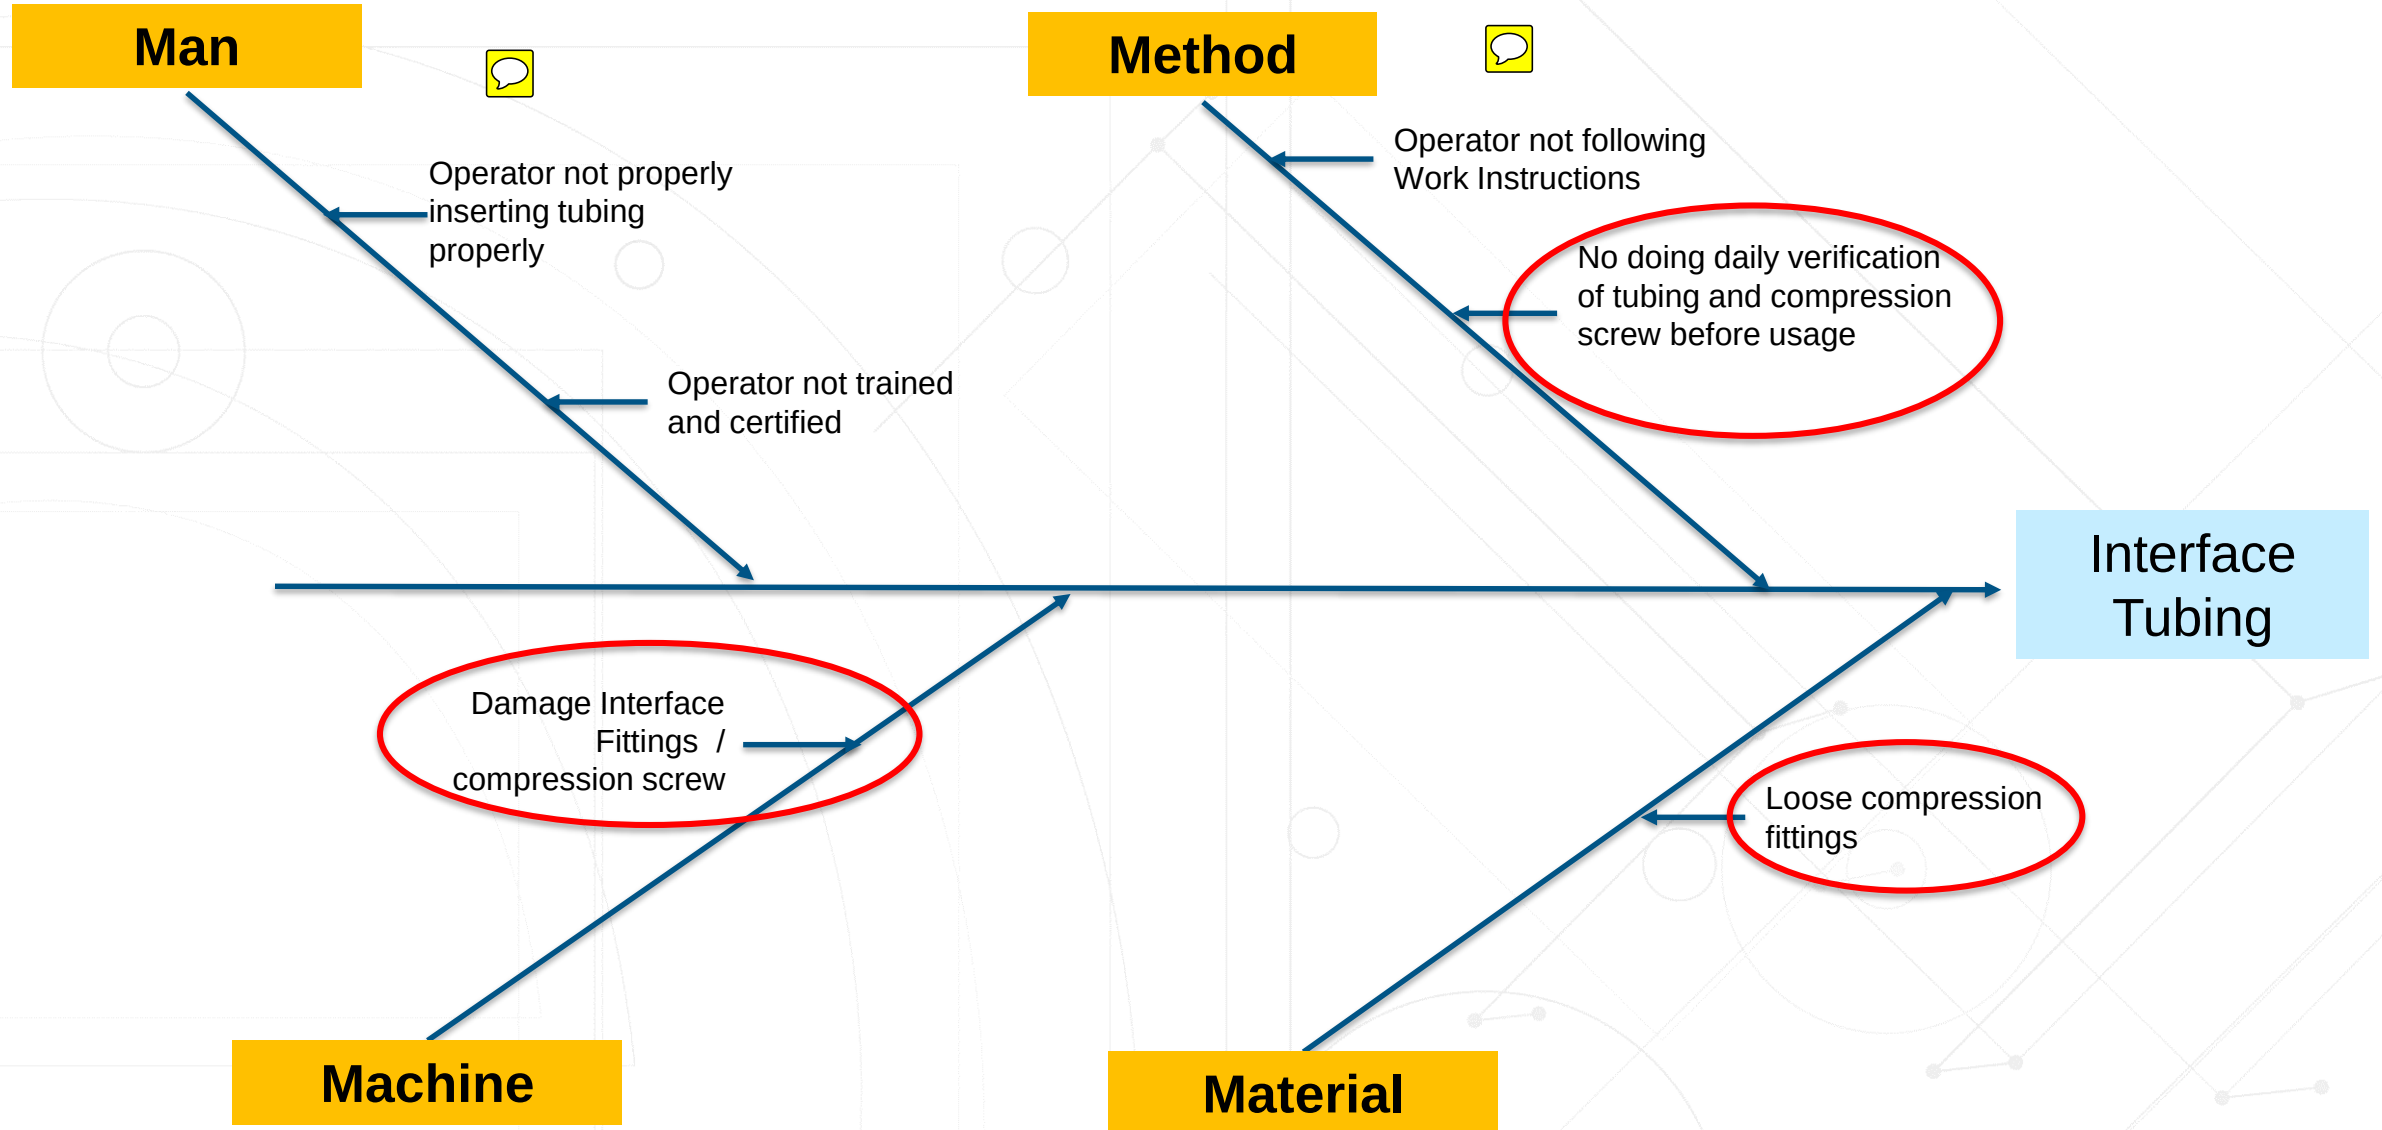
# Yield Improvement – Interface Tubing Replacement

## Possible Cause:

### When Interface tubing need replacement?

- Before Test – need to check the physical attribute of interface tubing such as damaged tip or loose compression screw
- Middle of Test - need to perform priming or verification of leak close to the interface tubing fittings and found to have leak.
- After Test - need to perform priming or verification of leak close to the interface tubing fittings and found to have leak.
- Tester wise or number of UUT run to the tester

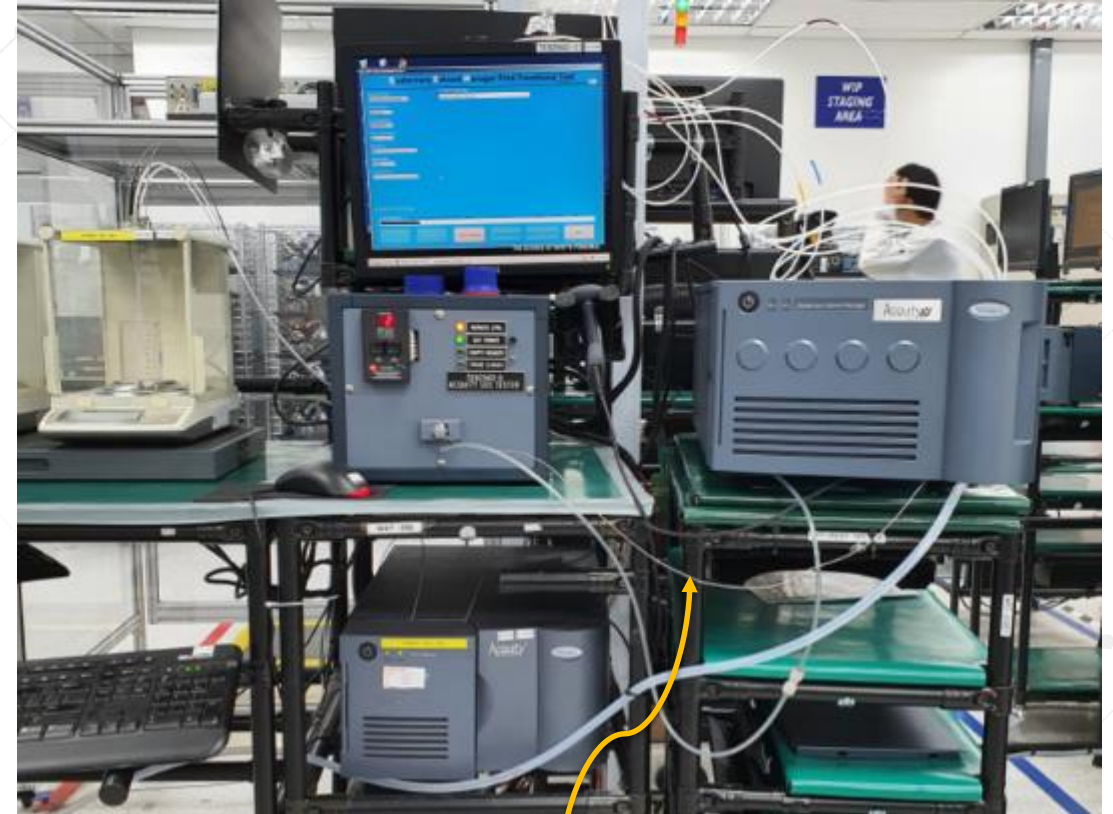
430001150 Interface tubing

Defect observed before replacement :

| | Possible Causes | Verification | Possible cause (Y/ N) | Proposed Actions |
|---|---|---|---|---|
| <b>Machine</b> | Damaged Interface Tubing due to wear and tear. | Verified the interface tubing and shown wear and tear | Y | To perform daily task by Test EA as below before release tester to production |

| Action Item | Who | Due Date | Actual Date | % Completed |
|---|---|---|---|---|
| 1. Before Test – need to check the physical attribute of interface tubing such as damaged tip or loose compression screw | Line Tech'n | 30 Jun 2020 | TBD | |
| 2. Middle of Test - need to perform priming or verification of leak close to the interface tubing fittings and found to have leak | Line Tech'n | 30 Jun 2020 | TBD | |
| 3. After Test - need to perform priming or verification of leak close to the interface tubing fittings and found to have leak. | Line Tech'n | 30 Jun 2020 | TBD | |
