## Waters Overall Account Update

06 May 2020

# Yield Improvement – Communication Failure

**Project Title :** Yield Improvement – Communication Failure

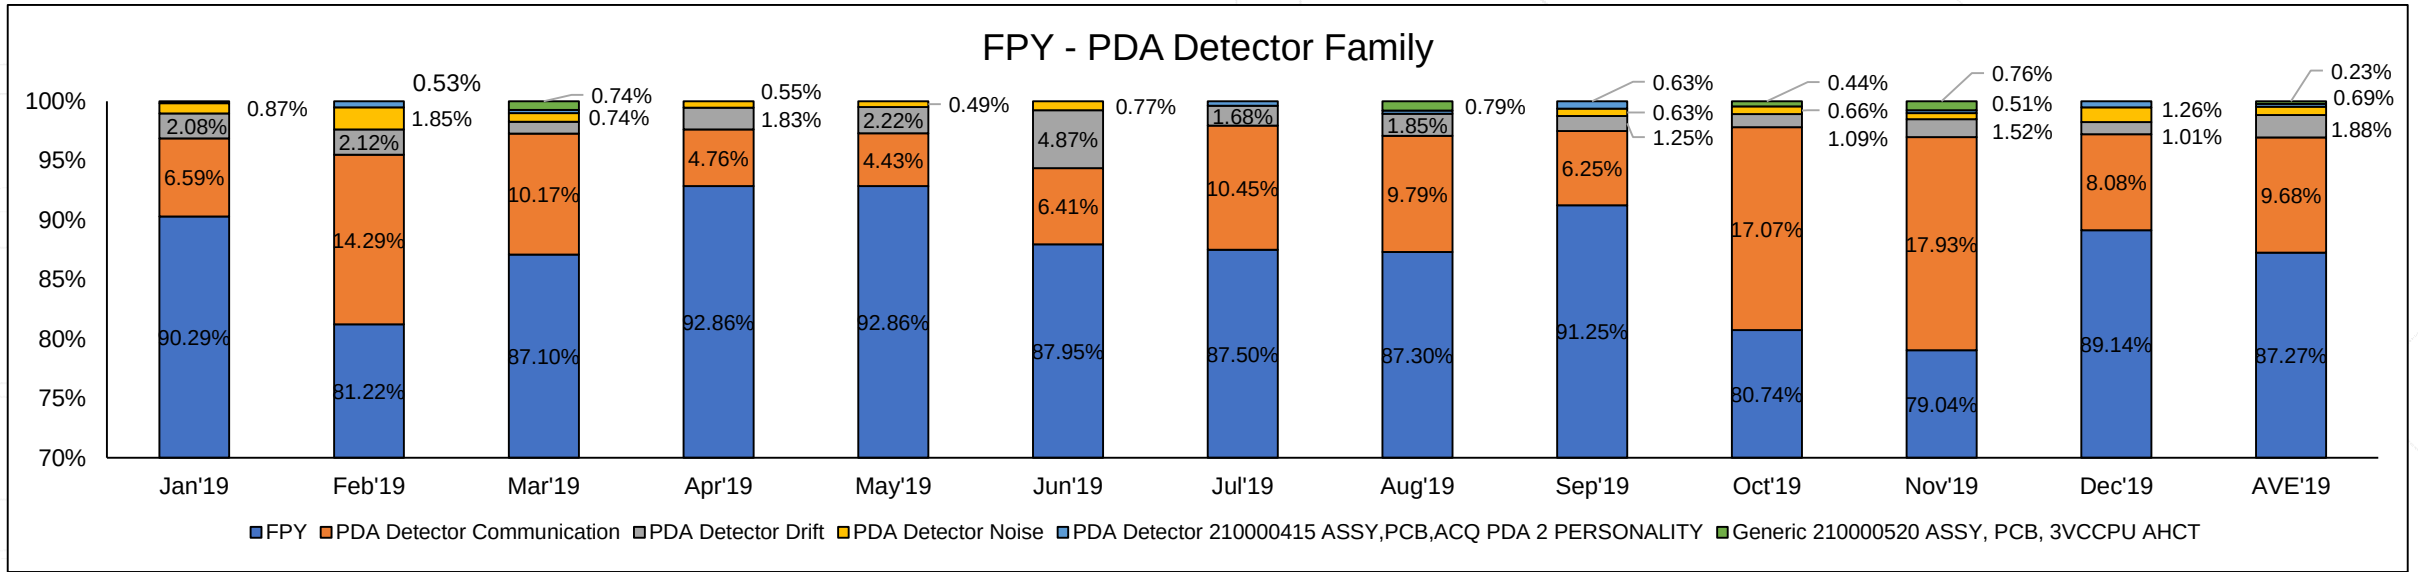
# FPY – PDA Detector Family

| | Jan'19 | Feb'19 | Mar'19 | Apr'19 | May'19 | Jun'19 | Jul'19 | Aug'19 | Sep'19 | Oct'19 | Nov'19 | Dec'19 | AVE'19 |
|---|---|---|---|---|---|---|---|---|---|---|---|---|---|
| <b>FPY</b> | <b>90.29%</b> | <b>81.22%</b> | <b>87.10%</b> | <b>92.86%</b> | <b>92.86%</b> | <b>87.95%</b> | <b>87.50%</b> | <b>87.30%</b> | <b>91.25%</b> | <b>80.74%</b> | <b>79.04%</b> | <b>89.14%</b> | <b>87.27%</b> |

★ Communication Failure – Team to focus on this Soft Failure  
Hard Failure such as part is low thus team to monitor through FPY

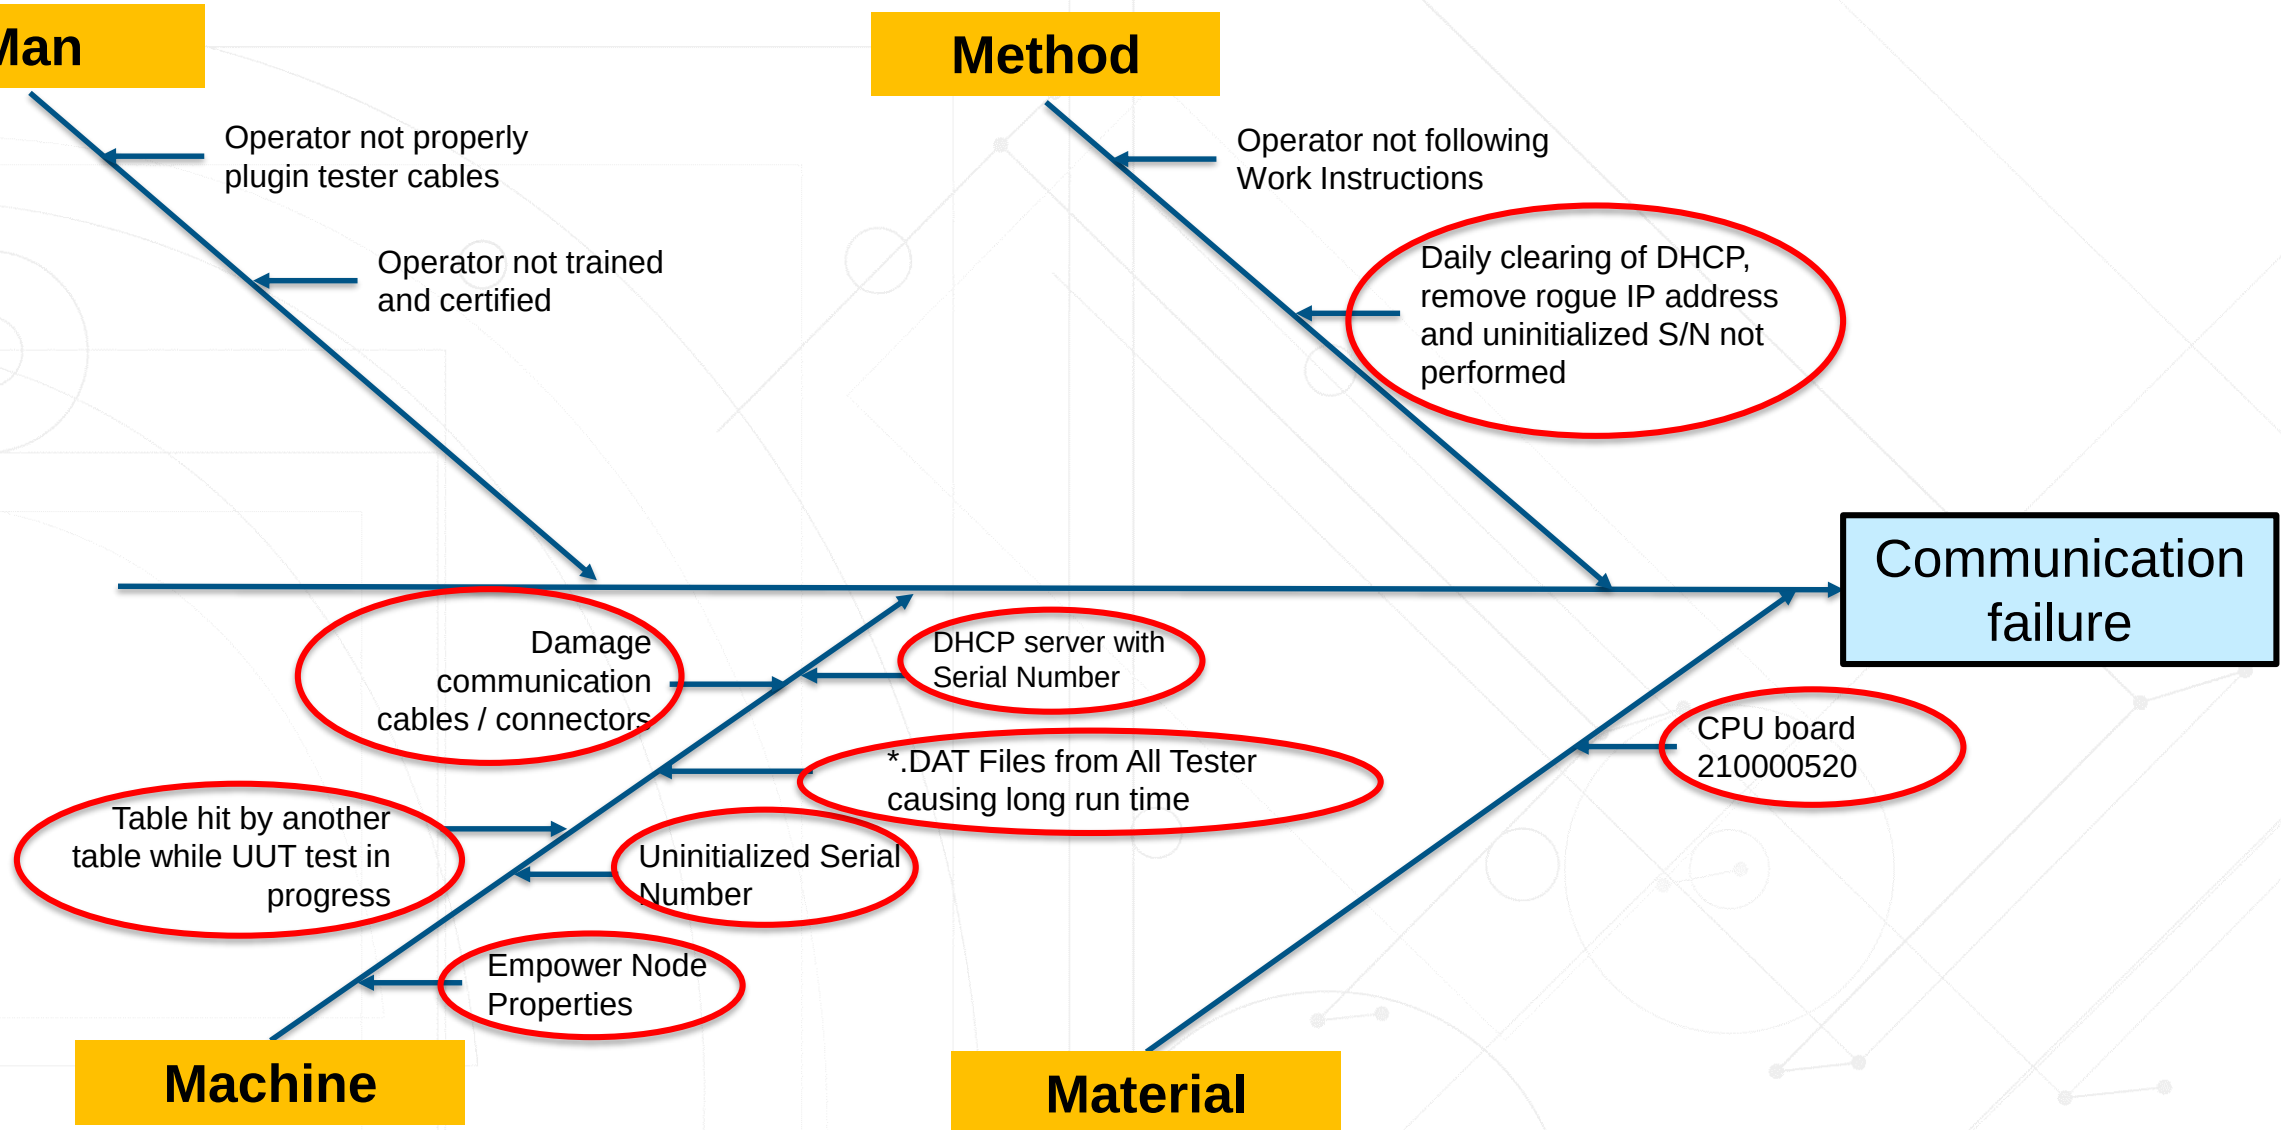
# Yield Improvement – Communication Failure 4M

- Test Tech'n \ Operator did not do daily clearing of DHCP, remove rogue IP address and uninitialized S/N not performed
- There's defective CPU board 210000520
- TE82882 have defective Ethernet\RS232 interface headers.
- Empower Node have conflict of settings. additional units.
- Disturb units under test by inserting new UUT while there's UUT running on other port \ position
- Table hit by another table while UUT test in progress

| | Possible Causes | Verification | Possible cause (Y/ N) | Proposed Actions |
|---|---|---|---|---|
| <b>Machine</b> | Test Station:<br>1. Old *.DAT file causing long test run time.<br>2. DHCP server with Serial Number<br>2.1 IP Address<br>2.2 Uninitialized Serial Number<br>3. Empower Node Properties<br>4. Damage communication cables / connectors<br>5. Using trolley instead of fixed table | 26 Dec – 2019 Completed the removal of old *.DAT to all TE82882 PDA Final Tester.<br>03 Mar 2020 - UUT is tested as complete assembled unit and failure able to detect to below station. Test stations have yearly PM for CPU as per station required.. | Y | To perform daily task by Test EA as below before release tester to production<br>- Restart tester CPU (Workstation computer)<br>- Click Stop Acquity Process<br>- Clear Waters DHCP Server to address item 1, 2, 3, 4<br>- Ensure the Ethernet cable lock is not broken to address item 5. |

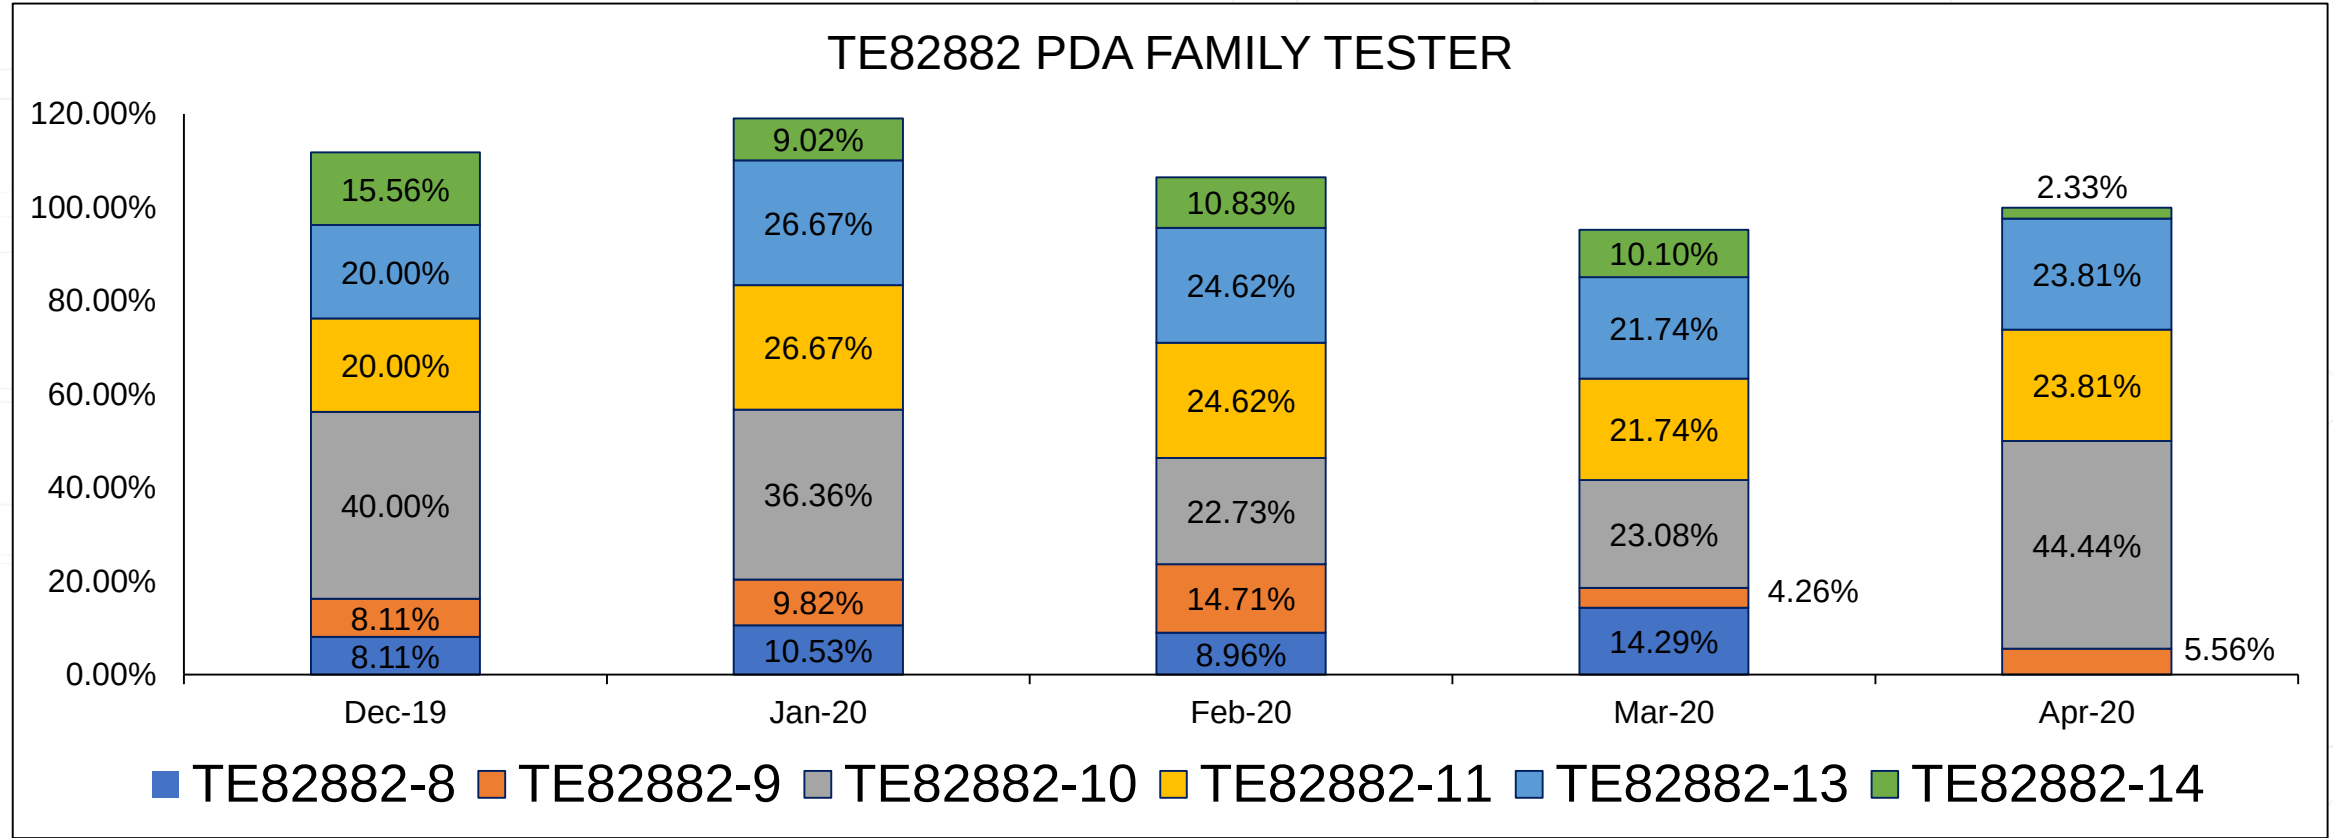
# Yield Improvement – Communication Failure

| PDA TESTER | Dec-19 | Jan-20 | Feb-20 | Mar-20 | Apr-20 |
|---|---|---|---|---|---|
| TE82882-8 | 8.11% | 10.53% | 8.96% | 14.29% | 0.00% |

- 26-Dec-19 Removed old \*.DAT files from all testers completed on 26 Dec 2019.  
 05-Feb-20 Cleared Uninitialized serial number/s in Empower Node before start of test  
 03-Mar-20 Check sheet for production to tick root cause of failure Add pre-check conditions in check list  
 06-Mar-20 Removed conflict address on Testers. ( Joel Informed HZL and Eric on 06 Mar 2020)  
     Tester TE82882-9 PDA conflicting address to 2998  
     Tester TE82882-13 PDA conflicting address to 2998  
     Tester TE82882-14 conflicting address to 2998  
 08-Mar-20 Stop usage of TE82882-8 in an attempt to load other tester  
 09-Mar-20 Installed with spacer in between UUT at TE82882-13 for simulation and study
- TE82882-8, 9 and 14 performed with lower loss comm failure
  - TE82882-10, 11 and 13 performed with higher loss comm failure
