# **Waters 2020 FPY Improvement Activities**

13 Aug 2020

# Yield Improvement – Communication Failure

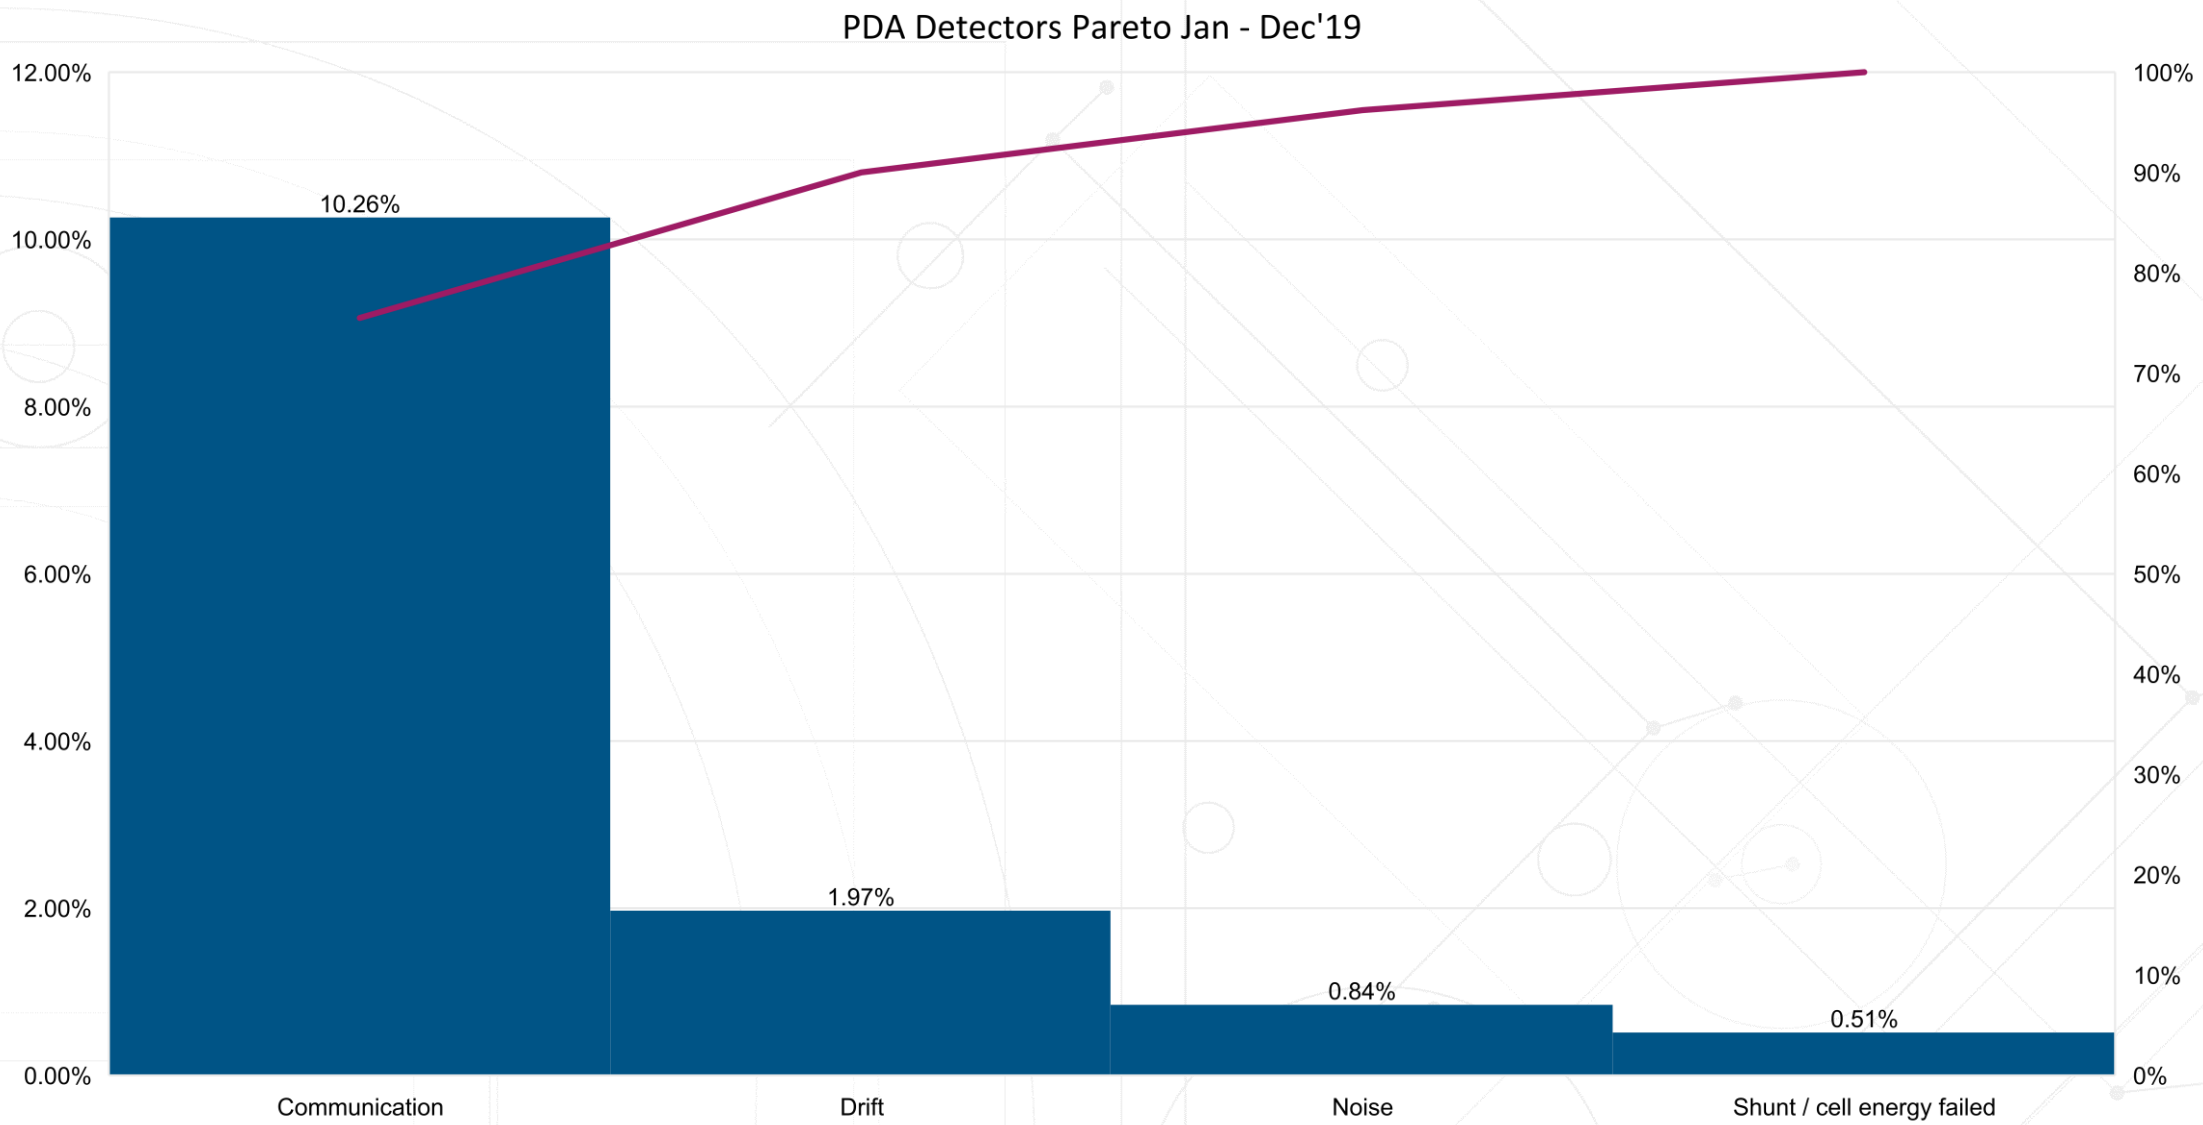
# Pareto Chart for PDA Detectors

| Failure Modes | PDA Detectors |
| Communication | 10.26% |
| Drift | 1.97% |
| Noise | 0.84% |
| Shunt / cell energy failed | 0.51% |
| <b>Total failure % contributed</b> | <b>13.59%</b> |

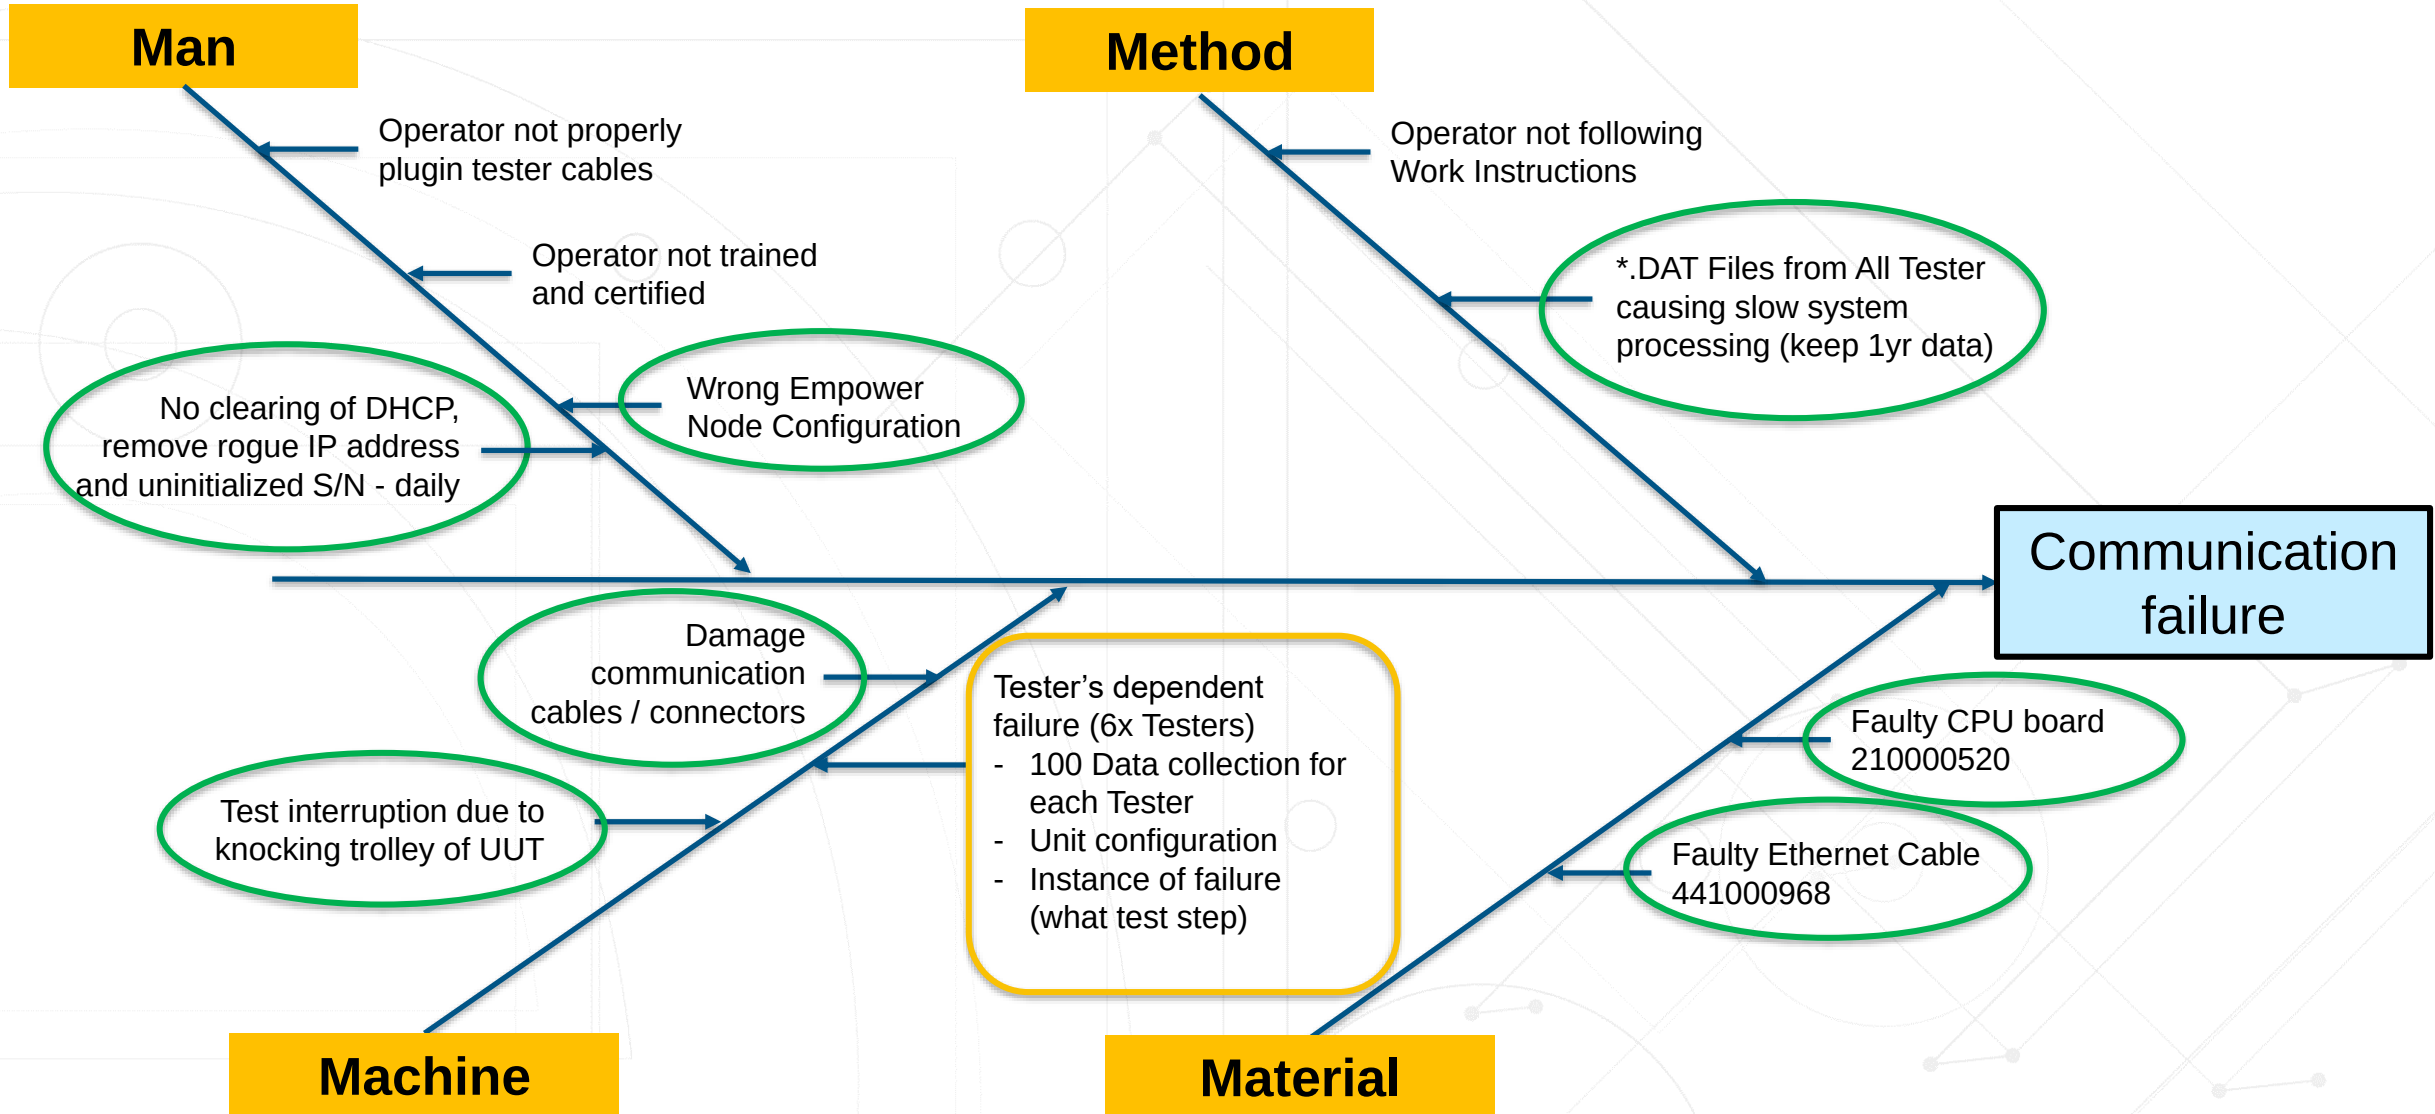
| Model | Target 2020 | Q1 2020 | Q2 2020 | Q3 2020 | Q4 2020 | Item | Progress |
|---|---|---|---|---|---|---|---|
| PDA Detectors | 77.44 % | 77.52 % | 65.19 % | 49.08 % | | Communication Failure | Completed 100 data points on all 6x Testers (EVALS20015)<br>TE82882-9, 10, 14 showing better yield<br>TE82882-8, 11, 13 showing low yield |

| | Possible Causes | Verification | Possible cause (Y / N) | Proposed Actions |
|---|---|---|---|---|
| | 3) Tester's dependent failure (6x Testers) | Data points per EVALS20015 showing high failure on 28 Testers TE82882- 10, 11, 13 | Y | 28 May 20 start to deactivate Testers TE82882- 10, 11, 13 |
