## ACQUITY UPLC H-Class or H-Class Bio System Troubleshooting Guide

This manual is a reference tool for field service engineers who are troubleshooting problems in ACQUITY UPLC H-Class® and H-Class Bio Systems (see [Figure 1](#)).

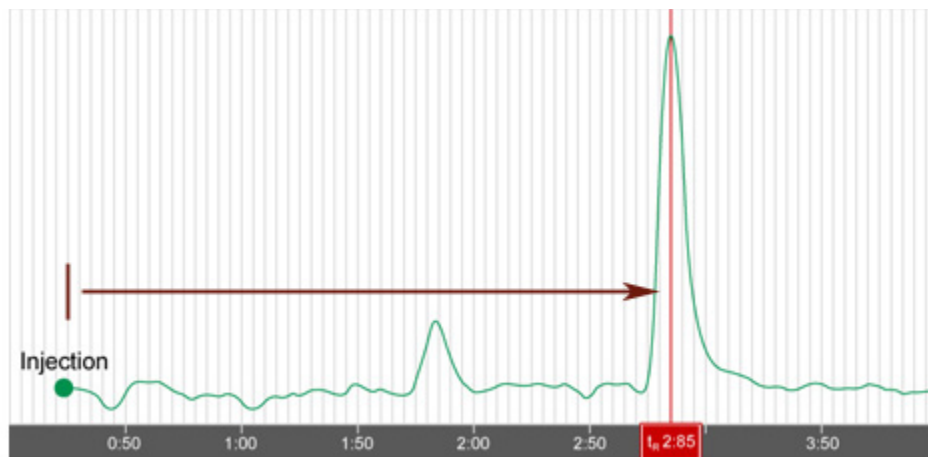
*Retention time* is the time it takes for the analyte to pass through the system from the moment of injection to the time when the peak maximum elutes (see [Figure 10](#)).

Figure 10 - Retention time

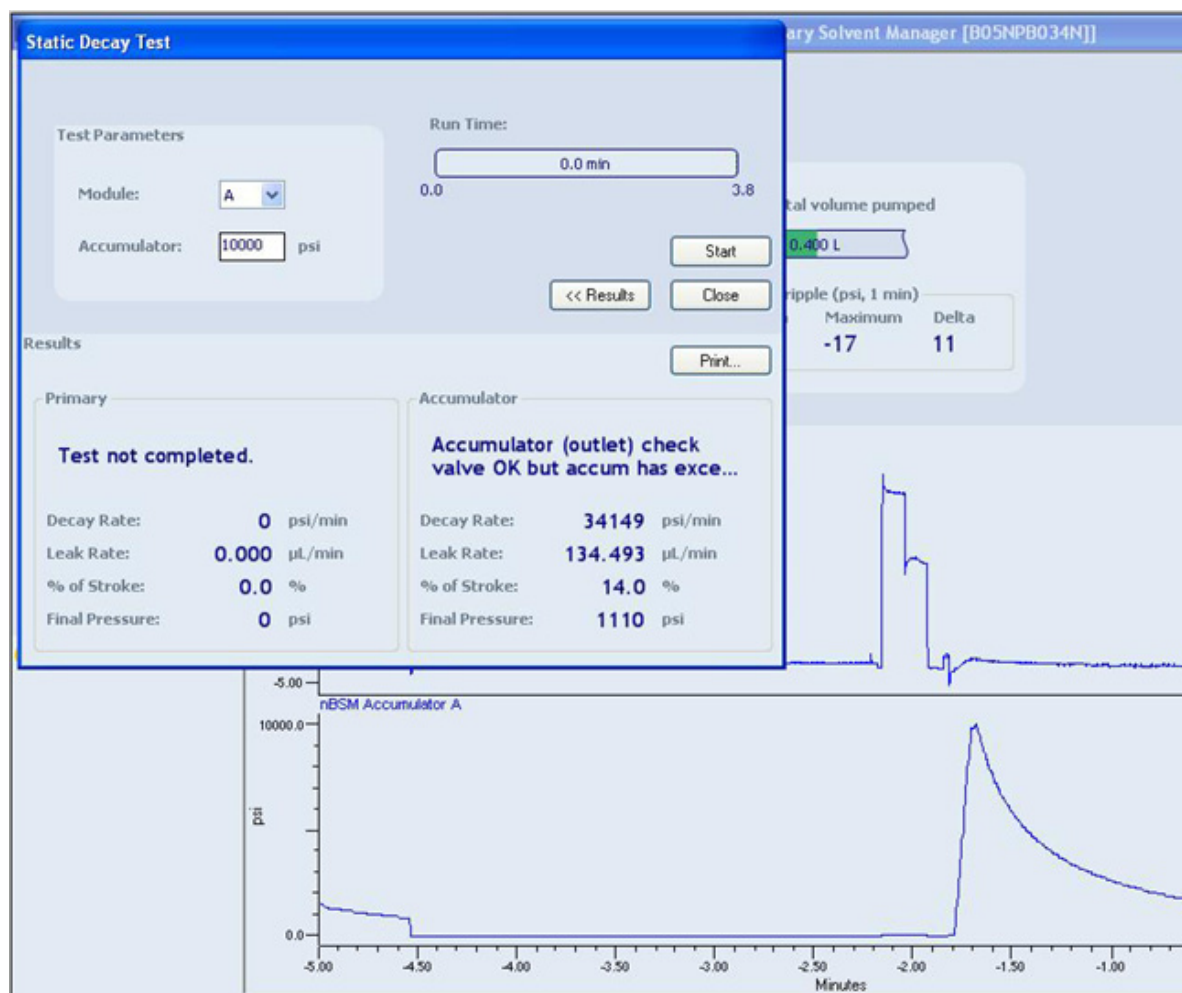
Figure 57 - Leak test (failure - primary pump)

The leak test performs a pressure ramp-up and then monitors the loss of pressure from the solvent manager to determine whether the check valves, tubes, fittings, or plunger seals are faulty. See [Figure 56](#) for an example of a passed leak test. ([Figure 57](#) shows a failed leak test.)

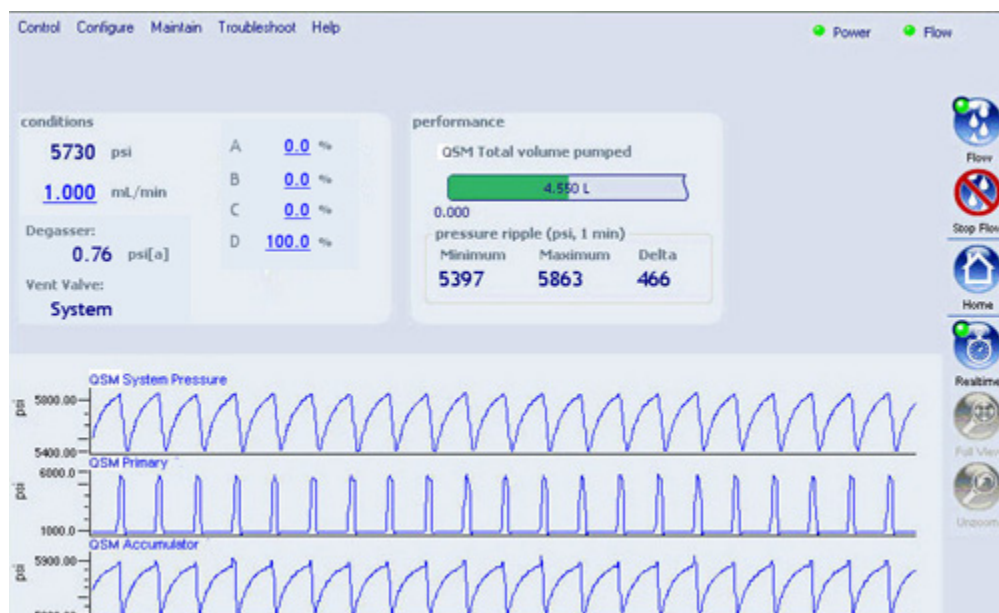
Figure 60 - Cyclic pressure increase
