# Evaluation of 20u 405001338 Needle

17 Jan 2019

- On 11 Jan 2019 evening, Eugene provided a base (guideline), to evaluate on the 10% failures reported at Alliance Injector Sub-assy in WW01-2019.

- About 50% of the needles found with scratches when checked under 40x magnification.
- Majority of the known good (no scratches) fresh needle are found with longitudinal scratches after testing.
- It may be a concern to observed longitudinal scratches on the known good (no scratches) fresh needle after testing. WPPL and Flex may need to look into this concern.
- As of to date 17 Jan 2019, it is still not known whether the needles themselves and/or possibly other associated mechanisms or parts, is/are causing the high reject rate (10% fallout) in Pressure Decay test .

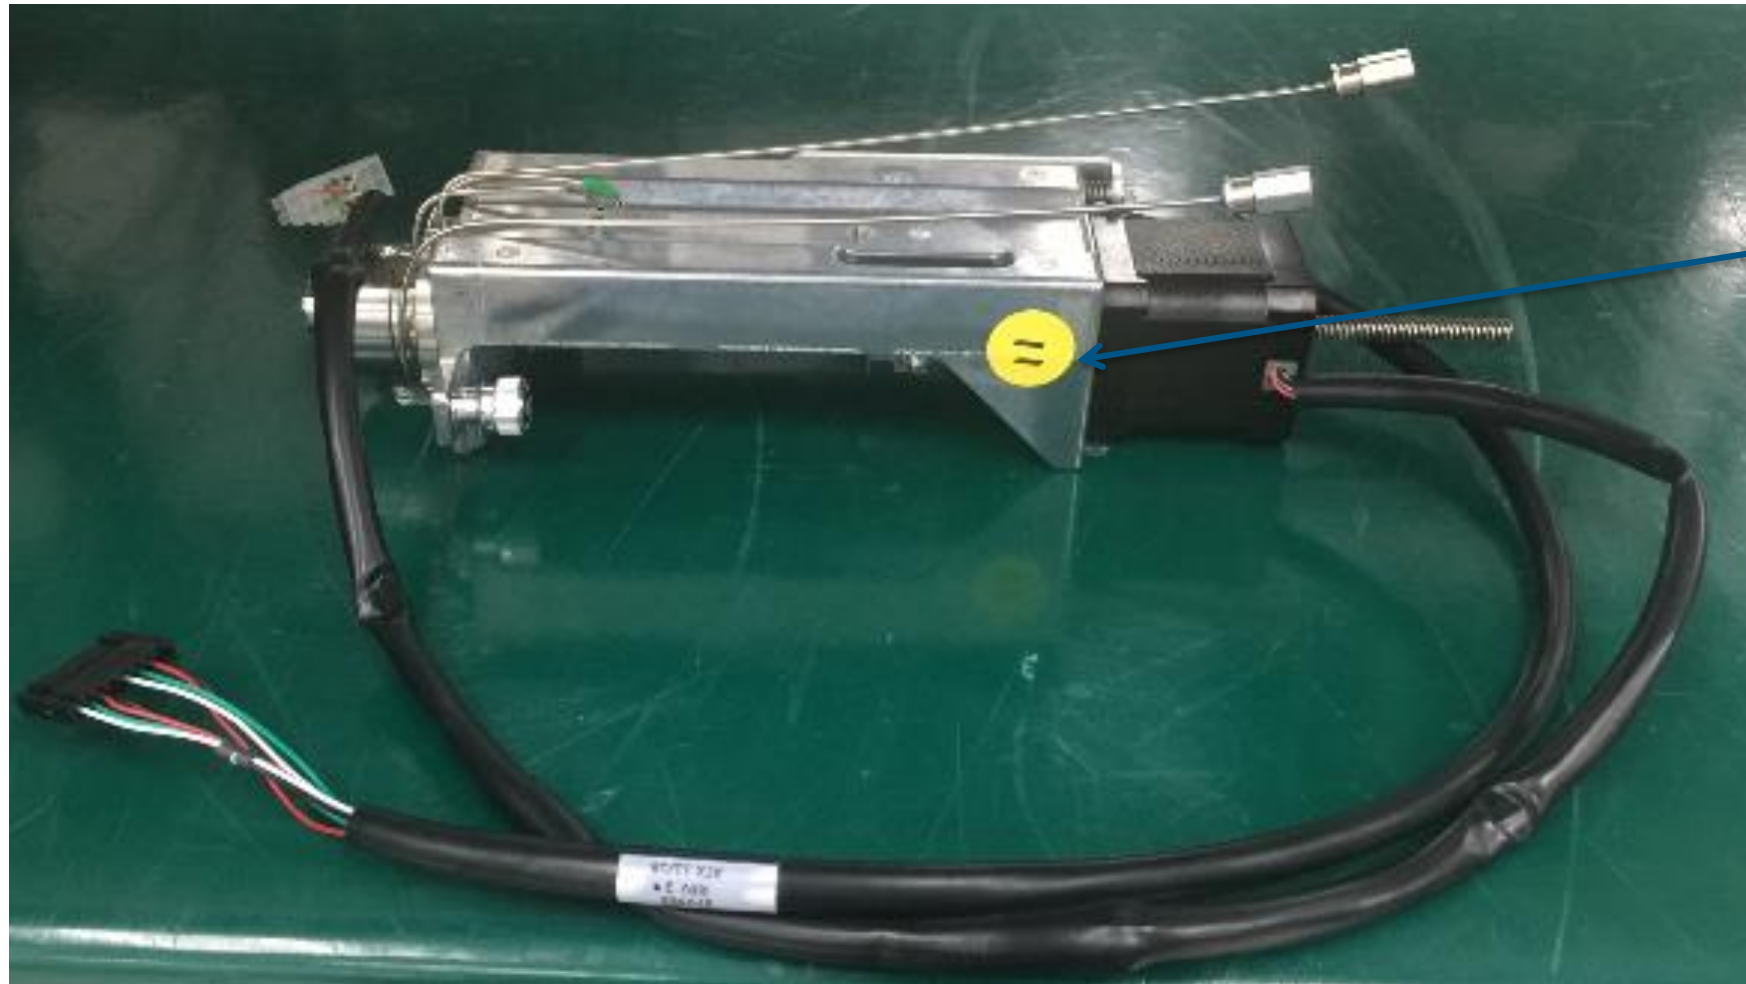
Number marking on Injector Subassembly based on Needle Sample # assembled to it
